# The Beaufort Preservation Manual

prepared for  
The City of Beaufort  
Beaufort, South Carolina

by  
John Milner Associates  
West Chester, Pennsylvania

August, 1979

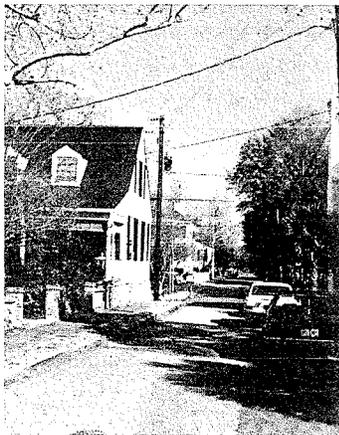
"Second Period" House Type

No early house has survived as it was built, but at least three structures near New Street, probably constructed before 1750, offer some strong suggestion for the plan and form of the early architecture.<sup>18</sup> According to this study's street survey, these examples suggest that at least two house forms were utilized in Beaufort's second and third periods of construction (1718-1750). The dwellings were timber framed and built on raised foundations of "tabby" concrete, a mixture devised from the local materials of sand and oyster shells. Some were one-and-one-half story, gable-roofed structures; others rose two stories above the raised foundation and were topped by a roof which was either gabled or hipped. In either elevation, the plan seems to have been limited to single-pile (one-room deep) construction. This plan was composed of a hall and parlor as adjacent rooms, or alternatively, hall, parlor, and center passage. The former would have best fit the requirements for a house 15' by 30', as set up in the early records. In either case, an outshut, or shed addition, may well have extended to the rear to provide added space on the principal floor.<sup>19</sup> The chimneys were brick and built on the exterior gable walls, sometimes in a "pilastered" or T-shaped configuration which visually expressed the various flues they accommodated. As a precaution against fire, the chimney stacks were constructed with a gap of several inches between the weatherboarded walls and the brick masonry.

Heart pine, obtained locally, and cypress, found in nearby fresh water swamps, were the major building materials used for framing and finish work. The interior rooms were either paneled or plastered and sheathed with horizontal wainscoting which covered the lower portions of the three exterior walls. Vertical board partitions were used to separate the major spaces into rooms and to box any stairs which may have been included in the interior plan.<sup>20</sup> It is also possible that stairs were either relegated to the exterior or assigned to stair towers built for the purpose.<sup>21</sup> Secondary buildings such as kitchens and servants' quarters were built close to the houses but without connection.<sup>22</sup>

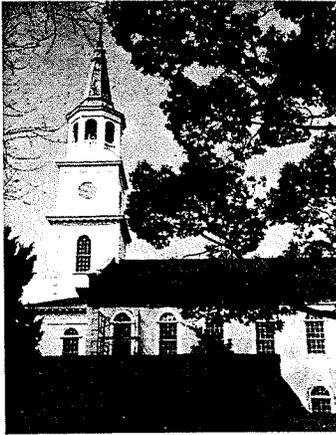
**St. Helena's Church**

church, St. Helena's, was disenfranchised. No longer a part of the British government, it became associated with the Protestant Episcopal Church in the United States, separate from but also akin to the Church of England. St. Helena's relied on the contributions of its parishioners rather than the overall support of the community. Coincidentally, the Methodist and Baptist communities began to grow just when the Anglican Church was fighting to survive. So, at the same time that the Palladian mansion became the grand Beaufort house type, the church as a building type was not emphasized. It was not until 1827 that the support of St. Helena's was strong enough to rebuild the church with a larger, galleried sanctuary. By 1842, the structure had assumed much of the form which, except for the steeple of 1942, it features today. This was a pretentious masonry structure in the Georgian mode with seven bays of two-tiered round-headed windows and an entrance porch and steeple.

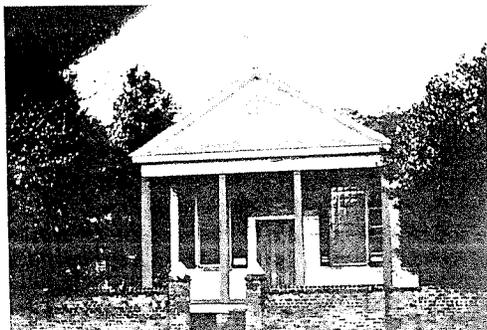
**Church of St. Peter the Apostle**

Carteret near King Street in 1846 was a chapel-sized building, probably smaller than the eighteenth century churches of the town. It referred, however, to the Greek Revival in its original proportions and classic in its attention to the more general relationship of voids to wall space and roof pitch to volume.<sup>29</sup> It quietly stressed an ecclesiastical reference.

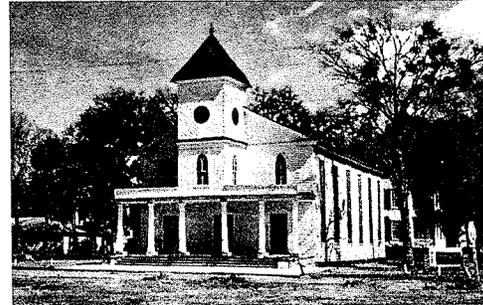
**"Praise Church"**

Other interesting examples of church architecture as applied to later nineteenth century style are churches based loosely on Gothic precedent but built in different generations, one in 1865, the other in 1900. Each was undoubtedly an economically conservative venture while also a successful house of prayer. The First African Church, familiarly referred to as "Praise Church," was built in 1865. Its free use of abstract forms seems to provide a direct reference to a new construction technique

known as balloon framing. Similar construction was used later in a Presbyterian Church at what is now 602 Carteret Street. Both exemplify successful use of picturesque materials which suggest, rather than copy, an academic style. Neither of the last two church structures is large, but each exemplifies a building type which conforms to church use, featuring a porch, a bell tower, an aisled sanctuary, and a chancel.

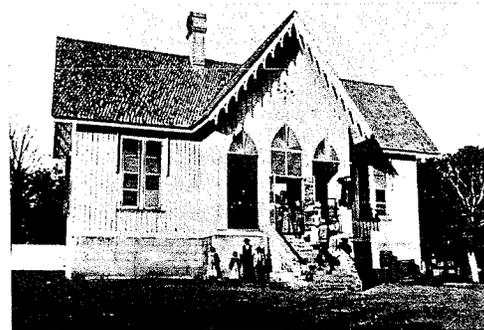
**Early School**

Architectural history tells us that schools, like churches, were generally advanced in their use of a building form which defined them as a type. No pre-1850 examples of schools as building types are known to exist in Beaufort, but the records suggest that, just as the Greek Revival was first used in Beaufort in church architecture, the Gothic Revival in its board-and-batten cottage form was used first for a school. Built in a cross form on a high foundation with a steeply pitched roof, "lancet" doors, and a curvilinear vergeboard at the gable's edges, this was a free frame construction<sup>30</sup> and, while it did not provide

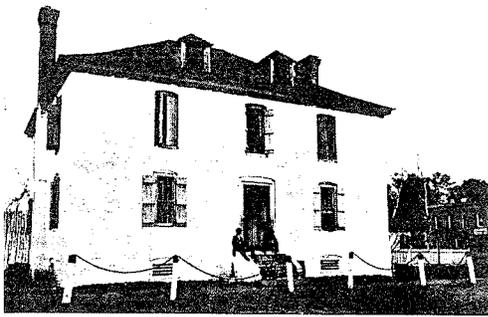
**Early Jail**

**Detention or Incarceration.** By 1740, a provincial law provided for a jail. Little is known of the building which served such a purpose unless it was the three-bay, hipped-roof brick structure which served as the Provost Marshal’s jail in 1863.<sup>32</sup> This may well be the case since the building was on “public” land (as established in 1710) east of the original Castle Square. The segmentally-arched windows and the general proportions of this long-gone structure assumed a date close to 1740. Other than the fact that this was a masonry building at a time when brick was not common in the area, this building was a typical dwelling in its overall exterior presence.

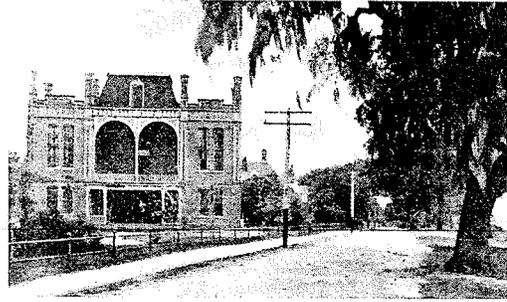
**Late Nineteenth Century Courthouse**

demeanor just as were jails. The epic era of courthouse construction came in the later nineteenth century when, sometime between 1887 and 1907, a monumentally eclectic building which featured a Romanesque entrance arcade was

built on a trapezoidal lot on Bay Street in the west end of the original village.<sup>33</sup> This structure was four ample bays wide; its recessed two-bay arcade stressed the second or principal floor and was flanked by single bays lit by paired double-hung windows. A “French” roof crowned the central two bays; the virtually flat roof of the outer sections was obscured by battlements. The “appended” quality of the design lent itself to interesting renovation later.<sup>34</sup>

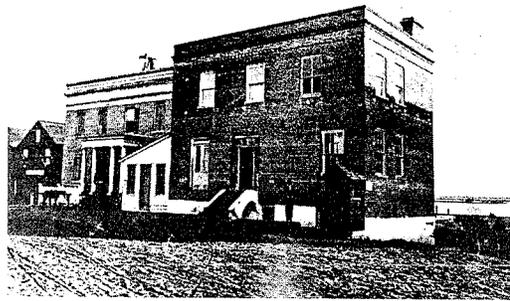
**Customs House**

Administration at the Federal level does not seem to have been stressed in the epic 1850’s when customs service represented high-level government. Like other public offices in the eighteenth century, customs services were usually housed in the home of the locally appointed officers or in rented rooms in a public house. A similar situation no doubt existed in Beaufort. In the nineteenth century, however, as America’s trade expanded, the Customs House as a building type became a prominent national symbol. It almost always presented a classical concept which provided a sense of firmness and unquestionable authority for a building which represented the Federal presence. In Beaufort, a Customs House was built sometime before 1860, indicating foreign trade was conducted from the port. This building was a classic four-square masonry building with an “in antis” porch on the south side placing frontal stress on its waterfront facade. If it followed tradition in plan, it featured not only offices but spaces for Appraisers’ Stores.

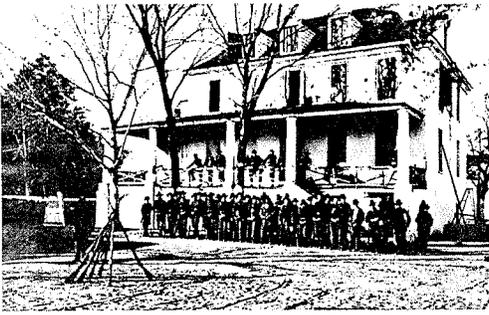
**Mid-Eighteenth Century House Form**

At the domestic level, the growth of the town continued through the mid-eighteenth century, but little “imagery” was deliberate before the late 1760’s. Early Beaufort by this time was essentially a commercial town where merchants and factors, intent on making the most of diversification, traded local crops for tools and household goods. There were at least three dry goods stores on Bay Street,<sup>35</sup> and the warfs nearby served ships which then connected Beaufort with the larger cities of the coastal colonies. A Civil War photo of a house then at the corner of Port Republic and West Streets exemplifies what could be the robust form of domestic architecture from

1745-1760. This displayed a chaste exterior which was nevertheless expanded to a two-story-over-raised-basement, double-pile plan. The major feature of this big box was the roof which was hipped or hip-on-hip. A similar elevation survives today at the corner of Boundary and Carteret Streets.<sup>36</sup>

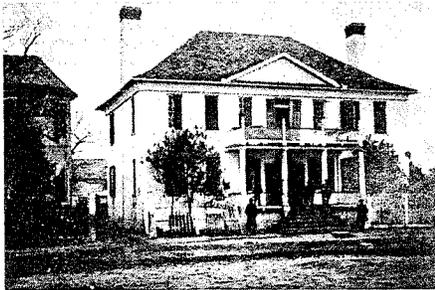
**Mid-Eighteenth Century House Form**

In another undated but bold example, a house built at the east end of Bay Street, there was a decided, almost Dutch, flair to the lower edge of the roofline. The cornices were coved, typifying the earlier William and Mary phase of classical evolution in American architecture. Each of these mid-century examples is conservative in its use of subtle detail, such as the single-stage porch. Each also stressed a piered basement, one high and the other low.

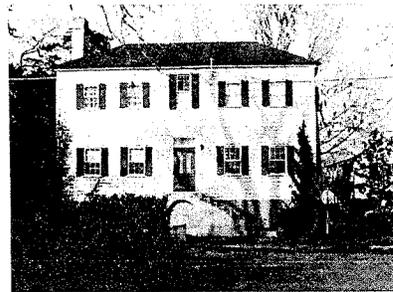
**Eighteenth Century House Form**

Just as local agriculture began to encourage the trade which had made mid-century new construction possible, the growth was interrupted by war with England. The c. 1776 William Johnson House is thought to be one of the very few structures built between 1770 and 1780. In form, this house harkened back to the second period, single-pile plan with exterior chimneys. Its attention to new concepts seems to have been concentrated on the interior where cornices, mantels, and other trim were delicately carved.<sup>40</sup>

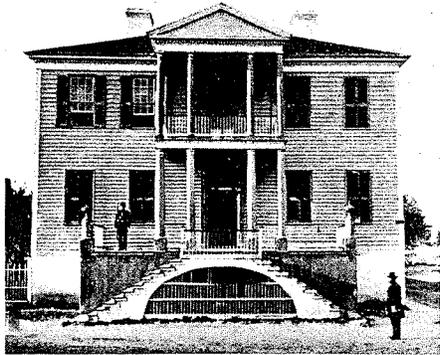
**Federal Era House Form**

In keeping with this suggestion of new wealth, the planter elite used Beaufort as a new resort to escape from the danger of fever so prevalent in a plantation summer. Coincidentally, at least five mansions were built within the limits of the town.<sup>43</sup> Based on the Palladian concept of triadic rhythms, delicate details, and harmonic proportions (principles tempered by a continued conservative approach to construction and a restrained use of the delicate Adamesque detail), these were two-story and two-and-a-half story, five-bay homes. They featured the hipped roofs and raised basements used earlier, but otherwise differed greatly from their less imposing antecedents.

More often than not, the major new feature was a projecting portico. This was a distinctive yet conservative motif in the form of a frontal, two-stage porch. It provided a feature in which Orders would normally have been superimposed (using the Doric on the first floor and the Ionic on the second floor, as an example). But, in Beaufort a simpler variation occurred and the Doric Order was used at each floor level with a differentiation in the size of the columns serving to identify each level. The columnation was set in a three-part Palladian rhythm, emphasizing a wide center bay flanked by two lesser bays. This tripartite detail was also employed in Palladian windows. In each example, a round-headed opening, flanked by two shorter and narrower openings, was set as a unit in the rear (north) wall to light the stairway and provide a significant interior focal point at the landing area. Elliptical fanlight windows over entrance doors provided a similar delicate but useful light source as an architectural focal point.

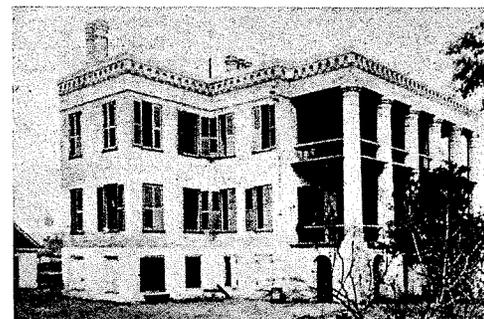
**1850's Veranda - Colossal Order**

While the mansions used colonnaded verandas to stress the Orders, the more vernacular shops and cottages used a limited amount of molded trim, and confined their classical reference

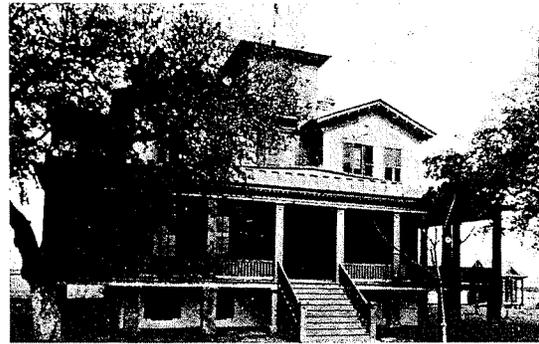
**1850's Italianate Mansion**

national vitality of the time in which it took place. By the 1850's, once the new framing systems were possible and inexpensive dimensioned lumber was marketed in the north, the Italianate style, classic in form but romantic in concept, and the cottage-Gothic, an even freer style, became the popular "picturesque." In Beaufort, the picturesque was usually limited to bracketed eaves, parapeted cornices, or beveled eaves. One Italian villa, however, was erected on the easternmost section of the Point, emphasizing the picturesque in its asymmetrical balancing of Classical forms. It fit easily into the community, providing a new concept of Classicism.<sup>52</sup>

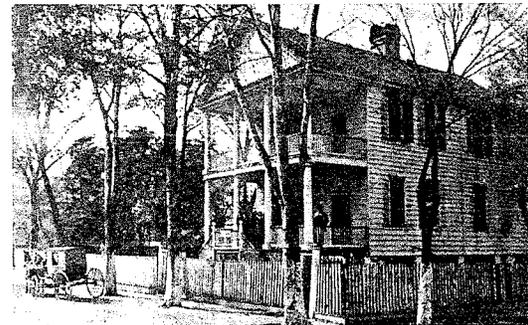
**1850's House Form**

Most of the fervor for new construction and renovation seemed concentrated on the building of mansions. Few modest homes which favored the Greek Revival were built before 1860. Those that were, were built on the less favored rear lots and took three forms: the two-story temple-form house, oriented to the street, the two-story traditional form, oriented to the south, and the one-story cottage.<sup>53</sup> Built on piers or raised basements, these usually were houses which featured pillared verandas; they were particularly significant in their representation of a lesser dwelling type adopting elitist detail. They represented the homes of the local businessmen who had come to Beaufort before 1860.

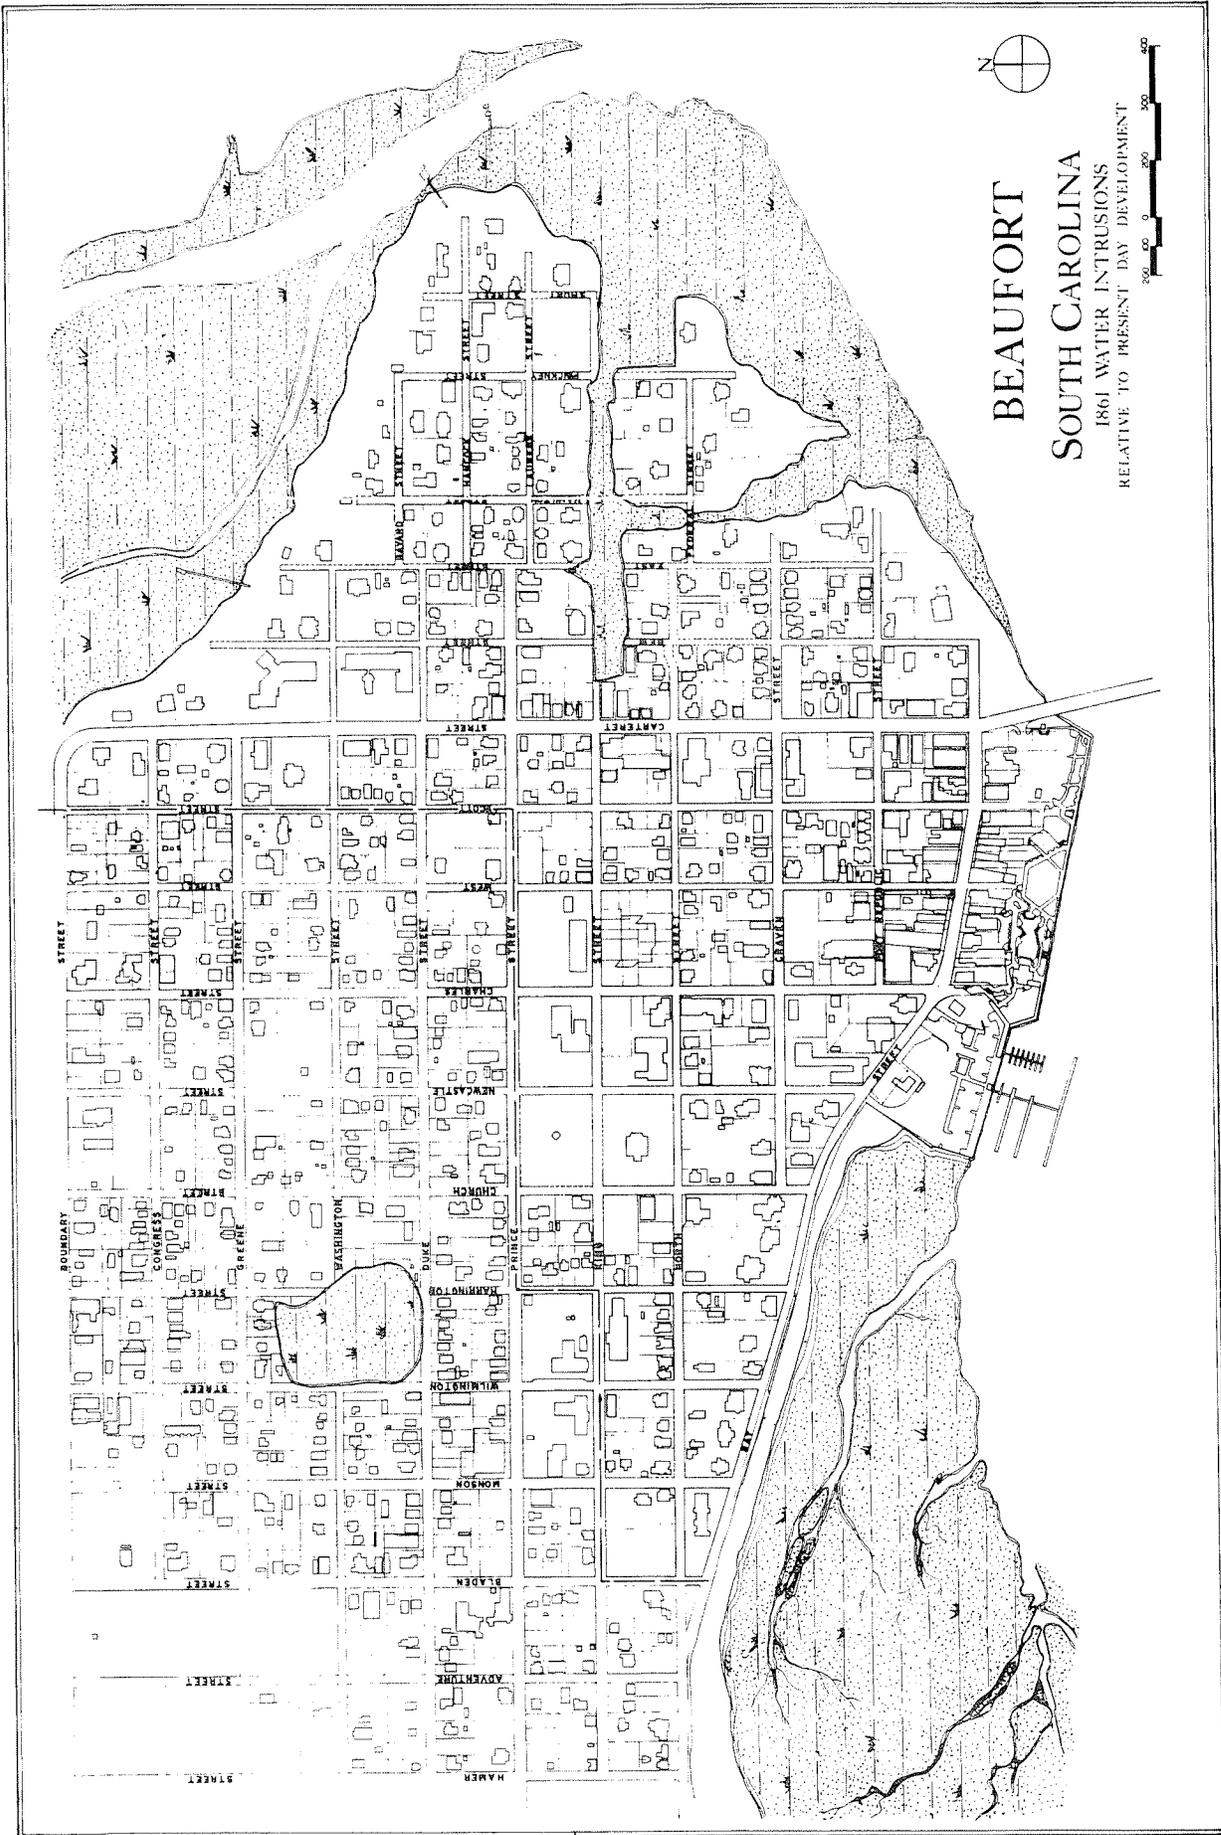
**BEAUFORT**  
**SOUTH CAROLINA**  
 1861 WATER INTRUSIONS  
 RELATIVE TO PRESENT DAY DEVELOPMENT

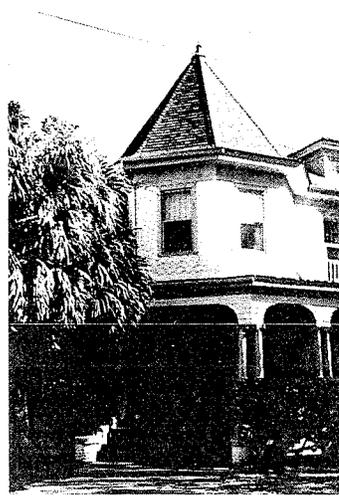
**"Queen Anne" House**

as "Queen Anne," these exemplified Americanization of a more serious English style. Because of its concentration on multiples and irregular massing, the style was probably the most contradictory form ever to be built in Beaufort. Only three examples seem to have been constructed and two of these were in the west end of town.<sup>66</sup> While these could have been residential responses to the similarly romantic Courthouse, there is also the suggestion that more freedoms were taken in the western section throughout Beaufort's developing period.<sup>67</sup> The more transitional examples, leaning toward the Colonial Revival, were built on the Point where the scale and style was dominated by the 1850's showpieces. The one exception was the Yacht Club. Built at the foot of Scott Street at the waterfront, this Queen Anne building suited its lighthearted role before it was so unsympathetically renovated.

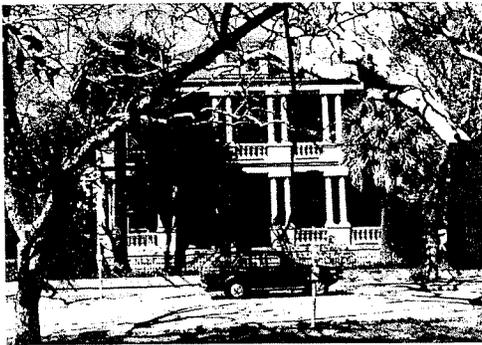
**“Beaux Arts” / Beaufort Mansion**

Just as the new construction of the 1870's had used new "cheap" building techniques, the rebuilding effort which followed the fire also encouraged new technologies and new design details. At the legislative level, an Ordinance of Council mandated tin roofs in any new construction after the fire.<sup>69</sup> At the innovative private level, the William Joseph House was built of concrete stone and reinforced concrete in 1909, featuring radical new materials for residential construction.<sup>70</sup> Although inspired by the Beaux Arts aesthetics which had been spurred on by the Columbian Exposition of 1893, it freely adapted its paired, stubby Doric columns to a Beaufortian two-stage veranda, correctly superimposing Orders in academic fashion. While indisputedly new, this mansion

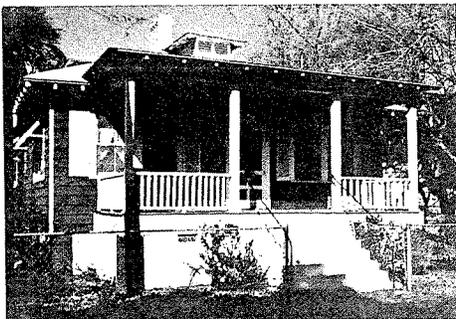
**Bungalow**

The bungalow in at least two forms dominated Beaufort’s new construction before and after World War I. It was devised from manufactured detail of the simplest and least expensive sort and limited in plan to a few spaces which performed multiple functions. In both form and materials, the bungalow was the same in Beaufort as it would have been in Davenport, Iowa, or Danbury, Connecticut, so that by 1925 Beaufort’s new development had no apparent reference to the past. Nevertheless, in the midst of new popular culture was the survival of many structures built before 1860. The elegance was not destroyed as “Everymans” homes were inserted.

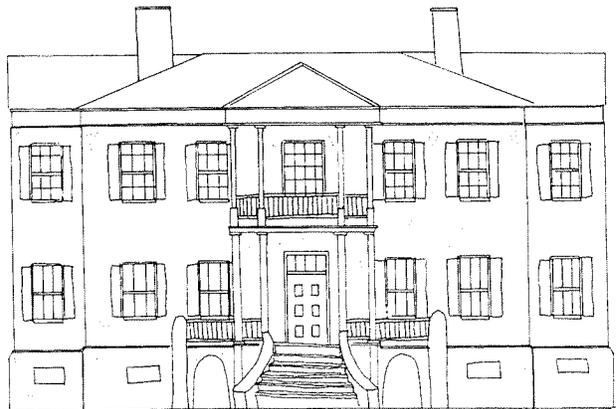
1211 Bay St.  
Tabby Manse

The illustrated examples show the following characteristics typical of this style:

- squarish proportions in the building mass
- vertical proportions in wall openings
- symmetry at the Main south facade
- low hipped-roof profile with symmetrically placed chimneys
- two-story pedimented porch at center bay; columns of upper stories are generally more slender
- thin window trim
- 5-bay facade
- clear relationship to ground -- no foundation planting
- detail refined and attenuated -- articulated cornice, slender balusters and low-relief detail at door architrave. The entrance detail, showing the door and fanlight trim at the Verdier House, is directly influenced by the work of the popular late eighteenth century English architect, Robert Adam, using

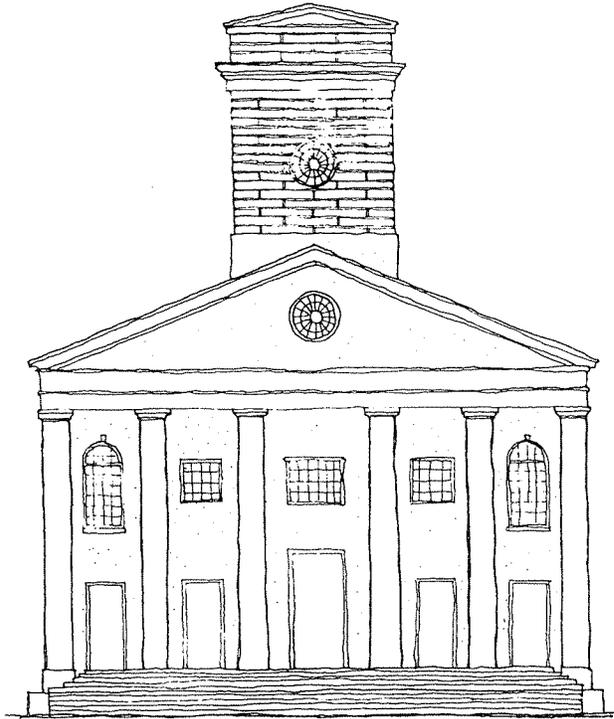
**Beaufort Baptist Church**  
600 Charles St.

(shown prior to addition of modern steeple)

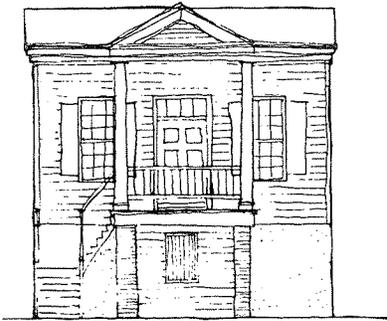
**Office for Freedmen**  
701 Craven St.

(demolished)

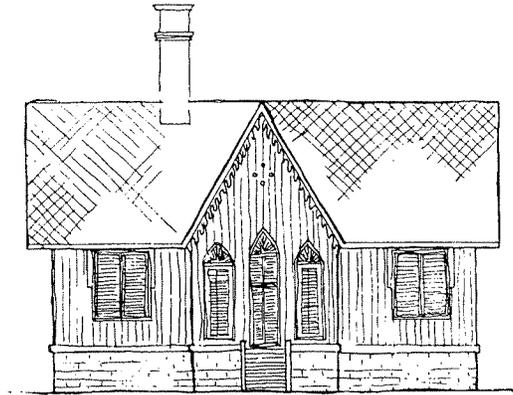
**Boy's School**  
Corner, New Castle & North  
(demolished)

- pointed arch openings
- window tracery
- steeply pitched gable roofs, often with ornamental vergeboards
- thinness of window tracery and moldings, often to the point of apparent fragility
- monochrome color, frequently of earth or stone tones with trim painted in darker hue of same color
- polygonal chimney pots
- vertical board and batten popular for wood siding
- scored stucco finish
- beginnings of minor and sporadic planting at foundation (see "Landscaping").

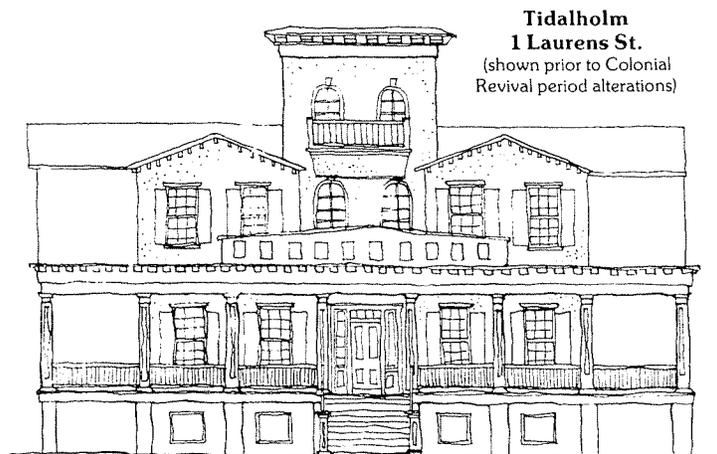
**Tidalholm**  
1 Laurens St.  
(shown prior to Colonial Revival period alterations)

**Italianate** 1840-1880. This style is virtually non-existent in Beaufort. However, Tidalholm, as it looked c. 1864, was originally a fine Italianate mansion before it was so significantly altered in the Colonial Revival period.

- The Anchorage, in which a Colonial Revival renovation added exuberant historically-inspired ornament to what had been a rather restrained facade
- Tidalholm, in which a fine Italianate mansion was cleverly transformed by Colonial Revival alterations
- 901 Craven, in which a pedimented “Beaufort Federal” porch at the center bay was removed and replaced with a Colonial Revival 5-bay porch spanning the width of the entire facade

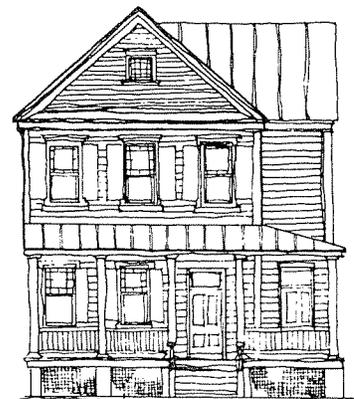
**The William Ritchie House**  
1307 Bay St.

(shown prior to  
modern porch alterations)

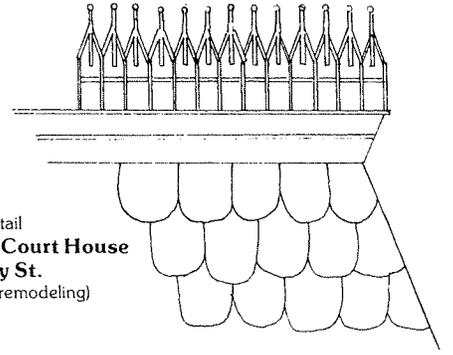
Roof Detail  
Beaufort County Court House  
1503 Bay St.  
(prior to c. 1930 remodeling)

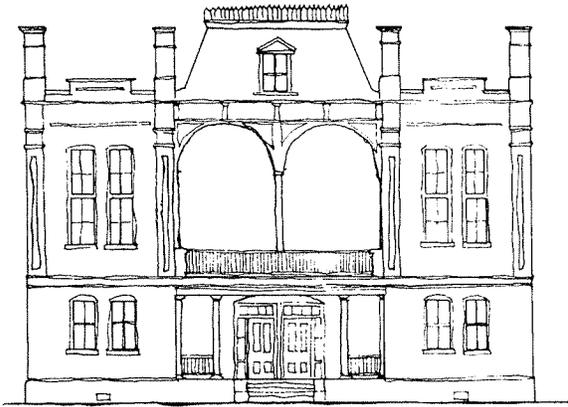
Beaufort County Court House  
1503 Bay St.  
(shown prior to c. 1930 remodeling)

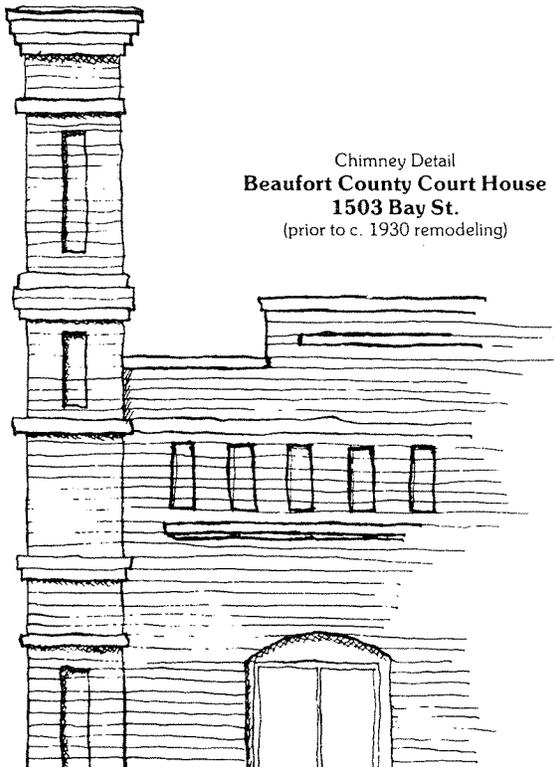
Chimney Detail  
Beaufort County Court House  
1503 Bay St.  
(prior to c. 1930 remodeling)

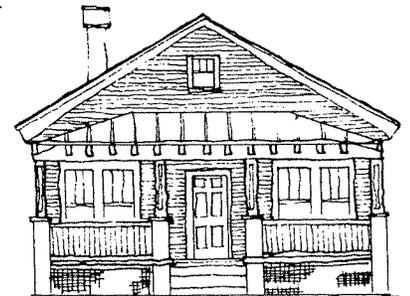
1311 North St.

The illustrated examples exhibit the important characteristics of this popular style as it appears in Beaufort:

- 1 or 1-1/2 story, 3-bay, entrance at center bay
- horizontal proportions
- elevated masonry porch piers, often battered
- frame construction
- set back from walk with small front yard and continuous foundation planting
- stock molding at doors and windows, often with no ornament at all
- gable roof facing street
- exposed rafters at porch and eaves
- 3/1 windows common, often in pairs
- simple square spindle porch railings
- window and door lintel trim often projects past jamb.

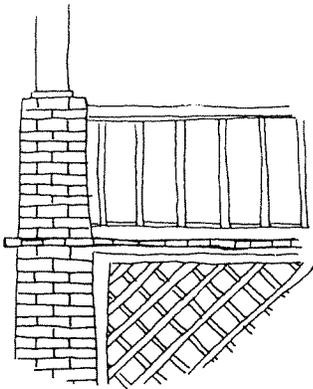
Porch Detail  
Bungalow Style

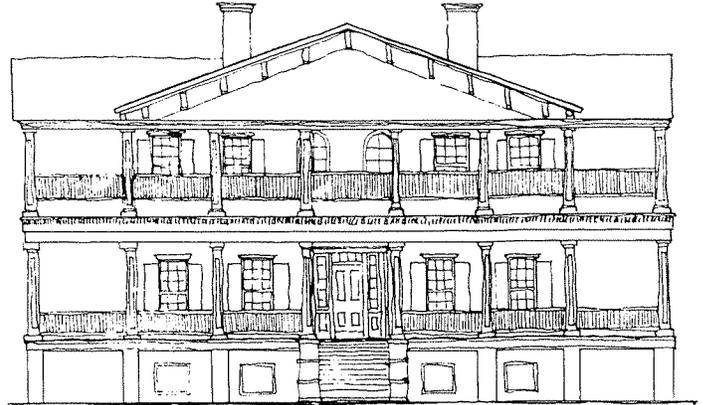
Tidalholm  
1 Laurens St.  
Colonial Revival Renovation

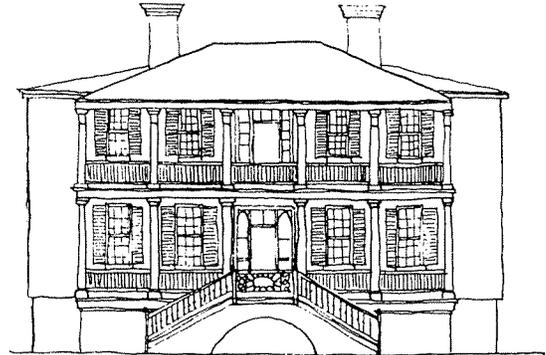
901 Craven St.  
Colonial Revival Renovation

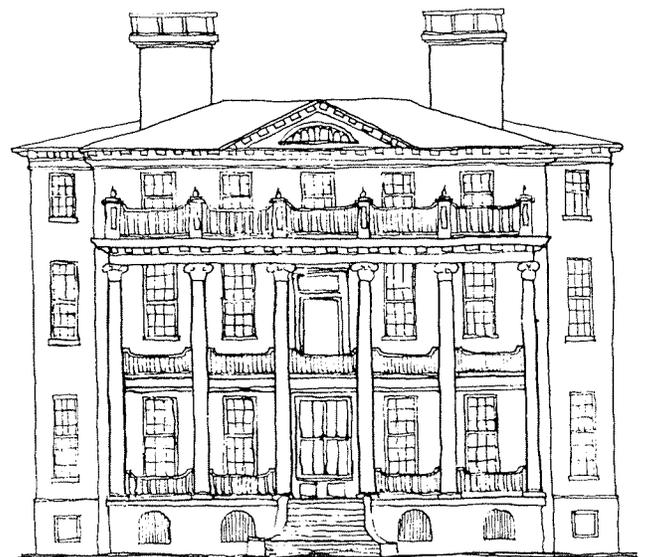
The Achorage  
1103 Bay Street  
Colonial Revival Renovation

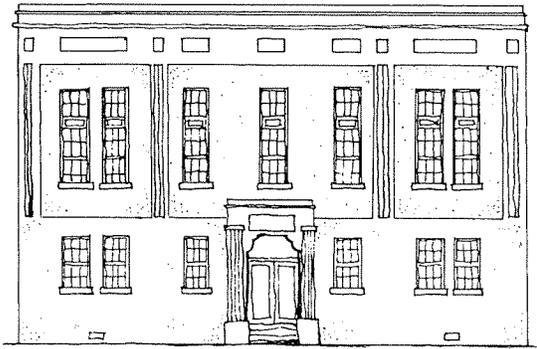
1503 Bay St.  
Beaufort County Courthouse  
Art Deco Remodeling

- The Beaufort County Courthouse, a renovation of an earlier structure (see “Queen Anne”)
- The Beaufort County Jail -- 1305 King

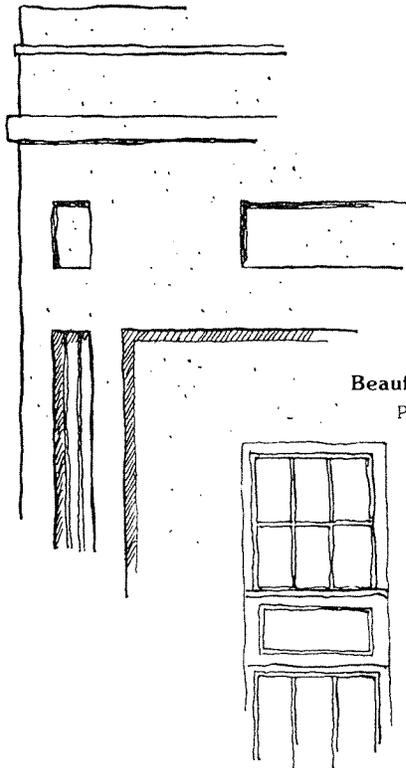
1503 Bay St.  
Beaufort County Courthouse  
Parapet & Window Detail

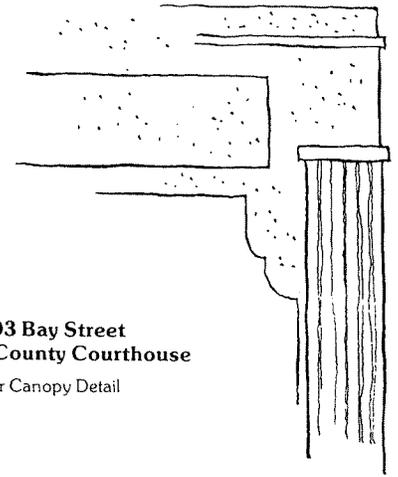
1503 Bay Street  
Beaufort County Courthouse  
Door Canopy Detail

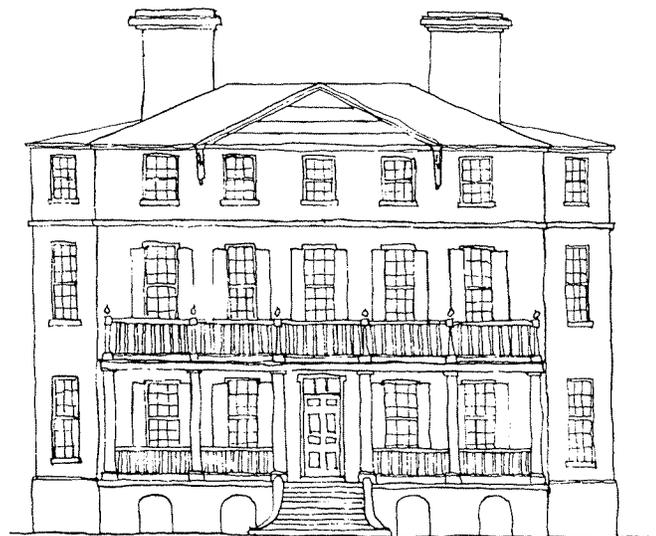
The Anchorage  
1103 Bay St.  
(shown prior to Colonial Revival Renovation)

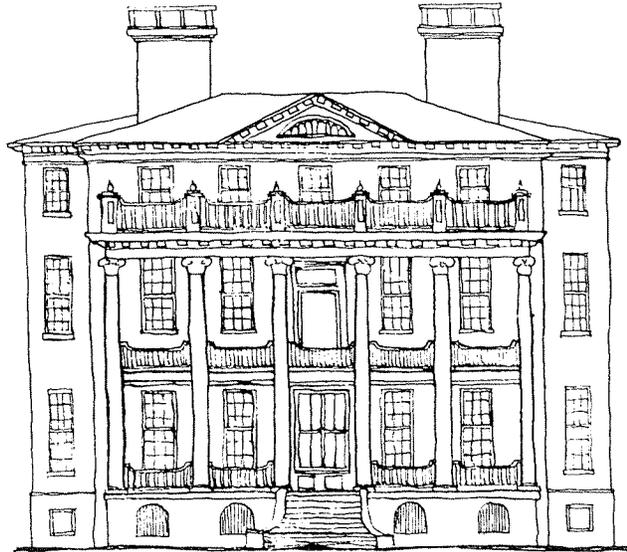
**The Anchorage**  
**1103 Bay Street**  
 Colonial Revival Renovation

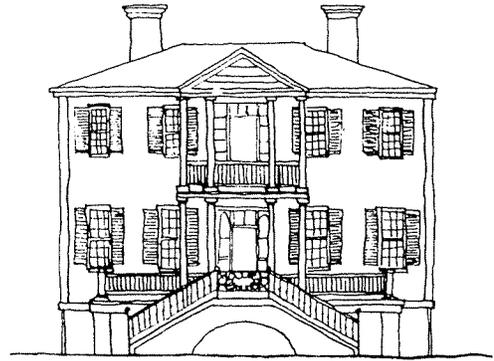
**901 Craven Street**  
 shown prior to Colonial Revival Renovation

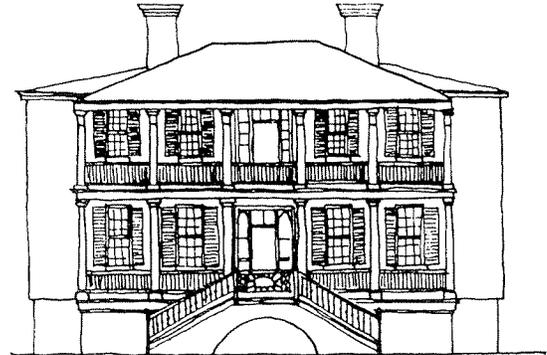
**901 Craven St.**  
 Colonial Revival Renovation

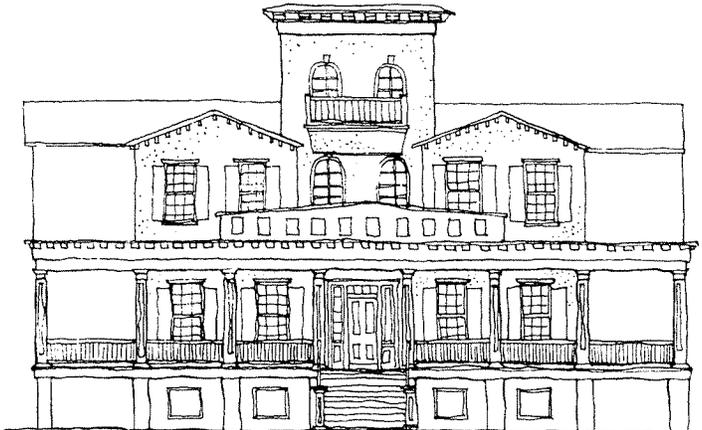
**Tidalholm**  
**1 Laurens St.**  
 (shown prior to Colonial Revival Renovation)

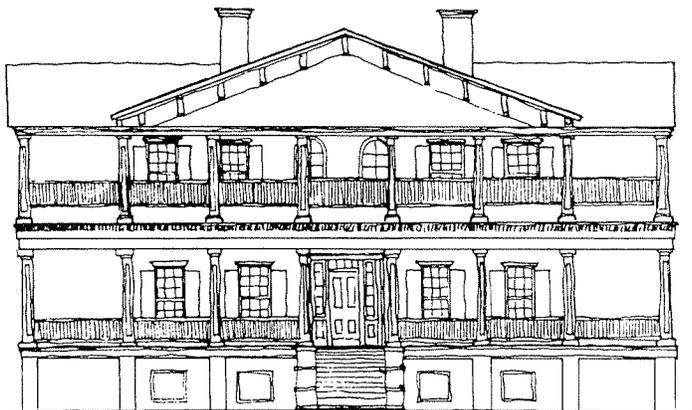
**Tidalholm**  
**1 Laurens St.**  
 Colonial Revival Renovation

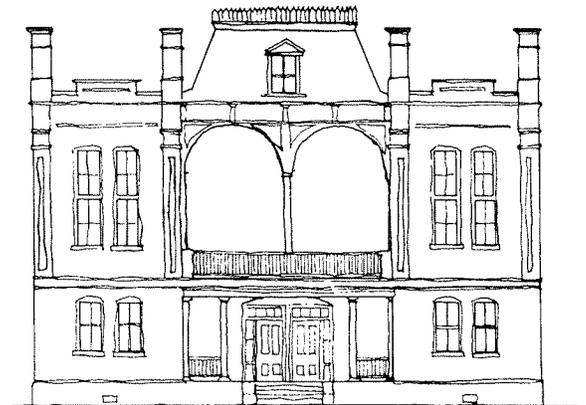
**Beaufort County Courthouse**  
**1503 Bay St.**  
 (shown prior to c. 1930 remodeling)

- The Beaufort County Court House, in which a remarkably successful Art Deco remodeling completely changed the appearance of an equally dramatic late 19th century eclectic structure displaying French, Moorish, and Classical influences.
- The George Elliot house, in which a second story porch was inserted into an existing colonnade in the Colonial Revival period.

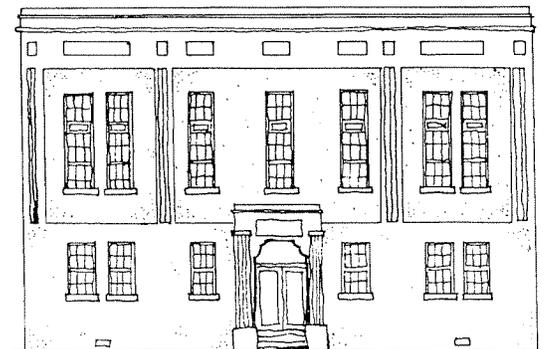
**1503 Bay St.**  
**Beaufort County Courthouse**  
 Art Deco Remodeling

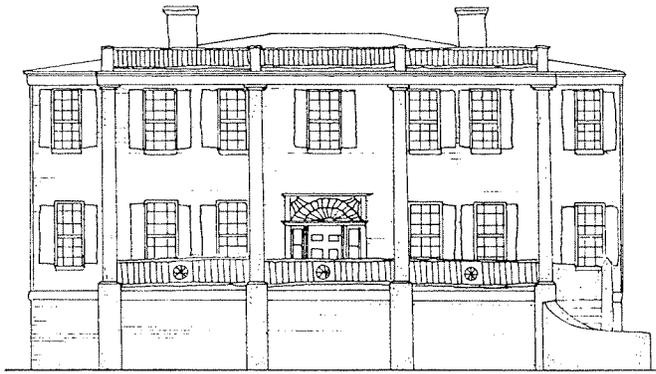
**George Elliot House  
1001 Bay**

(shown prior to addition  
of second story porch  
& relocation of stair)

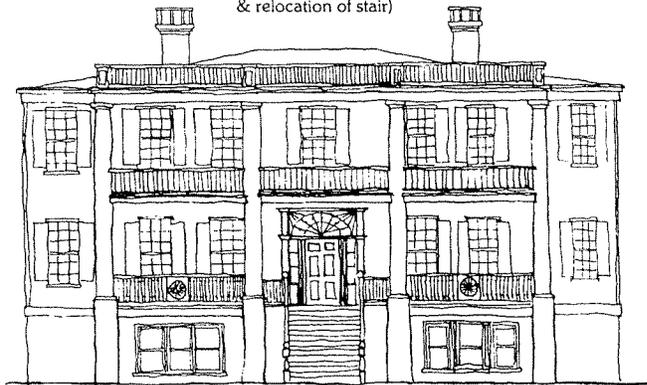
**George Elliot House  
1001 Bay Street**

(shown in current condition,  
with second story porch added)

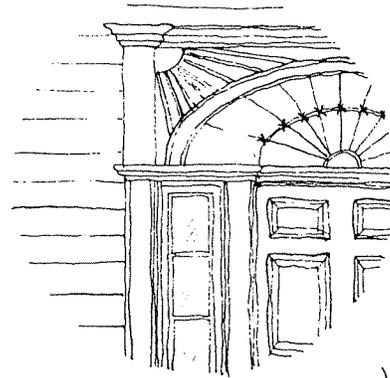
**Door Detail  
George Elliot House  
1001 Bay St.**

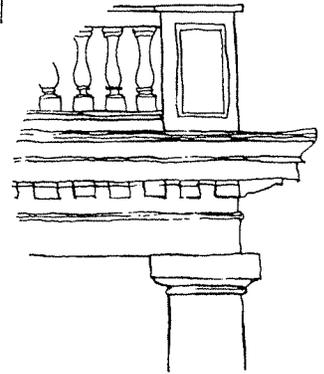
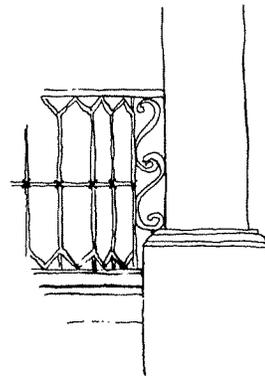
**Porch Cornice/Parapet Detail  
George Elliot House  
1001 Bay Street**

**Porch Detail/Cast Iron Railing  
George Elliot House  
1001 Bay Street**

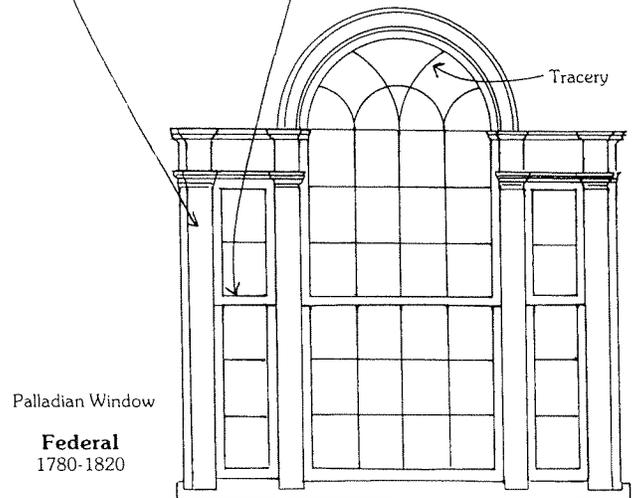
Palladian Window

**Federal**  
1780-1820

- The Palladian window so popular at stair landings on the north facade of Beaufort's houses is an early 19th century motif. It also was the inspiration for the tripartite flat-headed window which appears on such houses as 400 Wilmington and 501 King and which dates from the 1800-20 period.

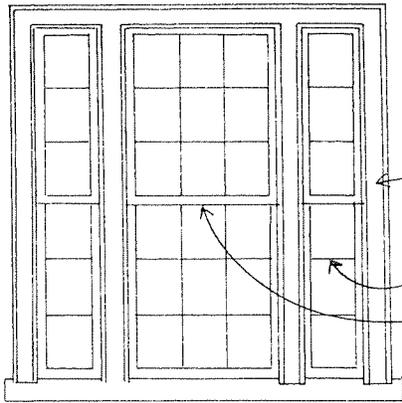
Tripartite Window  
inspired by  
Palladian Theme

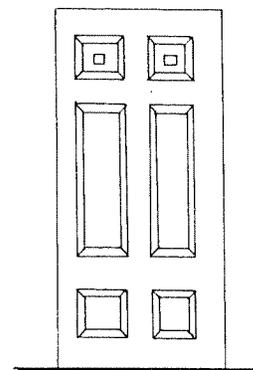
Bead At Center Stile To Imitate Double-leaf Door

**Doors** - Doors with arrangements of six or eight panels are not in themselves representative of any particular period of American architecture. Alterations in the basic design over time expressed themselves largely in panel trim and moldings.

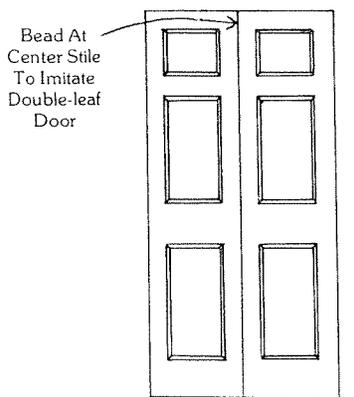
Bead At Center Stile To Imitate Double-leaf Door

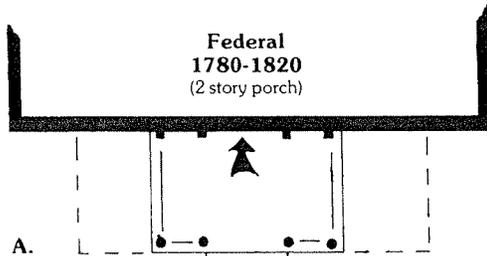
- A.
- 1203 Bay (original porch)
  - 1211 Bay
  - 901 Craven (original porch)
  - 412 East
  - 302 Federal
  - 705 Washington

- The three bay double stage portico shown in illustration A is typical of the Federal period in Beaufort. Generally, the end bays are narrower than the center bay (a 1-2-1 rhythm is common) and the columns of the upper story are more slender than those of the lower story.
- The “Beaufort style” porches illustrated in plans B—H cannot be directly linked to any of the commonly accepted styles of American architecture. Each betrays a range of stylistic influences which shows up mostly in details such as balusters and columns, described below.
- The three-bay, double stage porch spanning the width of the house with entrance in an end bay is illustrated in drawing J and is a Queen Anne period porch plan.
- The three bay single story porch spanning the width of the house with entrance in the center bay is typical of the bungalow style as it appears in Beaufort (K).

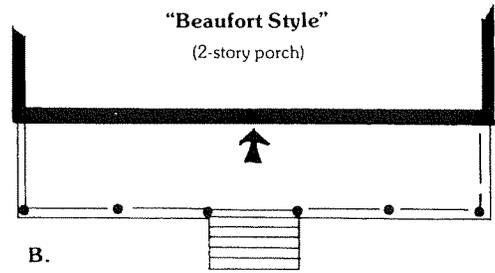
- B.
- |              |             |                   |

**Porch Plans.** Certain porch plan types can be attributed specifically to particular architectural styles, although of course they may reappear many decades later as a Revival. The “Buildings” section of this chapter illustrates many of these porches; it is the intent of the accompanying plans to categorize certain porch types by era:

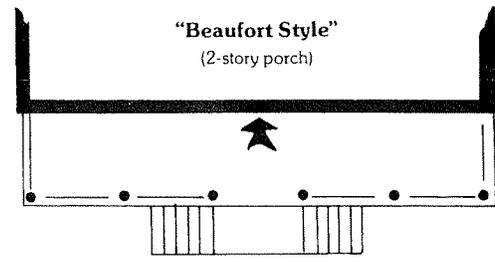
- C.
- 1207 Bay
  - 901 Craven
  - 901 Prince
  - 315 West (1 story)

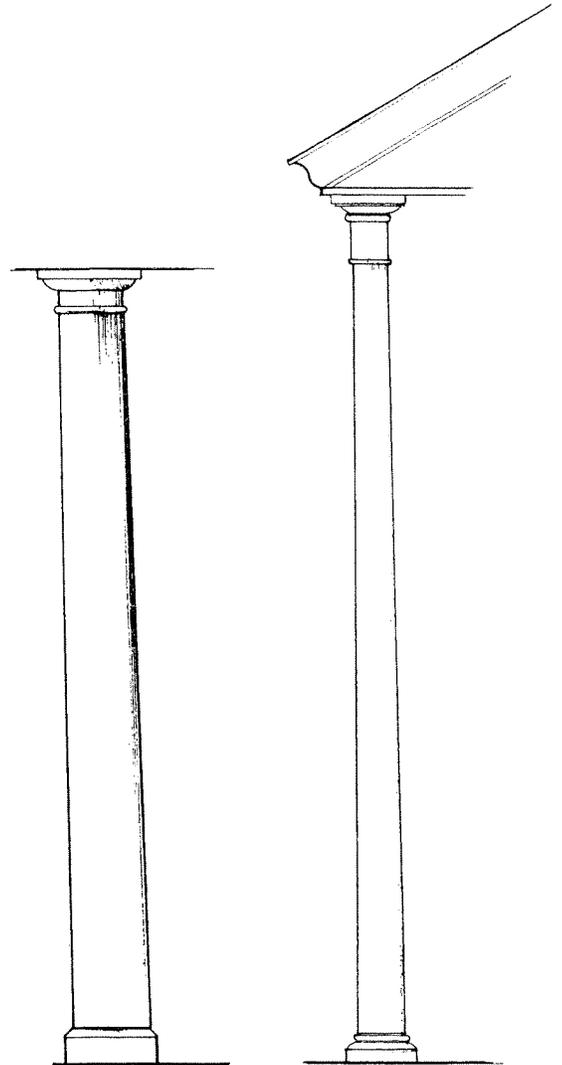
**A.**  
Verdier  
Federal  
1780-1820

- Federal columns (see illustrations A-F), exhibited the same refinement as other details characteristic of this style. Proportions were often slender, as for example in the delicate second floor columns of Tabby Manse or the Verdier house. Most columns of this period were careful to exhibit "entasis" (the slight inward curve, or taper, or the upper two-thirds of the column) which contributed strongly to their studied and graceful appearance. Entasis was also found on square columns (illustration F).

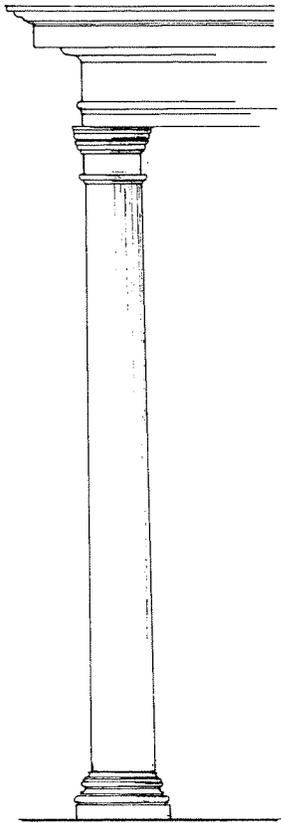
C.  
1790  
**Federal**  
1780-1820

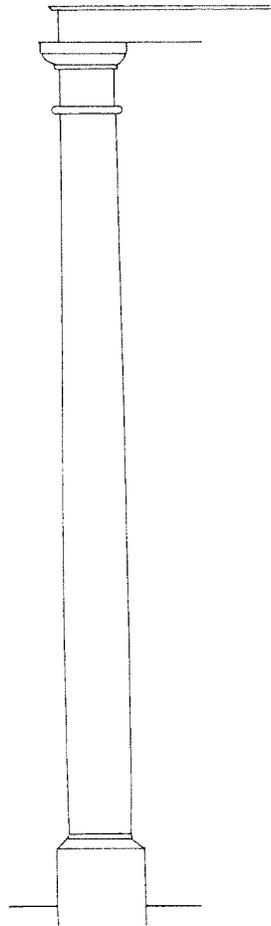
D.  
Tabby Manse  
1st Floor  
**Federal**  
1780-1820

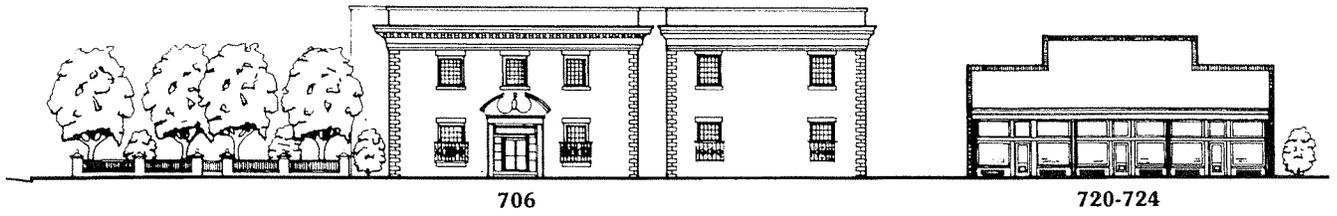
706  
720-724  
South Side, Bay Street

- Remove brick and aluminum storefront.
- Install wooden Doric pilasters at pier lines.
- Install new wood storefronts between each pilaster.

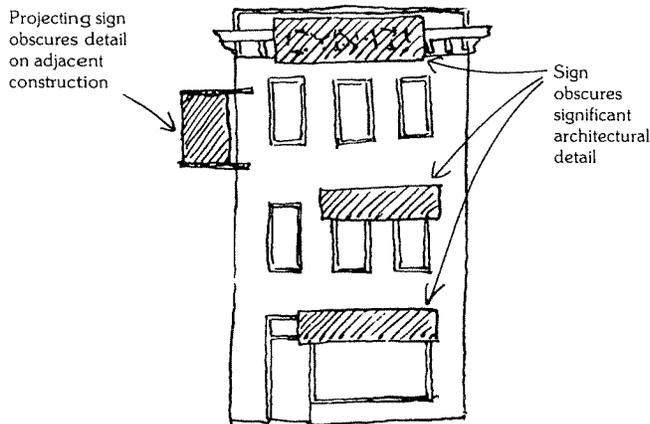
**Inappropriate Sign Locations**

- No sign should be allowed to interfere with a neighboring store. Thus, no sign should extend beyond its property line nor should it obscure adjacent signage or architectural features from view.

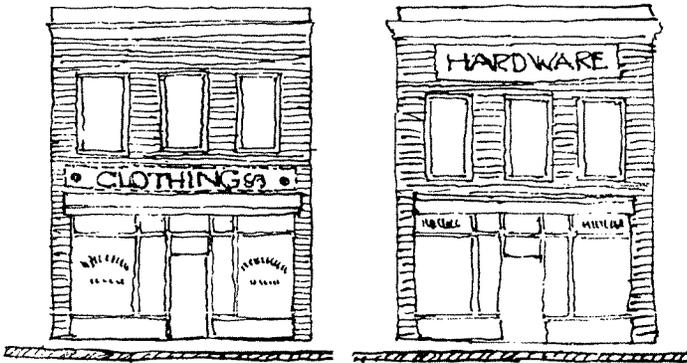
**Appropriate Sign Locations**

- New storefront improvements should not obscure signage or architectural ornamentation. For example, a new awning should not be mounted so as to obscure an existing sign or storefront cornice.
- Signs should be placed where they best complement the building; for example, on blank expanses of wall or building areas that are clearly designed as potential sign locations (e.g. large plate glass windows, painted overlights, or broad plain fascias in the cornices).

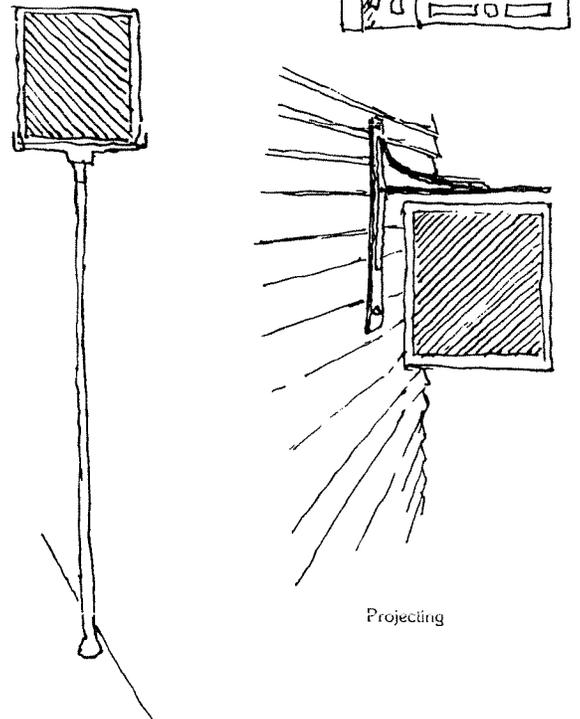
**Appropriate Sign Designs**

At first floor cornice

On display window case

Projecting

Freestanding
