# The Beaufort Preservation Manual

prepared for  
The City of Beaufort  
Beaufort, South Carolina

by  
John Milner Associates  
West Chester, Pennsylvania

August, 1979

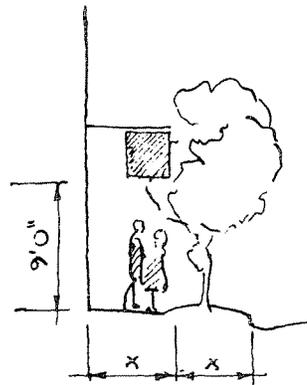
**Projecting Signs:**  
Recommended Placement

- Signs should never be allowed to project to the extent of presenting a visual or physical hazard to vehicular or pedestrian traffic. All necessary vehicular sign lines must be maintained. To prevent vandalism, conform to general storefront heights, and be easily visible to pedestrians and motorists alike, projecting signs should maintain a clearance of approximately nine feet from sidewalk level.

Buildings from the early twentieth century should be allowed to erect signage consistent with the period of structure. Such signs were often projecting, three-dimensional, and lit with incandescent bulbs or neon. However, this type of sign should **only** be permitted where dictated by the particular architectural style or period of the facade.

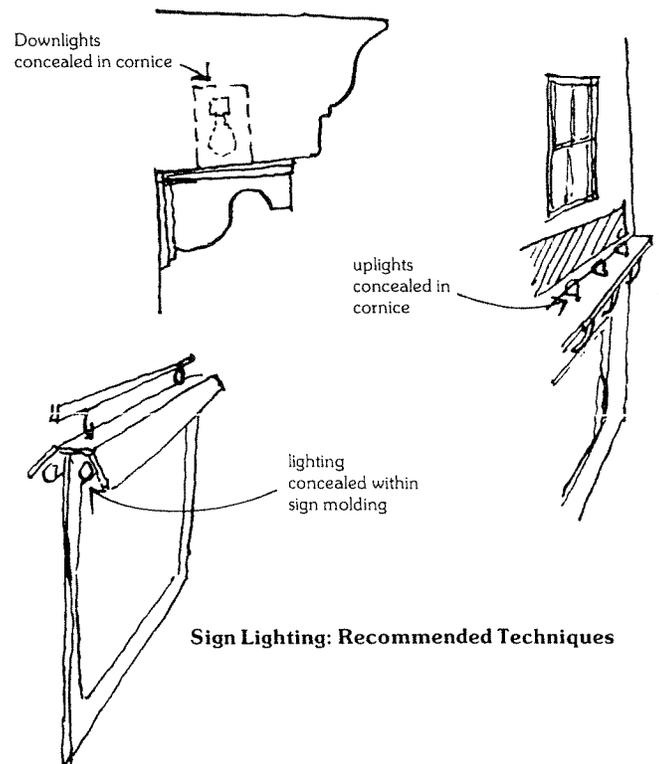
**Sign Lighting: Recommended Techniques**

**Lighting** - Concealed (or indirect) incandescent lighting is almost always to be preferred for signage in the Historic District. When considering a proposed sign, the review board should be certain that the illumination will not glare for either the pedestrian or driver. Exposed spotlights are unnecessary in a well-designed sign and should be actively discouraged. With adequate street lighting, it may be possible to omit the separate illumination of any building signs.

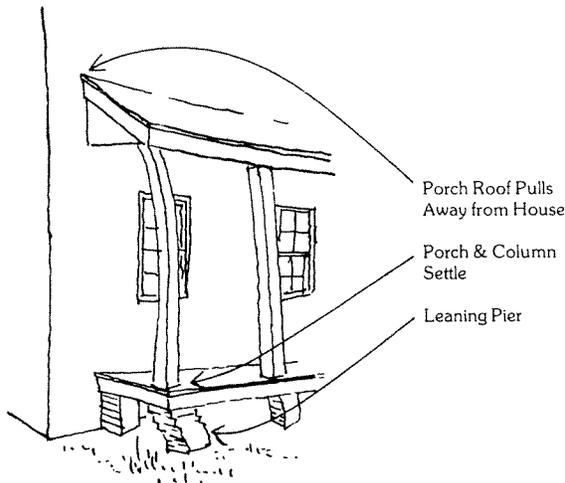
As the porch piers lean away from their intended position, the column and porch floor will settle to a new location pulling the porch ceiling along. Such strains can often put an excessive load on structural elements that were not designed for such work.

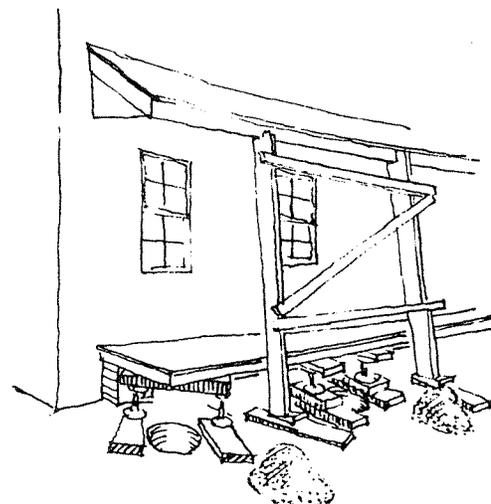
**Shoring Techniques**

Repairs for settlement and leaning: The preliminary requirement for solving pier problems is an awareness of shoring devices and techniques. Shoring is a means for temporarily supporting architectural elements such as porch floors or roofs while work is being performed on the structural members that normally support them. **CAUTION:** Again, a professional engineer should be consulted for advice as to the best method for any given condition. Structural problems can compound themselves rapidly, and the removal or revision of a supporting pier that may have been in position for one hundred years is not to be undertaken lightly.

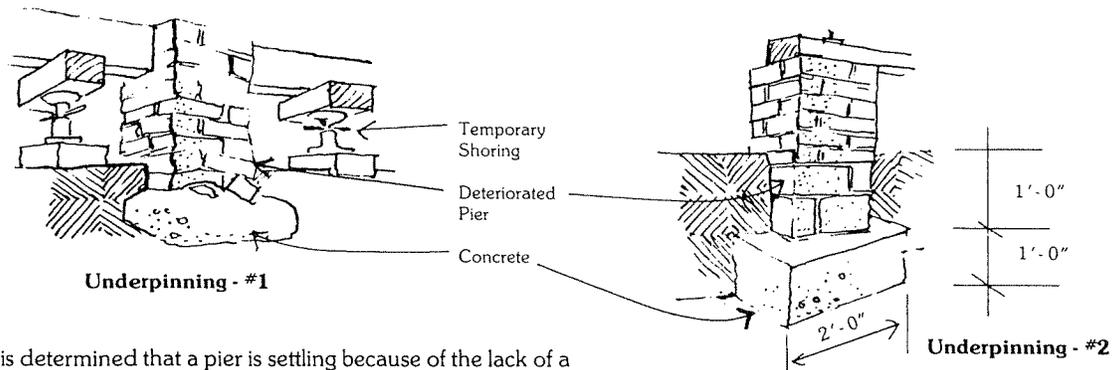
If it is determined that a pier is settling because of the lack of a foundation or the addition of unexpected or eccentric loads, a common solution can be provided by “underpinning,” a process by which a modern concrete spread footing is installed beneath an existing pier or wall. This is always done in stages to prevent the necessity of digging out the entire base of soil below the affected area. Temporary shoring is a necessity. Both the shoring and the staging should be determined by a structural engineer. There are two repair options: the first, although crude, could be fairly effective, but not so much as the second which is of a sort that a competent engineer would recommend. Such a repair requires the construction of wood forms to receive the concrete, and the laying of concrete masonry to form the pier base. Each of these options is beyond the capacities of the average home repair buff and demand an experienced and sympathetic contractor.

(Note: the dimensions given in the illustrations are in no way absolute and are only meant as a rough guide to the amount of material the property owner should expect to need.)

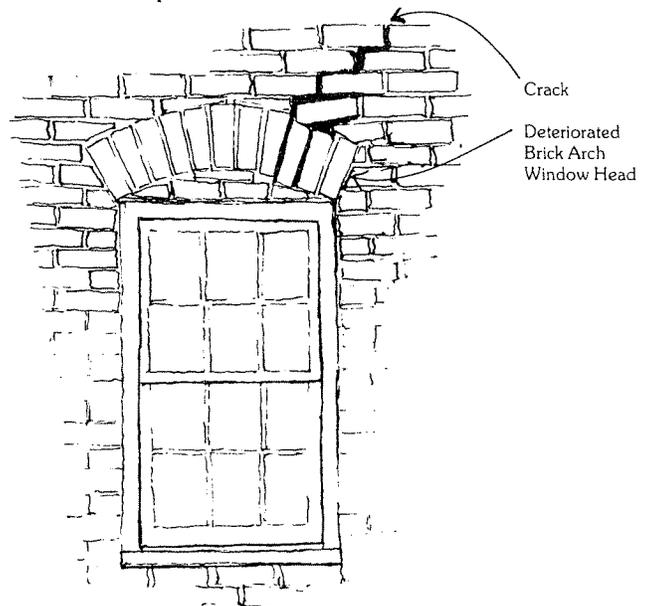
- Brick arched-head windows. The arched head of a window fails either because of inadequacies or deterioration in the pointing or movement of the building as a whole. The latter usually appears as a problem common to several openings within a structure. In the former case, the arch must first be shored on a wooden centering form, which conforms to the arch profile. It can then be rebuilt as necessary. An experienced mason is required.

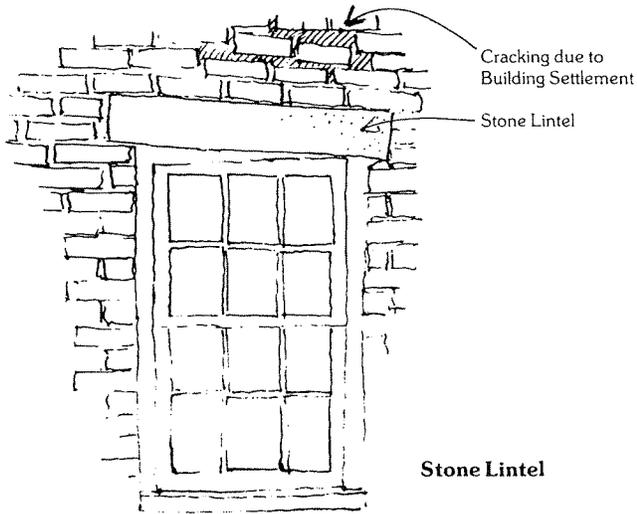
- reinforcement of the lintel with hidden means of support, for which the most obvious solution is a steel lintel extending four to six inches beyond the jambs of the opening on each side. Sizing of this member is always a matter for the engineer, as is installation a matter for the competent masonry contractor. This “helper” is most easily accommodated in windows which depend on wood frames for support, or in those which have arched brick heads over rectangular frames.

(note: in no case should the new lintel be visible. It should always be painted prior to installation with a rust-preventative paint, such as "Rust-Oleum," to prevent future brick stains caused by metal oxidation.)

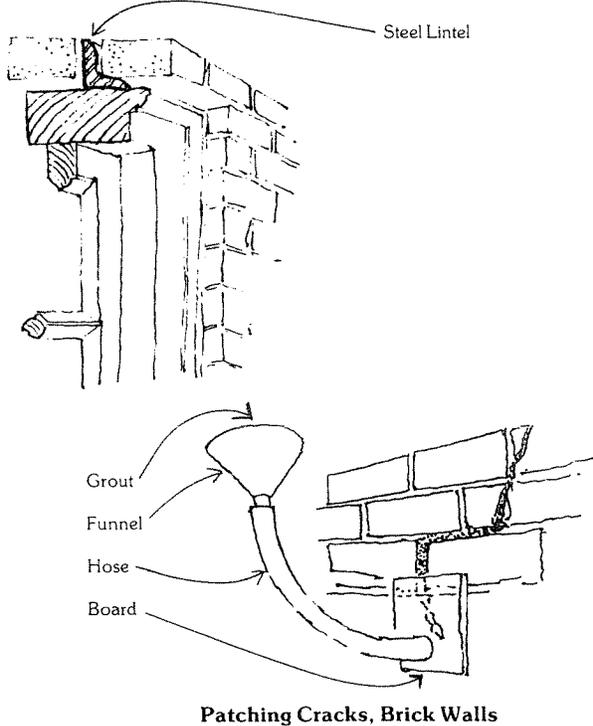
- patch the crack to prevent moisture penetration. If the break is long and deep, grout must be fed into it. Wet the crack and seal its base temporarily with a board. Pour grout into a funnel attached to a tube extending into the crack. Let the grout set for a day and then point over it. Move up the wall in stages as often as required to fill the crack.

(Note: the visual impact of such a repair can and should be minimized by using mortar coloring similar to that of the brick being patched, or by mixing into the grout a powder of similarly colored, pulverized brick.)

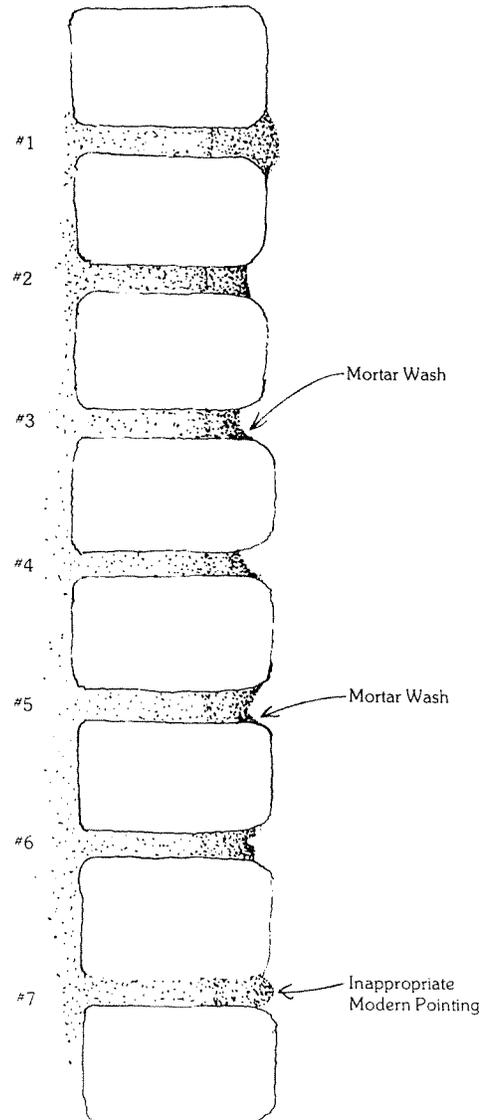
9. Where doubt exists as to the original mortar composition, it is advisable to seek out an expert who can perform a simple laboratory analysis of the contents and proportions of the mortar in the wall to be repointed.
10. It is important to match the tooling of repointed joints with those in the rest of the wall. Various options exist. In the illustration below numbers 3 and 5 possess the disadvantage of exposing the top side of the lower brick to the weather.

This drawback can be eliminated by allowing a thin “wash” of mortar to run continuously along the top surface of the brick below the joint. Number 1 should be avoided because the widened joints alter the original scale of the building, and because the upper edge of the brick course below the new pointing is vulnerable to moisture penetration. Number 7 is a modern version of Colonial brickwork which is comparable to “antiqued” brick in terms of its lack of authenticity. It is immediately recognizable as an inappropriate historic affectation and should not be used.

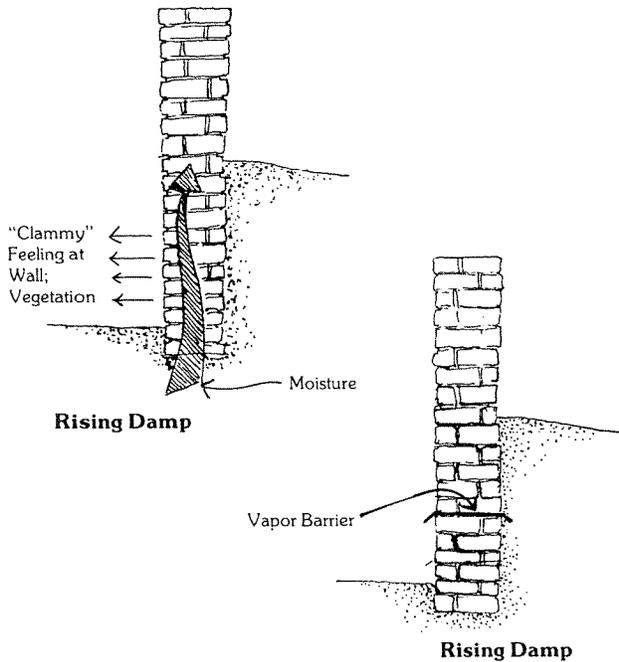
**Rising Damp** - This is a common and serious problem throughout Beaufort. Dampness in the soil, which is extensive given Beaufort’s particular climatic and soil conditions, is absorbed and drawn upwards by capillary action into the wall itself. Since a brick wall “breathes,” moisture within the wall will gravitate to the exposed surface, resulting in the characteristic moist, clammy feeling at or near the base of a wall. This is often accompanied by minute vegetation or mold which finds such moisture hospitable and which often imparts a definite stain to the brick.

This problem is often confronted directly in new construction by the installation of a vapor barrier of metal, polyethelene, or heavy paper which acts as a dam to the rising moisture. In cases where rising damp is not continuous, this is an effective technique. However, in a location with the climatic and soil conditions of Beaufort, this could have the effect of permanently concentrating moisture in one location, thus promoting deterioration of the brick.

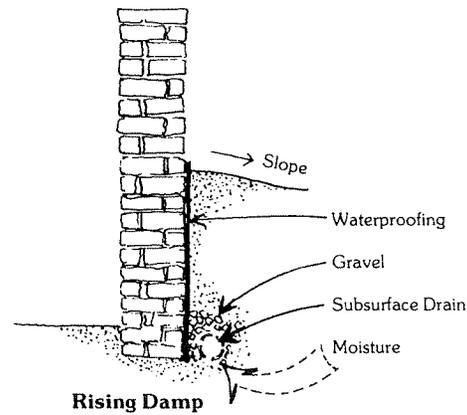
In existing construction, the problem of rising damp may be alleviated in part by providing an intentional path of least resistance through which the moisture may escape. This approach usually consists of a gravel bed or subsurface drain installed along the perimeter of the building, in conjunction with waterproofing of all below-grade wall surfaces. This is an effective technique, but it is laborious in that it requires a continuous trench to be dug around the perimeter of the wall to the depth of the bottom of the foundation. (Be sure to shore the foundation wall during this work). Where it is impractical or not feasible to expose an entire wall, a perimeter drain may be installed in a reasonably effective manner, utilizing a shallow (2 foot - 4 foot)

trench containing a perforated pipe and gravel fill. While some ground water may continue to affect the foundation wall below the level of the trench, the degree of saturation will be reduced. It is imperative for the perforated drain line to extend beyond the perimeter of the house and to carry the water to an acceptable discharge point.

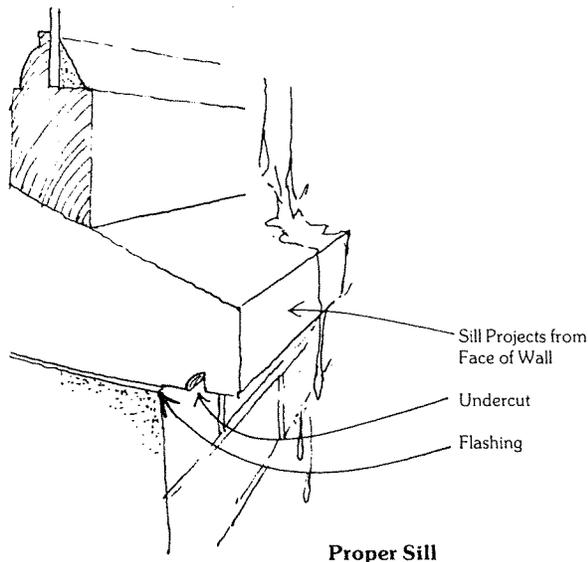
**Proper Sill**

- the sill is deteriorated and moisture is penetrating the sill and, subsequently, the wall beneath.
- the mortar joint or flashing immediately beneath the sill is flawed and water is entering the wall at this point.

In some cases, proper maintenance of sills, such as repainting, will regain the necessary watertightness. If severely deteriorated, the sill must be replaced. If original sills lack projection from the face of the building, the lower edge may be flashed, caulked, and repointed.

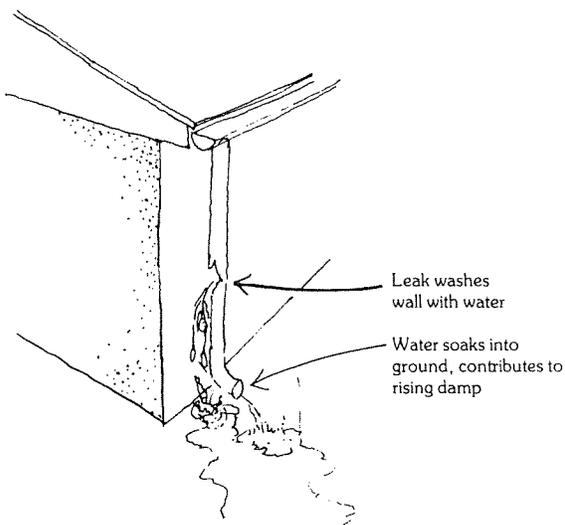
**Faulty Gutter/Downspout**

**Faulty Gutters and Downspouts** - Persistent damage is done to brick walls that suffer from moisture penetration caused by inadequate or leaking downspouts. During a storm or rainy season, such conditions concentrate a large and constant flow of water against a brick surface. The problem is easily discovered by merely investigating the behavior of the water removal system during a storm, and is remedied by replacing the deteriorated parts (see "Flashing").

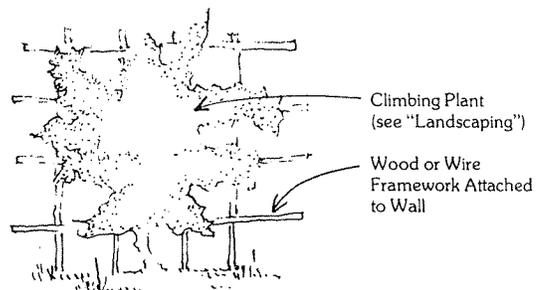
Espalier

It is possible to maintain vegetation on a wall with minimal adverse impact by means of the espalier technique. This consists of a wood or wire network held out from the surface of the wall which provides a firm support for any climbing plant (see “Landscaping”).

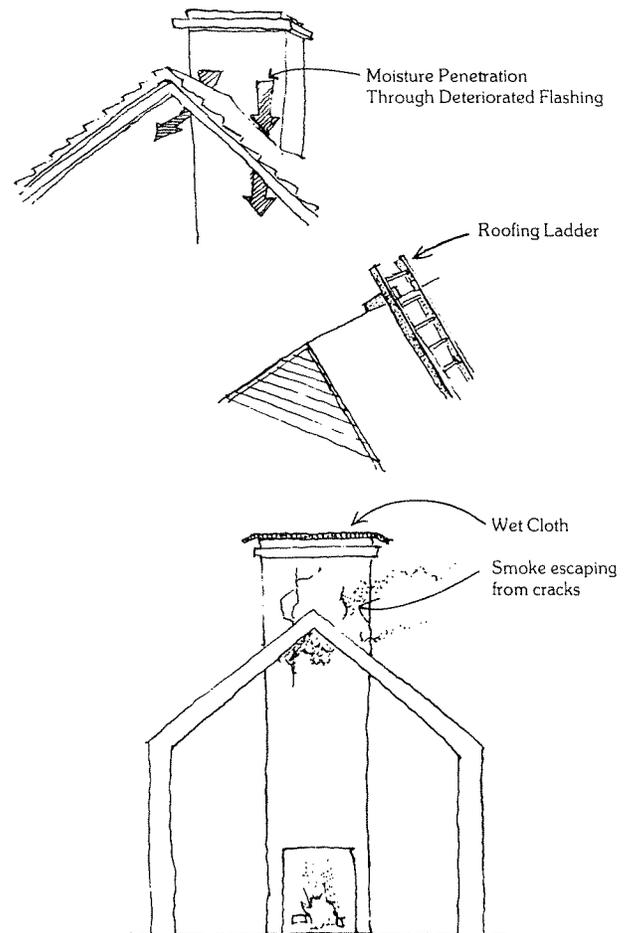
Checking for Chimney Cracks

If there is any indication of chimney cracks from which smoke or sparks could escape, a simple test should be performed which consists of draping a heavy, water-saturated cloth over the top of the chimney and lighting a fire in the fireplace. Smoke escaping through cracks indicates a broken flue or deteriorated brick or mortar and constitutes a serious potential fire hazard.

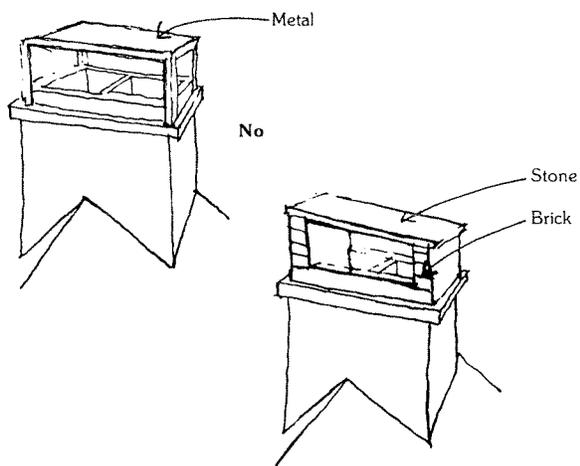
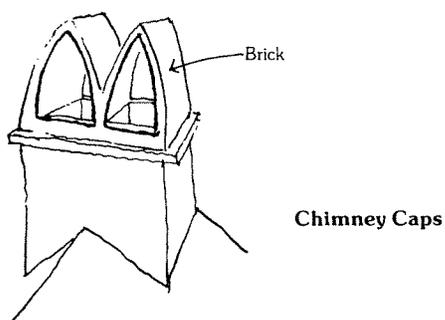
**Chimney Caps** - The final, but by no means unimportant, feature of brick masonry, is the chimney cap. These devices, when employed, form the visual terminus of a chimney, and thus become architectural features in and of themselves. The simple purpose of a chimney cap is to prevent rain from entering the flue. In addition, a chimney cap which is open only on the sides facing the prevailing winds can, in effect, create a wind tunnel, increasing an updraft.

If a cap is absolutely necessary, the stone cap has the least impact on pre-Victorian chimneys while the arched brick cap is most appropriate for late nineteenth century and early twentieth century chimneys in Beaufort. In no case should metal chimney caps be permitted in the District.

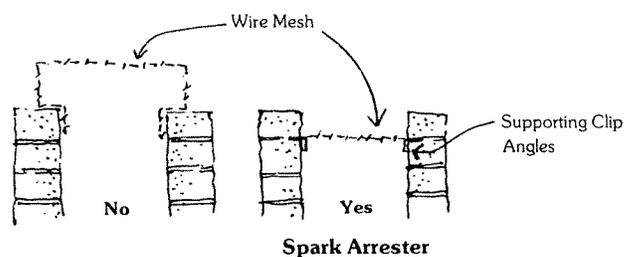
A more functional and less obvious alteration to a chimney is the spark arrester. In common modern construction practice this device is located so that it protrudes above the chimney. However, there is an equally effective method which is not as visually destructive to the chimney as a whole.

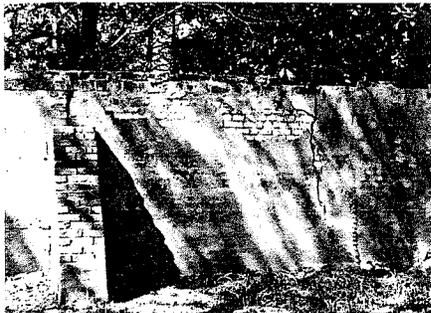
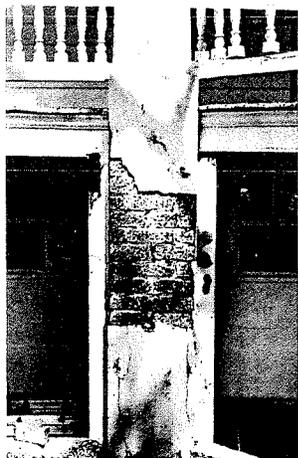
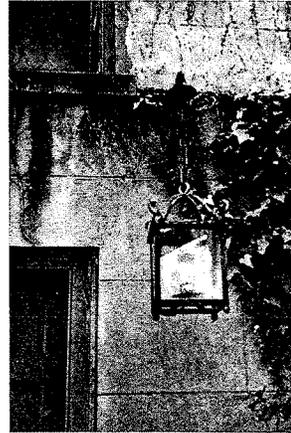
Tabby is an historic precursor of modern concrete and can still be found in North African structures dating from the sixteenth century. Basically a hard mortar, tabby is a composite of lime, sand, water, and an aggregate of oyster shells. A tabby wall is raised by pouring this mixture into wooden forms and tamping it until well packed. When the mixture has set, the forms are then lifted for each subsequent pour. As this material hardens, the

aggregate will settle forming a visible concentration of shells at the base of each pour. Older tabby walls occasionally contain small, irregularly spaced holes in which pegs were temporarily set to separate the forms.

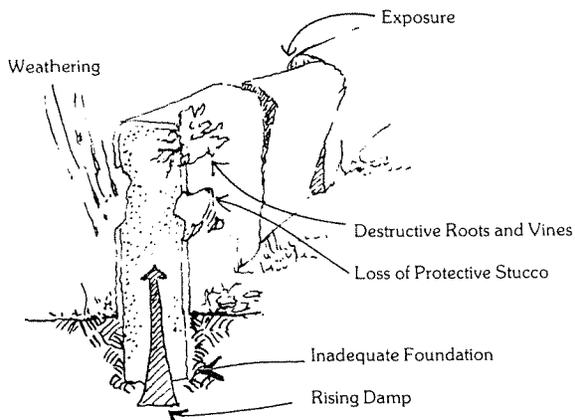
- loss of the thin protective stucco layer because of weathering, erosion, rising damp, etc.
- settling
- exposure of tabby due to deterioration or removal of other adjacent parts of the building
- penetration of the tabby wall by roots and vine tendrils.

Sources of Deterioration of Tabby Walls

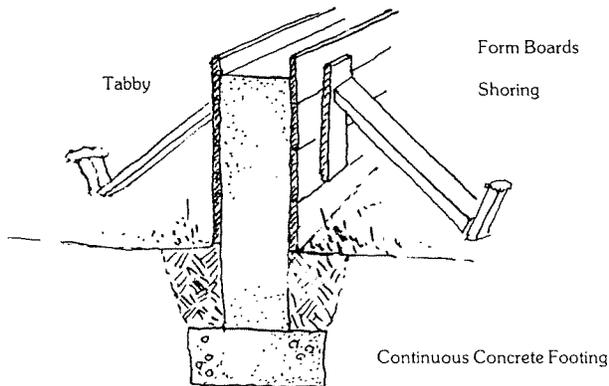
- **Rebuilding tabby walls.** The reconstruction of entire sections of wall is very similar to the historical process of building tabby. Horizontal form boards are used into which pours are made in 4 to 6 inch layers. Three to four hours after each pour, the forms are removed. The exposed face of the new wall section is then brushed with water and a fiber bristle brush to bring out the shell texture. Several precautions will help to insure structural stability. New walls can be set onto continuous spread footings while existing, while settling walls can be underpinned (see "Brick"); in either case the advice of a competent structural engineer is essential. New corners should be reinforced with steel mesh, and where old corners meet with new material, a "key" should be cut in the old tabby. With a stiff bristle brush, a mixture of "neat" cement (cement in which aggregate is omitted) is poured on to facilitate bonding of the new material to the old.

**Rebuilding Tabby Walls**

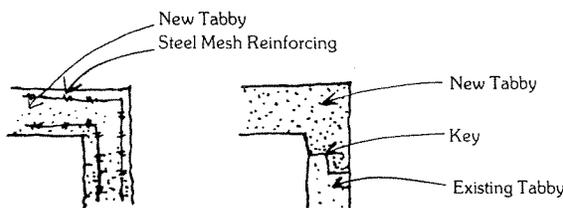
**Tabby Walls: Corners**

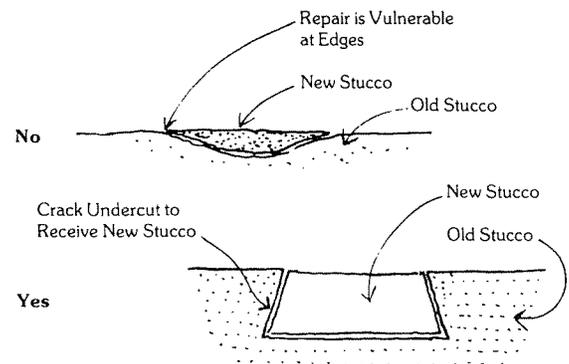
- Cracks. Never install new stucco in a crack that has been merely grooved to receive it. Instead, existing stucco should be undercut to provide a "key" for receiving the new work. This is made by opening up the crack with a knife and undercutting the edges with a hammer and chisel. Horizontal cracks, along with the top edge of vertical cracks, should be undercut so that no seam between existing and new construction will lead downward into the building.

**Cracked Stucco Repairs**

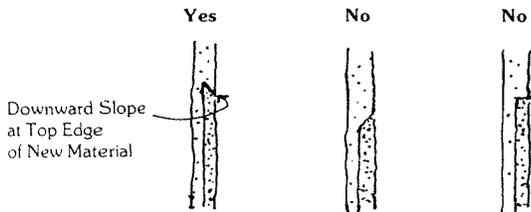
Stucco Patches

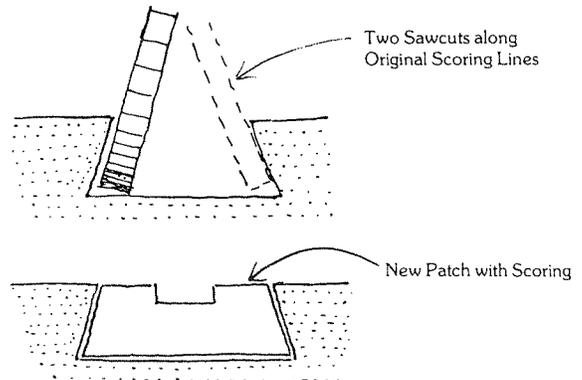
- Cut out along the original scores with a saw to make an undercut key for the new stucco which will contain the scoring. Two passes of the saw will be required for this keying. If the stucco is very thin, such cuts will have to be made by hand. Clean out the joints, patch with new stucco that has been tested for color match, and re-score along the original lines. When executing such major work on important buildings, it is always good practice to leave an undisturbed area as a record of original material.

Rescoring Stucco

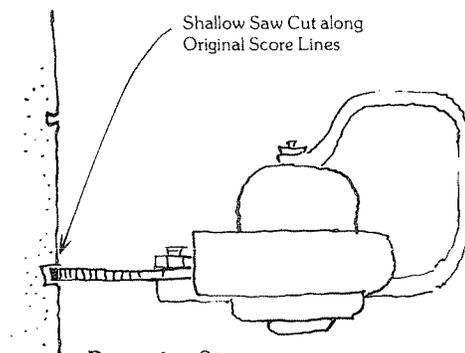
- Make one pass with a saw along each score line to slightly deepen the groove. Paint over the groove with paint to match the color of adjacent original material.

Rescoring Stucco

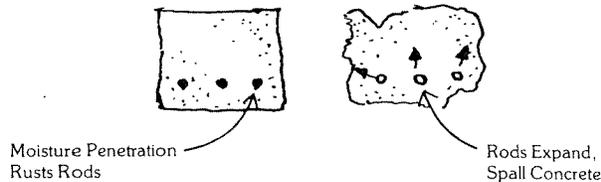
Exposed reinforcing rods pose a very serious problem for 607 Bay Street and should be inspected and repaired immediately. Inevitably, exposed rods will rust and, in the process, expand, thereby breaking off more concrete, further exposing themselves. This process can accelerate quite rapidly.

#### Deterioration of Reinforced Concrete

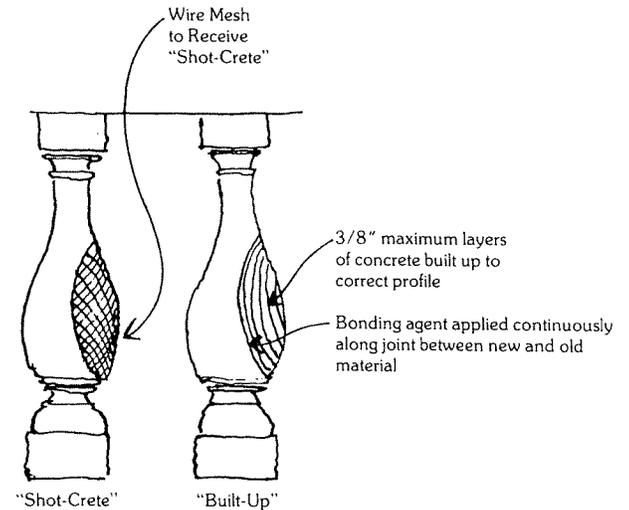
After applying the bonding agent, construct an armature of wire or chicken mesh so that it conforms to the general shape of the affected member. “Shot-crete” is then sprayed on the affected area. This is a concrete application process in which the concrete is effectively mixed in the air. A pressure gun with two adjacent nozzles is used. One nozzle emits water of the correct temperature while the other sprays the dry concrete ingredients. Irregular shapes and thin profiles of great strength can be achieved. An ornamental element can

#### Repair of Ornamental Concrete Elements

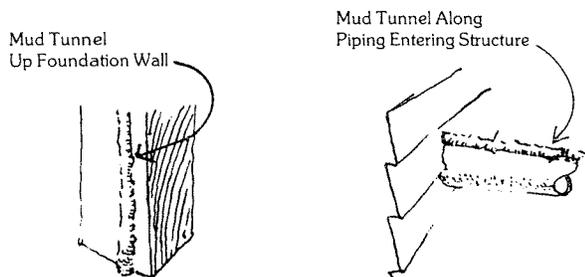
- half-round vertical mud tunnels on foundation walls, piers, piping, etc. These tunnels usually form the most direct route from the ground to the food source in the exposed wood. Crawl spaces should be frequently inspected for revealing tunnels.
- pathways at horizontal openings where piping enters the house or its foundation wall.

**Evidence of the Presence of Termites**

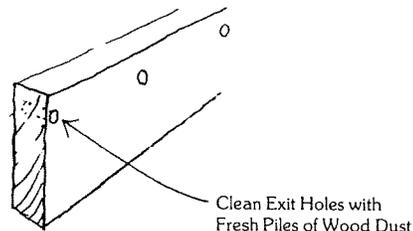
**Beetles** - Wood is especially susceptible to beetle attack during the process of seasoning and storage, prior to its conversion to lumber. No wood that is infested should be introduced to the property; suspect material can be sterilized by means of fumigation and the direct application of an appropriate insecticide.

**Evidence of the Presence of Beetles**

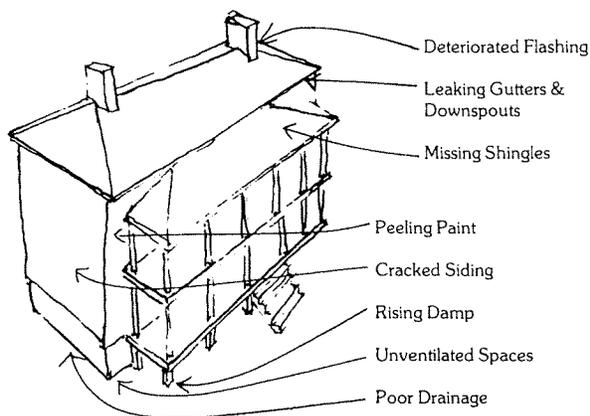
**Moisture Penetration**

- leaking gutters/downspouts
- inadequate/deteriorated flashing
- unventilated spaces
- failure in the integrity of the siding or roofing material, e.g. peeling paint, cracked siding, missing shingles
- poor drainage around the foundation
- poor rainwater removal at the foundation
- high water table/rising damp
- plumbing leaks

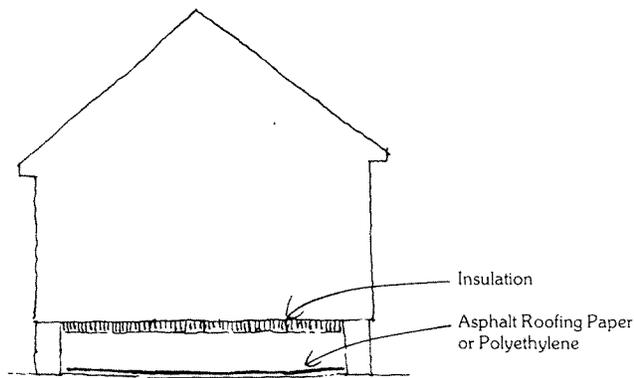
### Minimizing Crawl-Space Condensation

- **Condensation.** If a house is air-conditioned, the crawl space is especially likely to suffer from condensation, although every crawl space is susceptible to some degree. Strips of asphalt roofing paper or polyethylene laid across the ground in the crawl space are effective preventive measures, as is a 1" to 3" concrete slab. Insulation can also be considered (see "Energy").

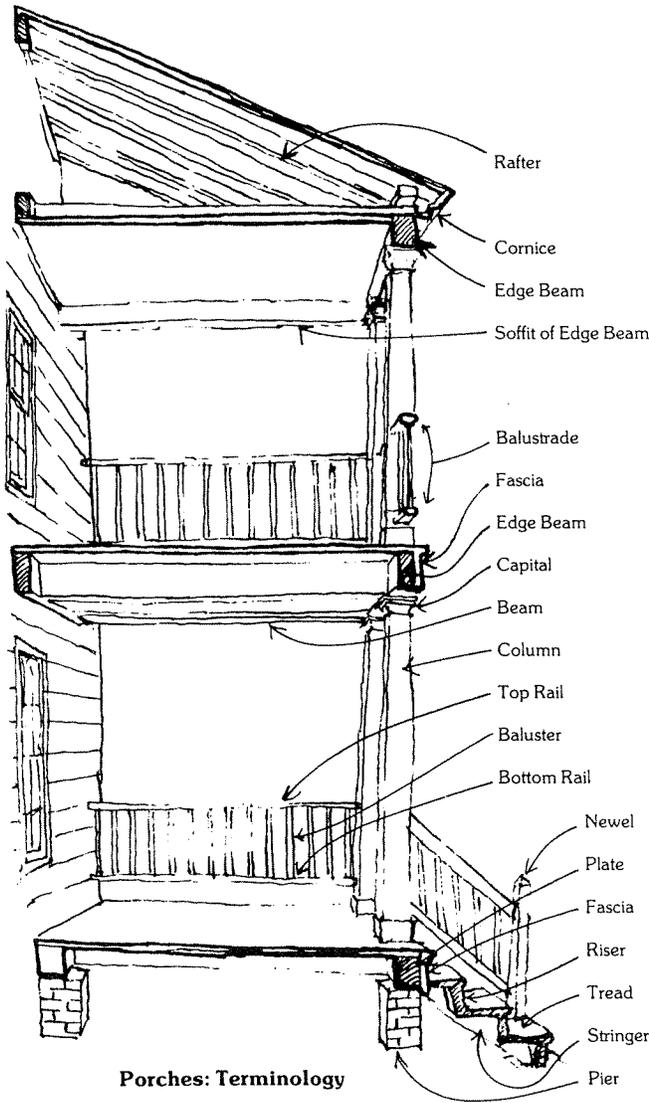
The accompanying sketch is intended to clarify several of the more technical terms used throughout this discussion.

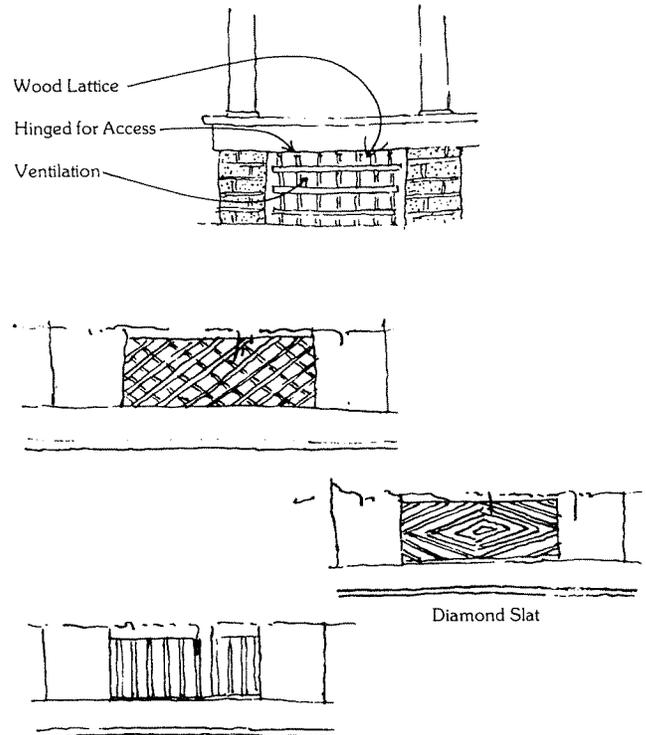
### Appropriate Lattice Infill At Foundation Piers

It is likely that, in most cases, the need for foundation infill was originally satisfied with some form of lattice, if there was in fact any enclosure at all. The raised first floor and open foundation system was conceived to serve several functions which remain valuable today:

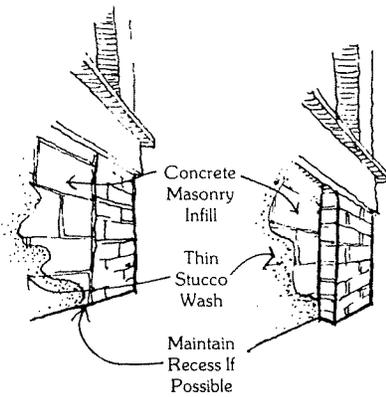
### Concrete Masonry Infill At Foundation Piers

- **Concrete masonry infill.** In all cases the optimal approach to this problem is the removal of the concrete masonry. If it must remain, there are two methods for minimizing its negative impact:
  - Where the face of infill masonry is flush with the outside face of the piers, the infill should be stuccoed with a thin wash, feathered out to a sharp line at the edge of the piers. (Note that the common modern 3/8" thick stucco coating would be inappropriate in this condition. See "Stucco" for an application technique of thin stucco wash.) The contrast between pier and infill can be heightened by painting the stucco a dark black-green color and planting out the foundation. This method

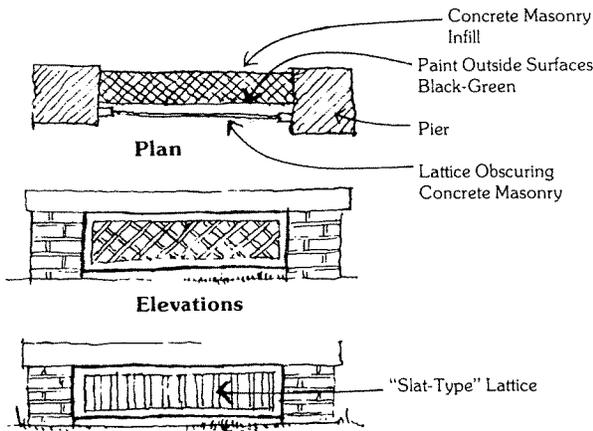
### Lattice Infill Over Masonry Between Foundation Piers

- If the face of the concrete masonry is recessed from the face of the brick pier, the piers are already expressed to a degree. If the setback is less than 1-1/4", the stucco treatment given above should be employed. However, the stucco should not be brought flush with the surface of the brick pier. If the setback is at least 1-1/4", it is possible to effectively and economically obscure the inappropriate concrete masonry with wood lattice. The concrete masonry should be painted a drab black-green prior to installation of the lattice. This treatment is also recommended for crawl spaces that have been enclosed to form additional living or storage areas; in such cases, the window and door openings can be expressed simply by framing the lattice around the existing opening.

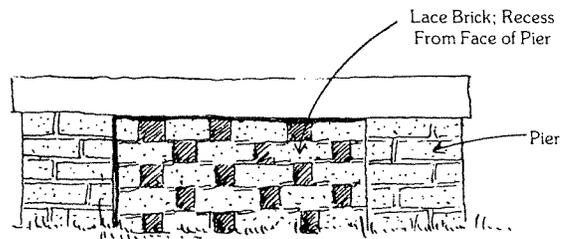
### Lace Brick Infill At Foundation Piers

- try to match color, size, and pointing of the brick of the porch piers if neither element is to be painted
- recess the outside face of the lace brick infill at least 2" from the outside face of the foundation piers
- do not key the brickwork of the infill to the brickwork of the pier.
- **Inappropriate infill treatments.** There are three modern infill treatments used throughout the District which are entirely inappropriate: chain-link fencing, plywood, and corrugated metal or fiberglass. The apparent intent of such infill is the exclusion of rodents and small animals. A simpler and less obtrusive solution consists of a frame of hardware cloth or heavy screen, painted black and attached to the inside face of the piers. At least one panel should be hinged for easy access to the crawl space.

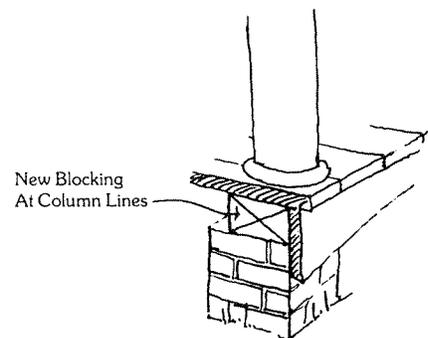
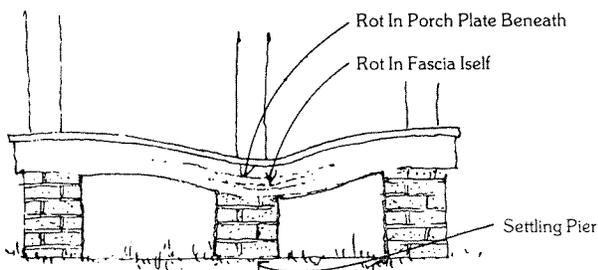
**Fascia Deterioration: Causes**

**Crushed fascia.** The most easily remedied, but least likely cause of this problem is decay, with subsequent loss of internal stability in the fascia itself. A more common cause is that the fascia, which was designed as a non-structural closure board, has been forced to perform a load-bearing function. This occurs when movement in the porch shifts the vertical loads from the column bases directly to the fascia. If the fascia is crushed directly below a column, poor structural condition is definitely indicated. This is likely to be the result of one of the following:

- Rotting porch plate. If moisture has deteriorated the porch plate to the extent that it no longer has structural integrity,

- Foundation pier settlement. If removal of the crushed fascia at the column line reveals that the porch plate is in healthy condition, it is likely that the problem is a result of settlement of the brick pier. This particular problem is often indicated by a sag at the corners of porches accompanied by a slight upward bow at the center of the porch. Such problems are more apparent when the porch is viewed from a distance. Underpinning the pier is usually recommended (see "Brick") although the problem can sometimes be temporarily alleviated with hardwood wedges at the top of the sound plate.

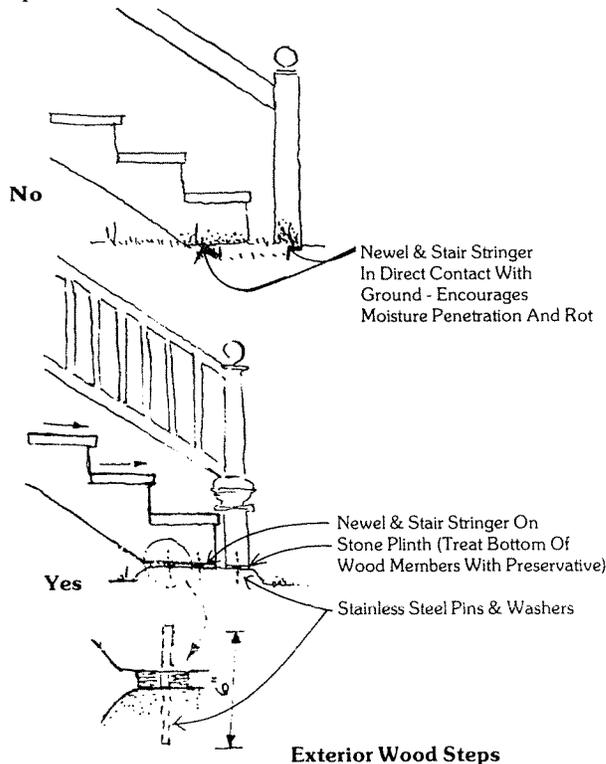
- Decay. This common problem is generally the result of bringing elements like steps, newels, or rails into direct contact with the ground where moisture can penetrate the wood. The bottom step or stair stringer should be set on a stone plinth, raised slightly above the surface of the earth. All treads should slope to drain away from the house. The use of stainless steel pins and washers, or stock post bases, allows water to flow under the stair and will further protect the vulnerable bases of wooden stairs. It is important that the stone plinth also slopes away from the stairs and has no depressions in which water can collect.

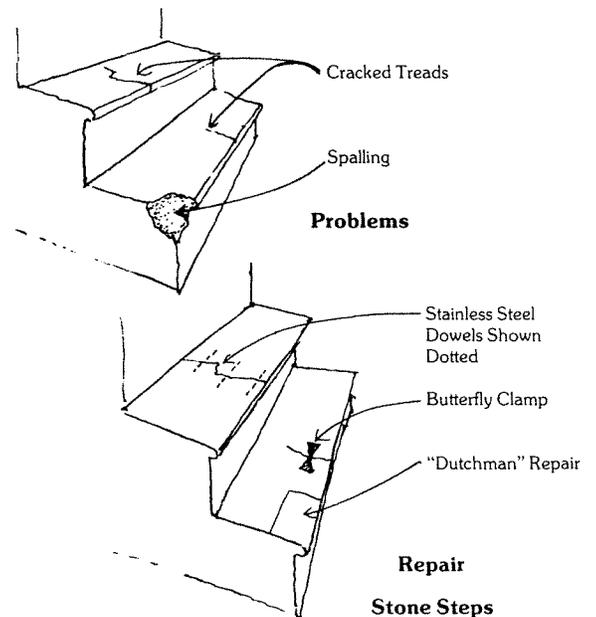
**Stone steps.** The spalling and cracking of stone steps usually occurs when iron rails, fasteners, cramps, etc. anchored into the stone corrode, allowing the water to enter. Both cracking and spalling also result from the differential expansion and contraction between iron and stone. However, if there are cracks in the center of treads or risers, they are more than likely the result of an inadequate original foundation. (This is similar to the leaning brick pier problem discussed in “Brick.”)

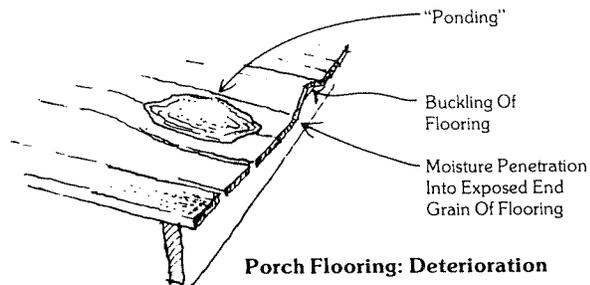
**Decay.** The frequency of this problem in Beaufort is the direct result of the city-wide practice of leaving the ends of each floor-board unprotected. This typical installation allows the continuous penetration of moisture into the porous end grains of the flooring. When the deterioration advances, small areas of buckling are created across the porch floor. These areas act as "ponds" in which runoff water is collected and retained. The process of deterioration is thereby accelerated.

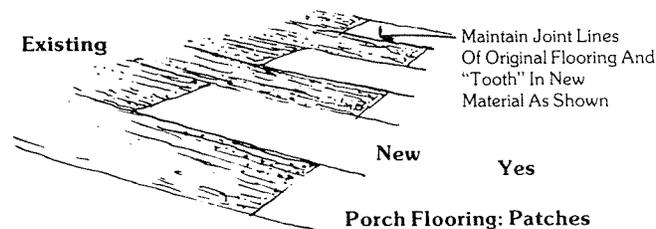
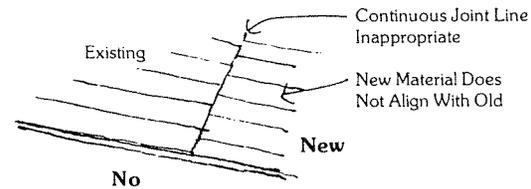
**Porch Flooring: Patches**

- Cut out all affected rotted wood (this material should be burned to eliminate the possible spread of infestation).
- Replace with new flooring of the same dimension and species.

Replacement flooring must be thoroughly soaked in preservative prior to installation. Patched areas must align with the floor joints of the rest of the porch.

- Protect the end grains with a continuous wood edge strip, either half-round or square. Do not edge your porch with metal.

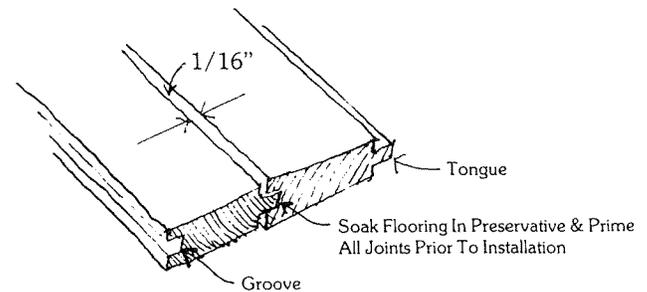
**Tongue & Groove Flooring: Correct Exterior Installation**

To repair this condition, carefully remove all affected flooring and inspect it and all adjacent pieces for rot (see "Wood"). If the removed flooring is not significantly deteriorated, it may be planed along the edges to decrease its width and re-installed. Tongue-and-groove flooring should be set with a  $1/16'' \pm$  gap to allow proper expansion. If the flooring is rotted beyond reuse, replace it as described under "Decay" above. In either case, the new wood must be liberally treated with preservative.

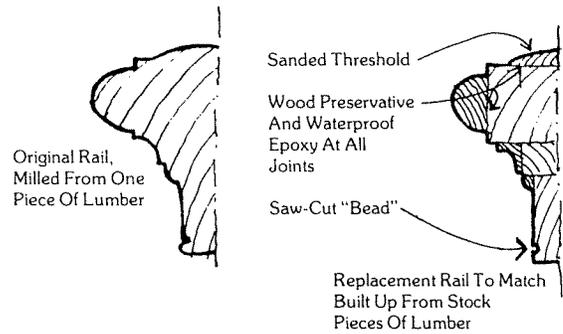
### Handrail Replacement

point of serious deterioration, it may have to be completely replaced. Most of the remaining railings in Beaufort have been milled with decorative profiles and a good mill can easily match the rail being replaced. As a more economical alternative, mouldings may occasionally be duplicated with stock wood mouldings built up to a shape that closely resembles the original. The major precaution for this sort of built-up moulding is that all pieces must be thoroughly soaked in preservative prior to assembly since the possibility for separation of the pieces is great. Moreover, the individual pieces should be bonded with waterproof glue in addition to standard trim nailing.

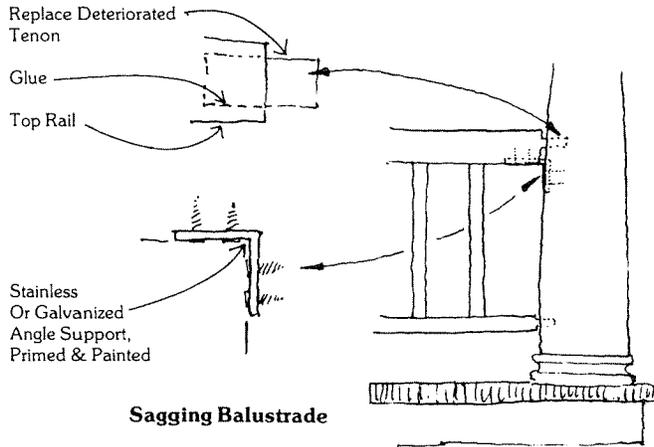
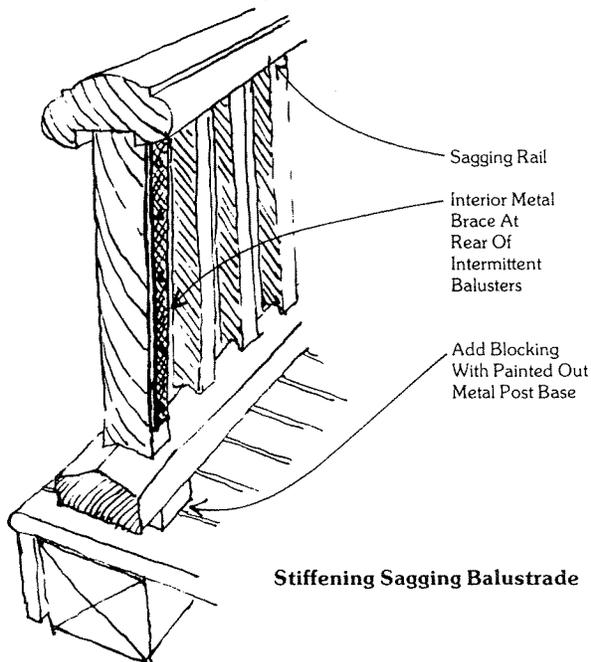
If the sagging balustrade is original to the porch, one should suspect deterioration in either the mortise of the column or the tenon of the rail (or both), resulting in movement and loss of dimensional stability. If rotted, the affected tenon should be removed and replaced. If the decay has proceeded along the rail, all damaged material will have to be removed and new, matching, treated material spliced to the old. If no decay is present, it may be possible to merely wedge up the rails to the proper position with hardwood wedges.

If the sagging balustrade is toenailed rather than mortised into the column, stiffeners must be applied at the ends to maintain a true horizontal. The corners can be strengthened with galvanized or stainless steel cleats, recessed into routed columns and painted over for minimal visual impact. Further stability can be achieved by using a thin, steel plate stiffener on the back side of every third or fourth baluster.

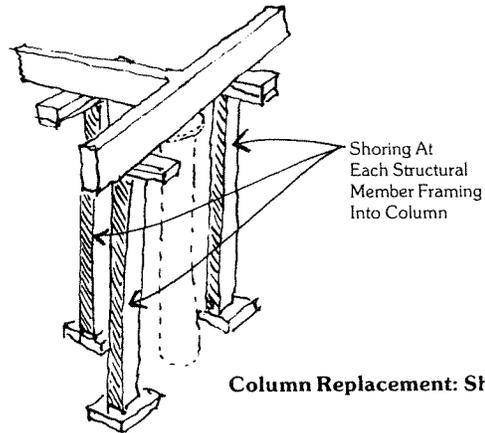
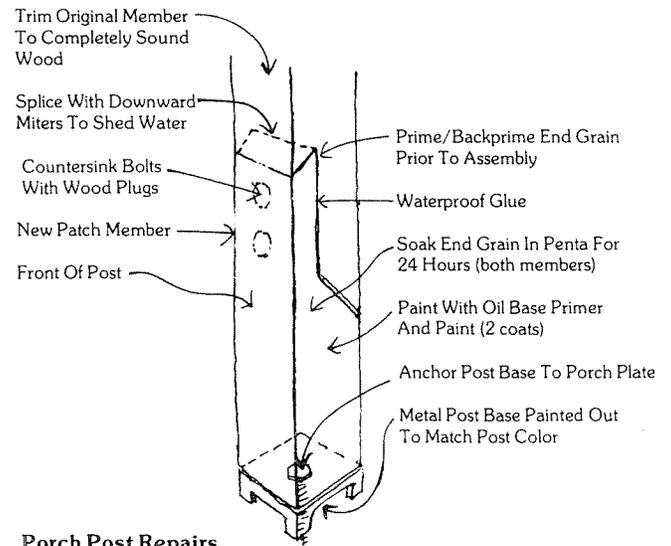
If a column base is intended as a load bearing element and shows signs of decay, all beams framing into the top of the column will have to be adequately shored to allow for harmless removal of the affected base. A new, matching base soaked in preservative can be slipped under the column and wedged into place. Always maintain continuous ventilation to the underside of the column base.

If the column base consists of ornamental trim surrounding the working column, the repair may be simpler. Be aware, however, that rotted trim may be symptomatic of deterioration at the base of the functional column. If so, a splice must be made in which new, treated material of matching profile is connected to existing. Shoring will be required for such a repair. If, however, only the trim itself is decayed, it need only be removed and replaced to match. Continuous

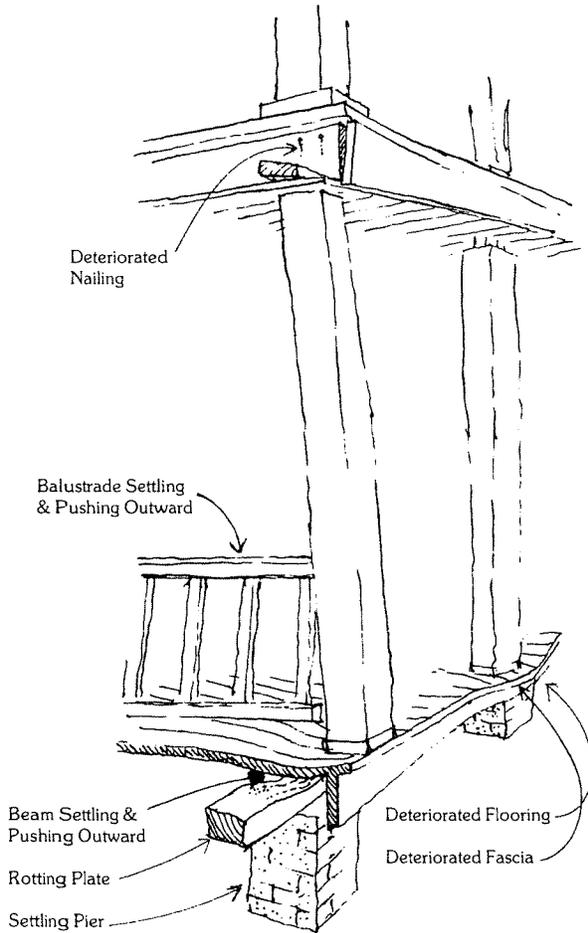
**Leaning/Rotated Columns: Causes**

- Leaning or rotated columns. Both, especially the former, are symptoms of a serious movement problem of which there are several causes. Repairs, which **must** involve a structural engineer, will generally require shoring. (Note: shoring should always be taken to grade. It is poor practice to shore a second floor element to a first floor support.) When the cause of the problem has been determined, the column can either be re-set or replaced to match after applying a preservative treatment.

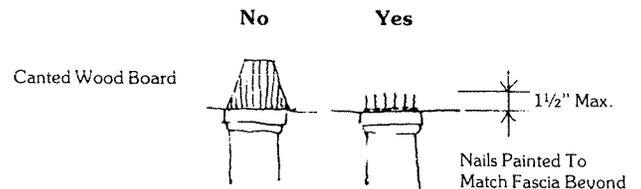
**Bird-Proofing**

- installation of a low profile wedge with a high gloss slippery coating at the exposed surface
- exposed nails, although the exposure should be limited to 1-1/2". Nails should be primed with rust-inhibiting paint and painted out prior to installation. The top of the column should be appropriately soaked with preservative to eliminate damage from moisture penetration at the nail holes.
- miscellaneous: various noise devices, light devices, chemicals, adhesives, etc. are available as bird deterrents. Rubber snakes have even been found to be effective in some applications.

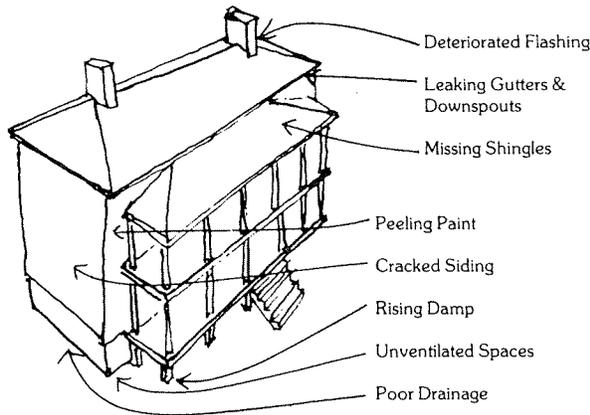
**Moisture Penetration**

Many of the porch ceilings in Beaufort, especially at the second story, are sagging, a sure sign of moisture penetration from above. Rather than merely re-nailing loose ceiling boards, it is advisable to remove them and investigate the exposed condition for the possible source of moisture penetration. The accompanying sketch shows the range of the most likely sources of trouble. If the opportunity exists to examine the ceiling during a heavy storm, it is likely that water will be seen entering from one of the several locations. The floor or roof in the suspect area can also be flushed with water from a hose for purposes of examination. Of course, if daylight can be seen through the roof, the source of the leak is obvious. Be sure, however, that water is not penetrating in other locations as well. If none of the suggested locations is the source of the leak, it is possible that the porch ceiling is buckling downwards due to a lack of interior ventilation. Provide continuous protected ventilation to all such enclosed areas.
