# The Beaufort Preservation Manual

prepared for  
The City of Beaufort  
Beaufort, South Carolina

by  
John Milner Associates  
West Chester, Pennsylvania

August, 1979

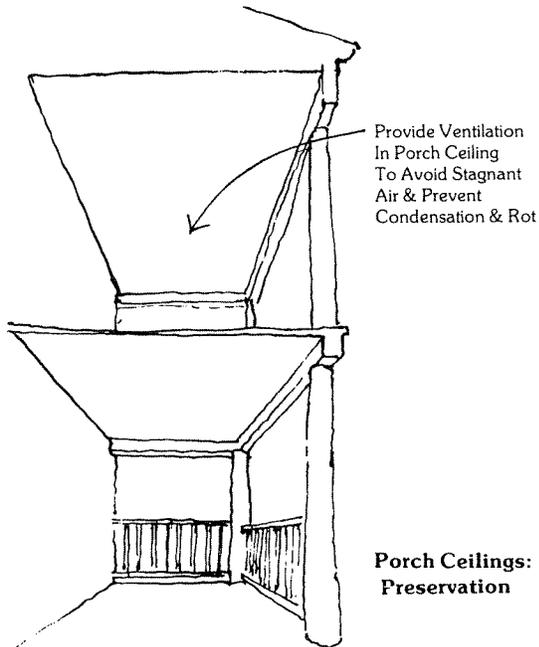
**Porch Ceilings: Preservation**

More appropriate is the traditional tongue-and-groove board ceiling. If joined too tightly, these boards are subject to the same buckling problems as porch floor boards. However, if laid correctly, tongue-and-groove ceilings have great flexibility and possess the correct historical appearance. Repairs to buckling tongue-and-groove board ceilings are relatively simple: remove the tongue of the affected member with a floor chisel so that the board can be lifted out. Other adjacent affected boards can then be removed without damaging the tongue, and the whole series of boards can be re-nailed. The board with the removed tongue can be narrowed by planing and replaced last.

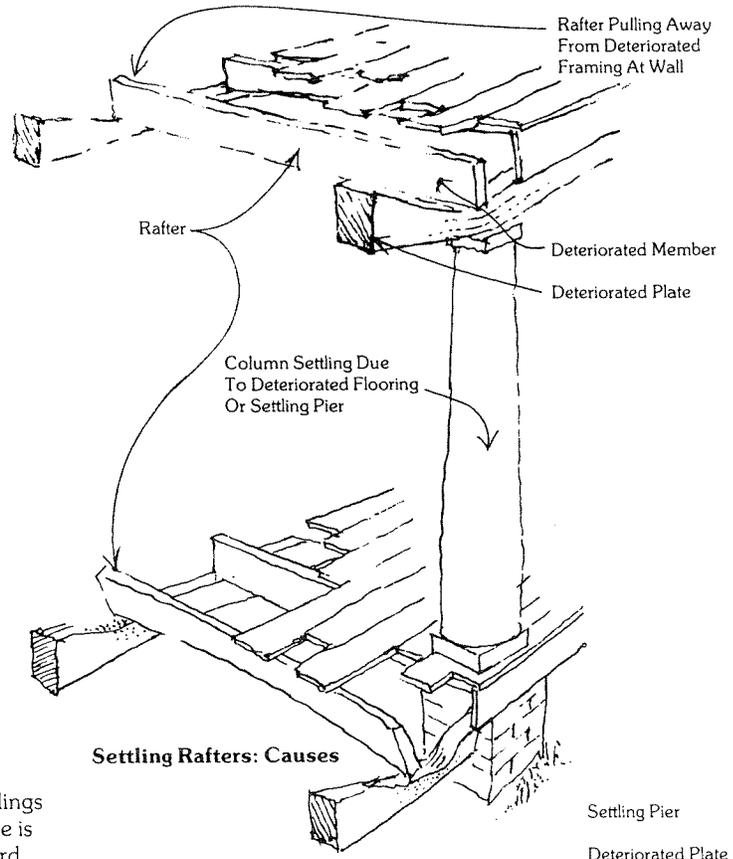
**Settling Rafters: Causes**

As structural members, these elements require shoring during repairs and alterations and **must** be investigated by a competent structural engineer prior to any work. Roof settling is almost always the cause of cracking or dislocation of rafters and beams, though decay plays an important role as well.

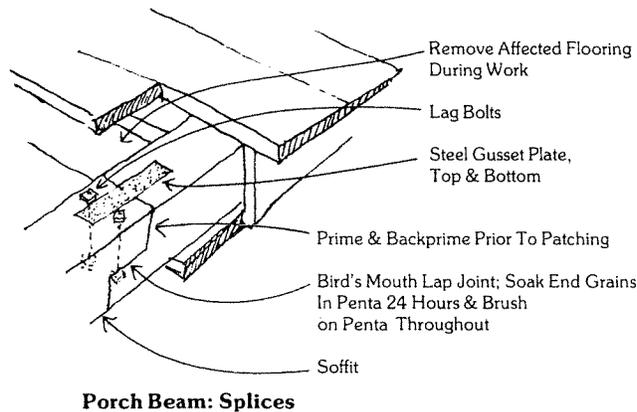
A typical edge beam splice repair is shown in the sketch below. It is suggested **only** as a guide to the type of repairs that will be necessary, and not as a replacement for on-site advice that relates to specific conditions.

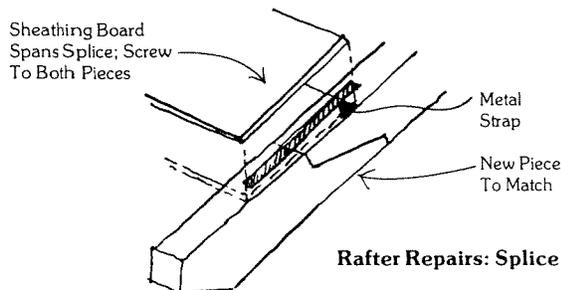
Concealed rafters that are sagging or which threaten to lose most of their structural capacity are often repaired with a "helper." This piece should be carefully attached to the sagging rafter by means of pre-drilled holes which have been brushed

liberally with wood preservative. The helper **must** be anchored into sound wood and completely span any deteriorated portion of the rafter. If all areas of the rafter are in poor condition, the helper should bear upon the rafter plates, completely relieving the deteriorated rafter of any structural load whatsoever.

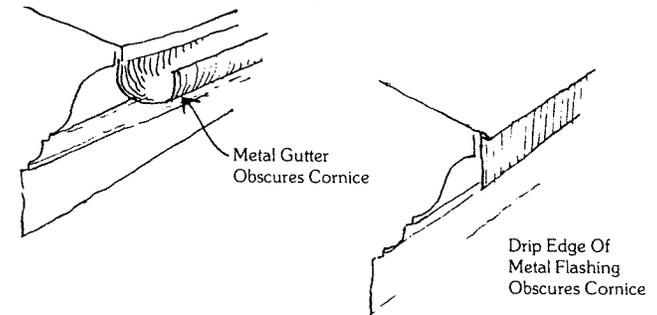
### Porch Cornices: Intrusions

- rain gutters, installed so as to obscure the cornice (see "Downspouts and Gutters" for recommended repairs)
- roof edge flashing, installed so as to obscure the cornice (see "Flashing")
- deteriorated cornice trim. Again, deterioration is usually the result of moisture penetration, the source of which should be discovered and eliminated prior to repair.

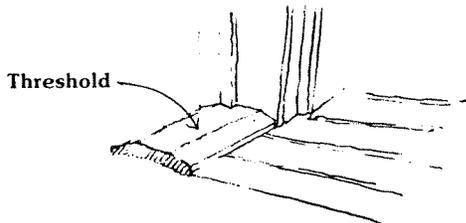
**Rotted Door Threshold** - Deterioration of this part of an exterior door's frame is serious in that it allows moisture to penetrate directly to the interior floor and sub-floor and even, in some cases, to the principal house plate. Steps for replacement are as follows:

- Carefully measure the existing threshold so that an exact copy can be made.
- Remove the threshold. If it projects beneath the door frame, this may necessitate removal of the door stop. If the threshold is completely rotted, it may be easiest to remove it piecemeal by chiselling. Otherwise, the center section can be cut out with a backsaw to allow for the play required to remove the threshold from beneath the frame.

- Prepare a new oak or hardwood threshold similar to the one that has been removed. Be careful to include the "ears," or lugs, at each end, and be certain that the new threshold is fashioned so that it slopes for drainage. Make sure the new threshold has been treated with wood preservative and back-primed prior to installation.

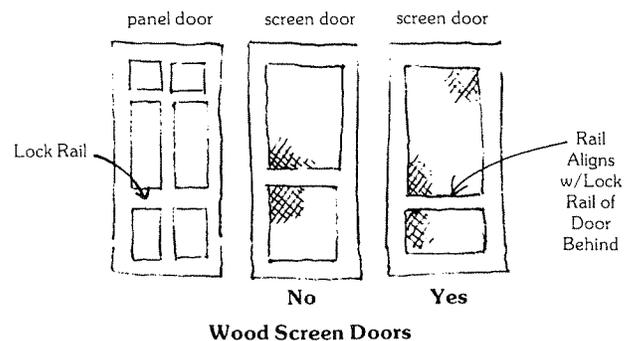
**Wood Screen Doors**

**Inappropriate Modern Screen Doors**

Screen doors should be made of wood and kept as simple as possible. Extant, original screen doors of late nineteenth century houses should be retained and maintained. The simple wood frame can be painted in a color similar to that of the screen itself. If a horizontal rail is required, its location should coincide with the height of the lock rail of the paneled door behind it. (Screen doors that are located out at the line of the balustrade as part of a porch enclosure should be treated somewhat differently, as described in "Porches.")

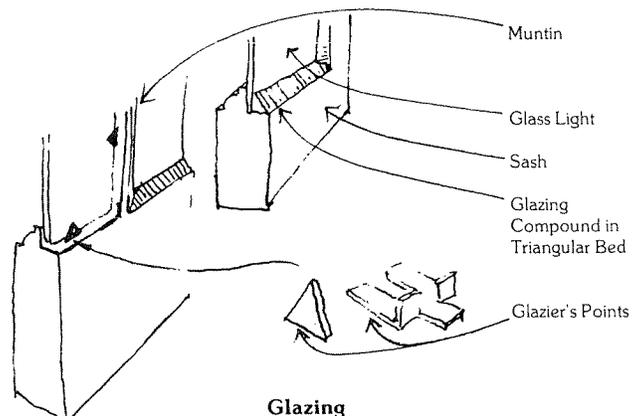
**Re-glazing** - Inspection of window glazing should be part of a yearly maintenance program for any structure. Broken panes and cracked or missing putty can allow moisture penetration and can cause rapid deterioration and rot of wood sash. Steps for proper re-glazing are as follows:

- Examine the condition of all wood frames and sash. All open cracks and holes should be cleaned and filled with putty, and all loose or blistering paint should be scraped and replaced (see "Painting").
- Remove all loose and cracked glazing putty, with a putty knife. (The glazing putty is the final moisture seal of the window; it is not what holds the glass in place. Glazier's points, described below, are used for this purpose.) Remove all dust and dirt from the putty area with a stiff bristle brush and a strong vacuum cleaner.

- Treat the exposed wood area with wood preservative.
- Install a new bed of putty which can be struck clean with a putty knife. In modern practice an elastic glazing compound is recommended because, unlike putty, it remains permanently flexible. Thus it is not subject to the cracking and splintering that affects the original material.

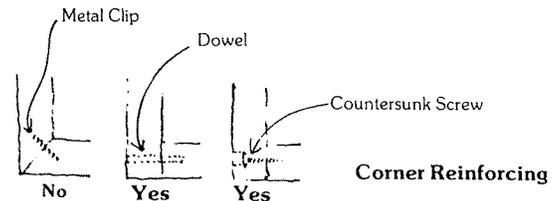
**Warped and Sagging Sash** - Such deterioration usually requires removal of the sash, which is most easily accomplished

from the inside by first removing the stop bead. (Caution: the cord holding the sash weights should be secured at the top prior to removal so that it is not pulled to the inside of the frame when the window is removed.) When the sash is removed, the following procedures can be taken to remedy the warping:

- Planing
- Reinforcing the corners, preferably by means of a hidden repair

- Lubricating the frame with soap or silicone so that the sash will move more easily
- For seriously racked sash the mortise and tenon joints of the rails and stiles must be realigned and redoweled, or the members replaced.

- Sagging and warping. This common problem is treated with the same corner reinforcements shown under "Warped and Sagging Sash," earlier in this section.
- Screen appearance. Screens, whether of wood or aluminum, should relate to the sash of the window in which they are placed. If a horizontal rail is required for the screen, it should align with the meeting rail of the window behind.

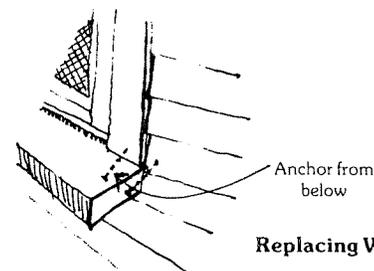
**Replacing Rotted Window Sills** - This repair is similar to that described for door sills. The sill is the part of a window frame that generally receives the most punishment from the elements; often, it is the only part of a frame that needs replacement. The following is the proper procedure:

- Prepare a new sill of hardwood or preservative-treated yellow pine or cedar to match the original sill. The new sill should be sanded, primed and backprimed prior to installation.

- Gently tap the new sill into place and anchor it to the window casing from below. Caulk all joints.

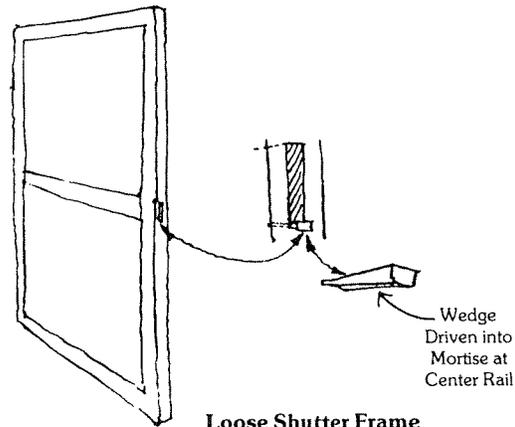
**Loose Shutter Frame**

- If the joints are extremely loose, disassemble and reglue the entire shutter. Dowels, or "pins," in the mortise and tenon joints may be punched out if loose, or drilled. If realignment of the rails is necessary, the dowel holes may need to be relocated/redrilled and new pins installed.

Sagging shutters can also be stiffened by driving a wedge into the underside of the center mortise at each end of the rails.

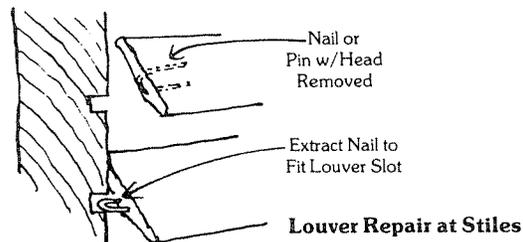
**Louver Repair at Stiles**

**Loose Louvers** - Operable louvers can become loosened at two locations: the vertical rod which controls their movement, and at the stiles into which they are framed.

To repair the connection at the vertical rod, a very small finishing nail can be used. The head is cut off and filed to a point, and the nail is then bent into a U-shape using a needle pliers. The new pin is then simply wrapped around the post and forced into the holes of the missing pin.

Similar repairs are used to restore the connection at the stiles of the shutter. Again, the head of a small nail is cut off and the blunt end sharpened. Bent into a U-shape, the nail is then forced into the side of the loose louver deeply enough so that the louver can go back into its frame. When in place, the pin is withdrawn with the needle pliers to a distance sufficient to support the louver in the hole supplied for that purpose.

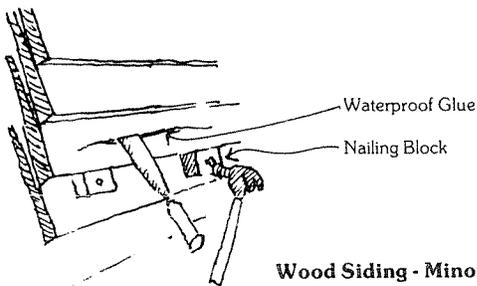
Wood Siding - Minor Repair

In a preferred alternative to minor repairs, the crack in the siding is filled with waterproof glue, then forced closed with a "nailing block" which is left in place during the glue-drying period. Upon removal of the wood block, all nail holes should be sealed with putty, primed, and painted.

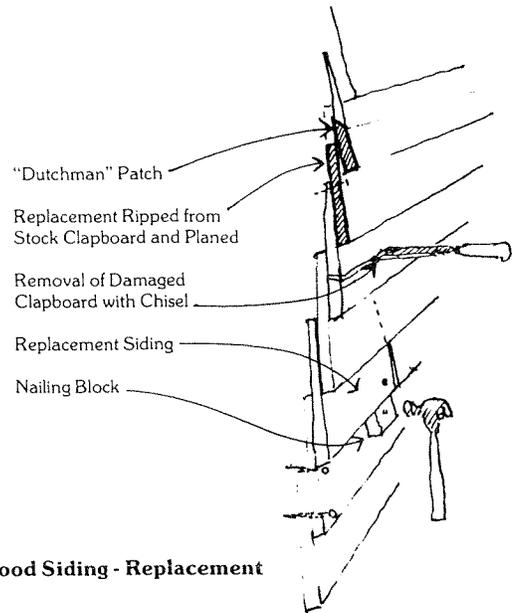
Wood Siding - Replacement

If the required replacement is extensive, it is preferable to use siding that is a genuine match for the existing material in species, overall size, and shape. The most desirable repair technique for serious siding problems requires cutting the damaged siding with a backsaw along the butt edge of the adjacent clapboard.

The board is then carefully removed with a chisel. Special care should be taken to avoid puncturing any membrane (i.e. building paper) that might exist beneath the siding, though this will probably not be present in most historic houses. If the damaged board was nailed near the upper rather than lower edge, the adjacent clapboard must be pried out enough to allow the nails to be cut with a hacksaw.

When the damaged siding is removed, the replacement piece can be inserted. It should match exactly in profile and species the siding that is being replaced. Prior to replacement, any holes in the building membrane of the affected area should be patched with roofing compound. The new piece of siding, after suitable treatment with wood preservative (see "Wood"), should then be tapped gently into place with a nailing block. It should then be nailed along the bottom edges to avoid penetrating the piece of siding immediately above. After the siding is secured, all end joints and nail holes should be sealed with putty. When the putty is dry, the siding can be primed and painted.

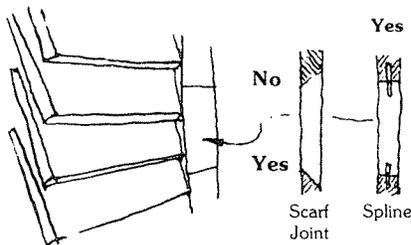
**Corner Board Patches**

If the decay is limited to a small section of the corner board, it should be carefully cut out using downward sloping (scarf) cuts. The new patch piece must be carefully spliced to the old so that no visual disruption will occur. (An alternative to the scarf joint is the spline, a more difficult joint to fashion but not dramatically more effective than the scarf.) In no cases should butt joint patches be used because they are very susceptible to moisture penetration.

When the new piece is attached, the joint lines are sealed with putty or plastic wood. The seal is sanded when dry and the piece is then primed and painted.

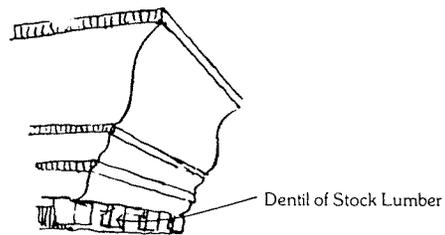
**Patching Cornice Dentils**

- Cornice dentils. Missing dentils can sometimes be replaced with wood lattice. More often, this material is too thin and stock lumber must be used for the purpose.

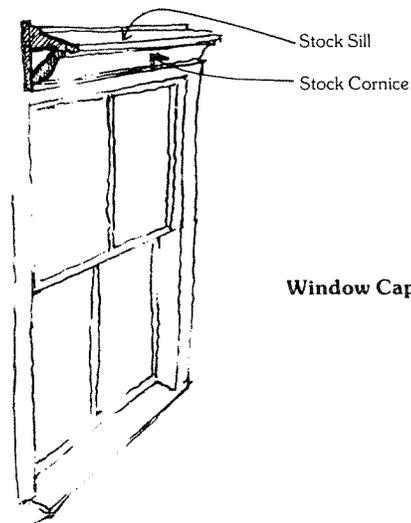
**Window Caps**

- Window caps. Most trim dating from the middle of the nineteenth century onward is built-up of several sections of milled lumber. The technique is no different today, although the stock shapes and sizes have changed. It is best to become thoroughly familiar with the range of shapes available at a good local lumberyard. Such familiarity can suggest a whole range of possible combinations. A window cap, for example, may combine a stock sill and stock cornice molding.

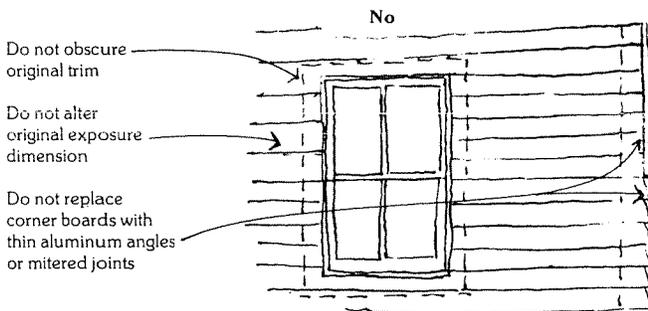
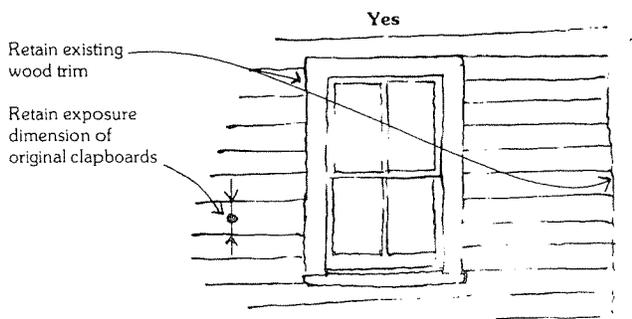
**Aluminum Siding Installation**

- Do not obscure such trim as window frames, door frames, and corner boards. Aluminum siding should butt the trim in a manner similar to the original wood siding since such trim is

an important element of the historic structure. Aluminum siding increases the overall thickness of the wall if applied over existing siding. Thus, it may be necessary to remove and pack out all trim if the visual integrity of the structure is to be preserved.

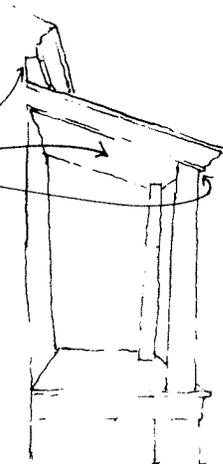
Signs of Moisture Accumulation

Rot, Peeling or Blistering  
Paint at:

- Eaves
- Ceiling
- Soffit of Porch Beams

- Rot and/or peeling and blistering paint at eaves.
- Rot and/or peeling and blistering paint at the soffit of porch-edge beams.
- Rot, peeling and blistering paint and/or sagging at porch ceilings.
- Lifted, deteriorated, or missing shingles.
- Cracked, bulging, or discolored ceiling plaster.

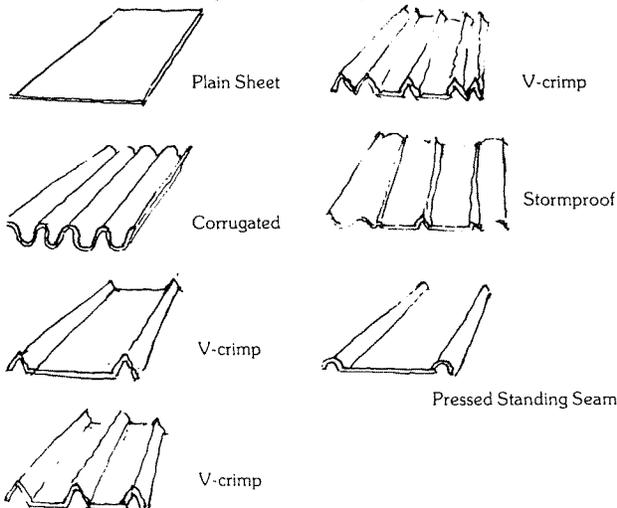
Sheet Metal Roofing: Profiles

- Patching. There are numerous sheet metal profile types available on the market. However, few are appropriate for use on the historic house. Corrugated and pressed standing seam sections are, for example, to be discouraged for use on all but modern construction. Of the remaining profile types, plain sheet metal has been in use for the longest period of time and is recommended. Of the two joint treatments, flat seam and standing seam, the standing seam was the more commonly employed. It is obvious that the corrugated sections shown in the sketch are not appropriate in patching earlier material since no blend is possible. Nevertheless, many metal roofs in the District have become a quilt of incongruous sheet metal sections. Care and common sense would have avoided this unfortunate appearance.

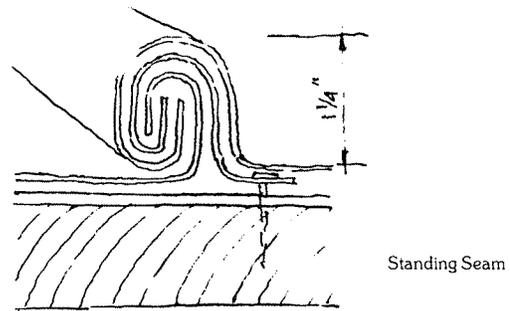
Standing Seam

### Sheet Metal Roofing Joints

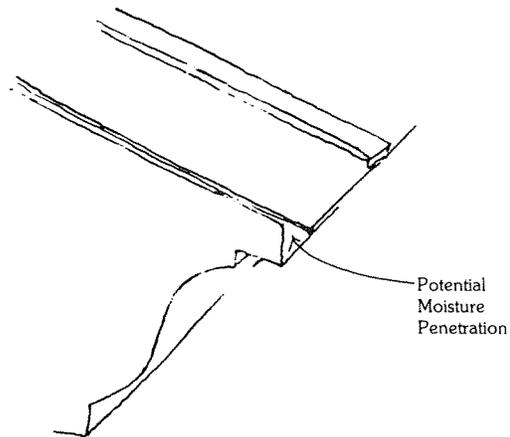
Flat Seam Metal Roofing: Improper Edge Treatment

- Edge treatment. The typical edge treatment of metal roofing at the cornice line throughout the Beaufort Historic District is abrupt and detracts from the other detail of the buildings. It is common to see the metal roofing simply stop at the cornice with no edge treatment whatsoever. This not only deprives the facade of the very important line created by the edge of the roofing, but it also makes the edge of the roof sheathing more susceptible to moisture penetration.

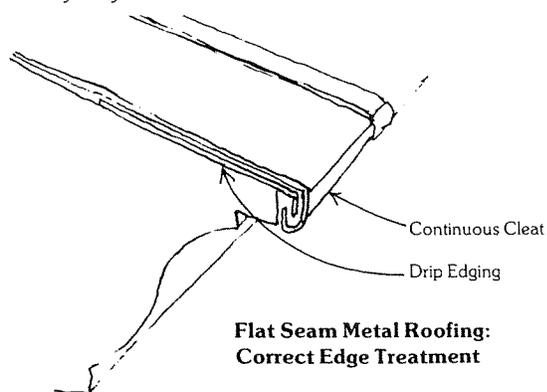
A preferable treatment for flat seam metal roofing offers several advantages:

- the edge of the roof sheathing is protected from moisture by the drip edging and the continuous cleat
- the continuous cleat gives visual depth to the roof line
- the lower edge of the drip is hemmed for purposes of added strength and stability
- the edge of the cleat does not obscure the cornice in any way.

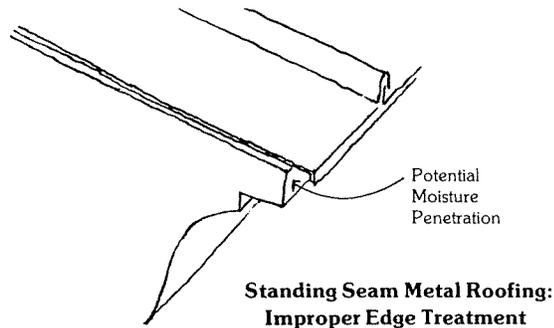
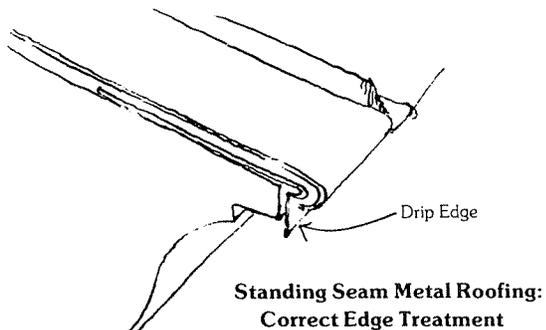
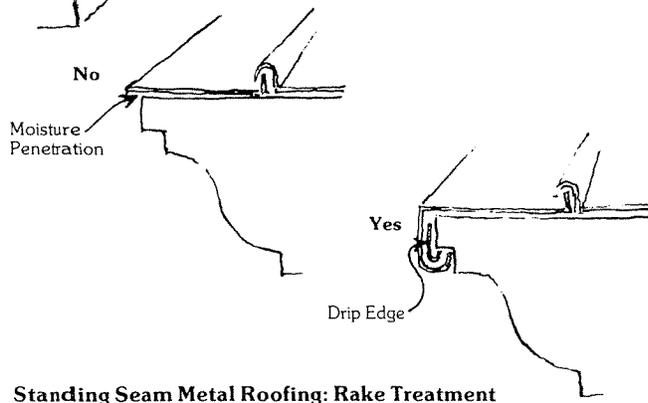
Similar treatment should be given to the edge of the metal roofing along the raked, or sloping, edge of the roof at gable end walls.

The edges of standing seam metal roofing should be treated in a similar manner showing cornice and rake conditions.

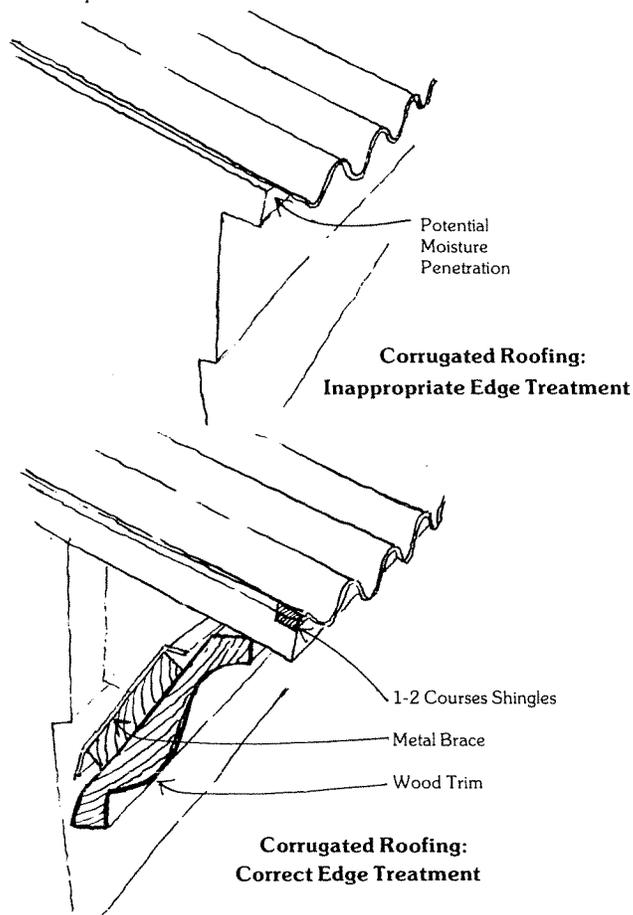
The corrugated and pressed seam sections that have been installed on the roofs of many Beaufort houses, however inappropriate, are not likely to be removed in the near future. However, in many cases this roofing projects several inches beyond the edge of the roof sheathing and should be trimmed and closed. This procedure simply modifies the standard industrial metal brace by allowing it to function as a support for a piece of wood trim. In addition, two courses of wood shingles along the edge give desirable depth to the important roof line.

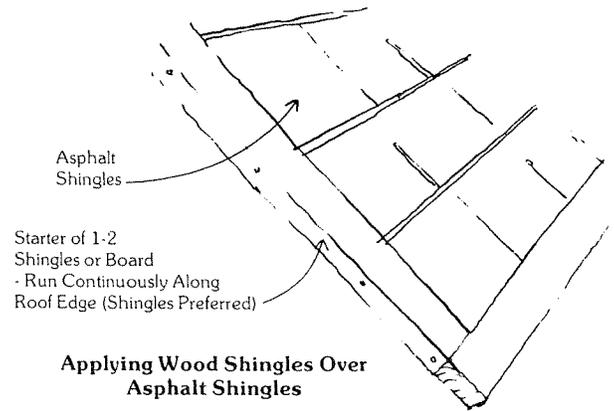
- An existing asphalt shingle roof need not be removed in order to apply a new wood roof. However, it is desirable to remove at least one course of the asphalt shingles along the eaves and rakes and replace them with a starter

course of shingles. This will conceal the asphalt roofing and provide the desired visual thickness at the edge of the roof.

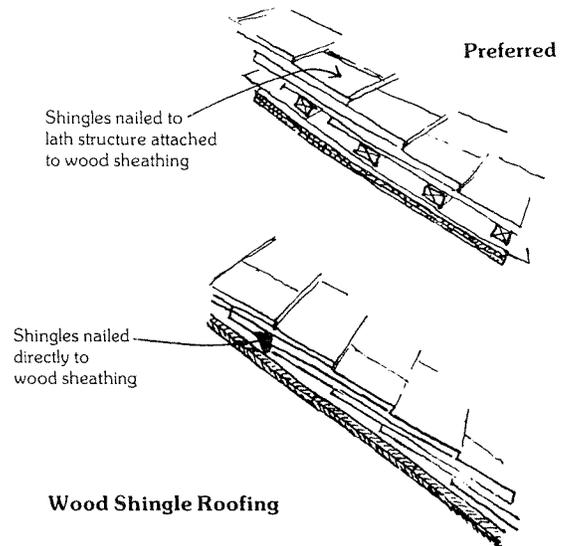
**Wood Shingle Roofing**

- Do not install wood shingles on a roof with a slope of less than six inches vertical to twelve inches horizontal.
- Try to nail the shingles to a lath structure so that they can be exposed to air on their underside. This lengthens their life and improves their performance.
- Because it is directed away from the prevailing wind, the best ridge treatment for use on the historic house is the comb.

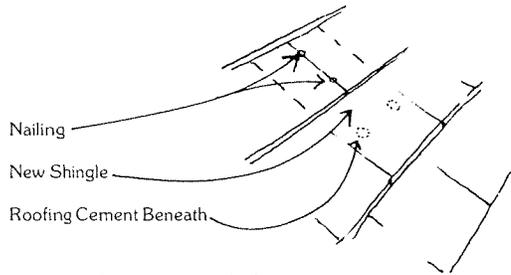
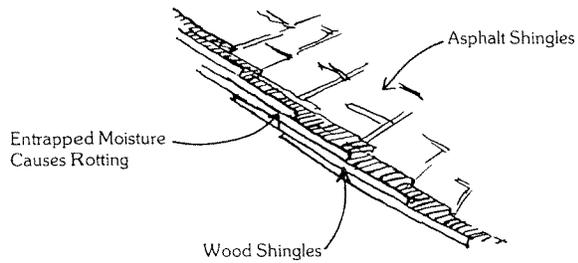
### Replacing Asphalt Shingles

- Securing replacement shingles: after sliding a new asphalt shingle into the proper position, it should be nailed along the joint of the two shingles immediately above it.

- It is best to repair asphalt shingles on a warm day when they are less prone to cracking.
- A small patch of roofing cement along the underside of their bottom edge will help keep replacement shingles from lifting.
- Asphalt shingles should never be applied directly over wood shingles because they can easily entrap moisture and cause rotting of the shingles and the top face of the rafters beneath, thus loosening important nailing and lath.

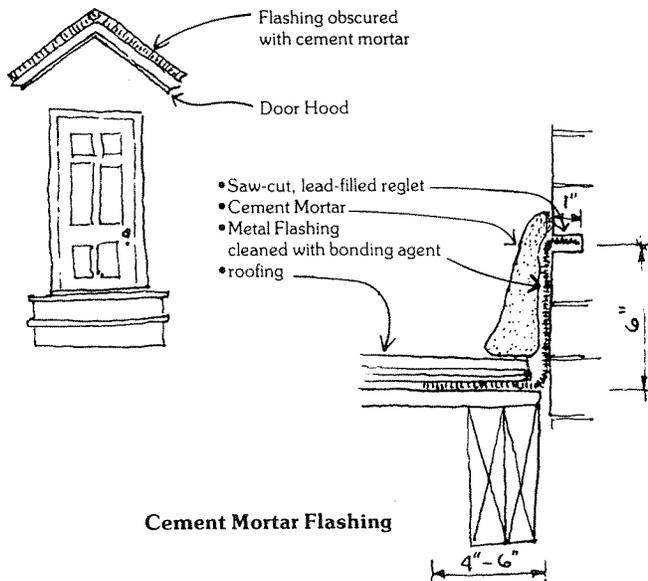
**Cement Mortar Flashing**

For example, joints between horizontal wood and vertical brick surfaces can be treated with cement mortar flashing. This treatment, which would be appropriate for flashing the joints of wood roofs and brick chimneys or wood porch roofs and brick walls, is especially recommended for pre-1860 construction. It is apparent that this technique does not eliminate metal flashing but conceals it with cement mortar. (Black roofing pitch is sometimes seen as a substitution and is entirely inappropriate.) It is best to prepare the metal flashing with a bonding agent and to epoxy grout it to the brick surface prior to applying the cement mortar. These steps minimize the movement in the flashing and improve the bond between mortar and metal, increasing the life expectancy of the mortar flashing.

Note: This concealment technique is not recommended in cases where the vertical surface is wood as, for example, in joints between the roof of an addition and the wood siding of the original building. The best form of concealment in this case is simply proper installation.

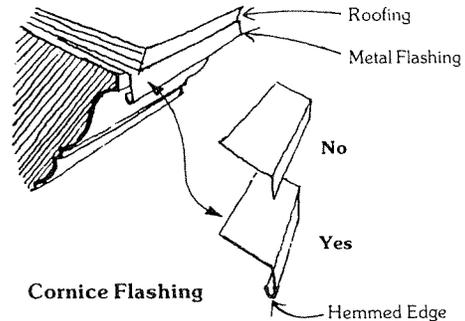
**Cornice Flashing**

- The bottom edge of the flashing is unrestrained and susceptible to bowing. This can be prevented by hemming the leading edge to provide extra thickness. The hemming provides the stiffness needed to resist wind and maintain the visual strength of a straight line. Without a straight edge, flashing calls attention to itself as material different than the adjacent wood cornice.

- The drip edge of the metal flashing should never project below the top vertical facet of the wood cornice. This condition alters the cornice proportions and projects a heavy shadow where one is not intended.
- Flashing should always be painted to match the cornice and not remain exposed as untreated metal. If the building has a painted metal roof, exposed-edge flashing should match the cornice rather than the roof color.

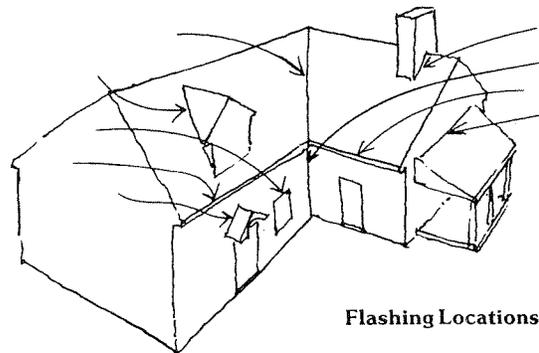
**Flashing Locations**

There are several locations where proper installation and maintenance of flashing is critical. Annual inspection should focus on these areas. If there is leakage or decay adjacent to any of these areas, deteriorated or missing flashing is the probable cause.

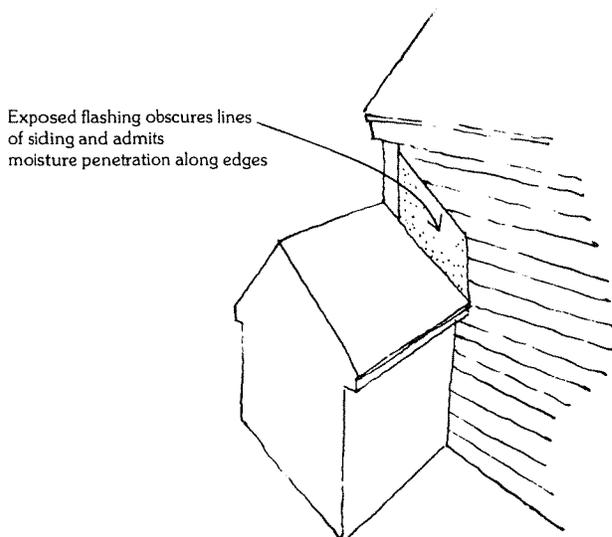
**Inappropriate Flashing Installation**

- Repair of inappropriate existing flashing. Too frequently, flashing applied to wood siding is lapped over several courses of clapboards. This destroys the visual continuity of the siding by interrupting the shadow line of each course. It also prevents inspection of the siding's condition at potentially weak joints with respect to moisture penetration. The flashing should instead be installed so that it laps under consecutive courses of clapboard. Shadow lines are thus uninterrupted and a "patched" appearance can be avoided.

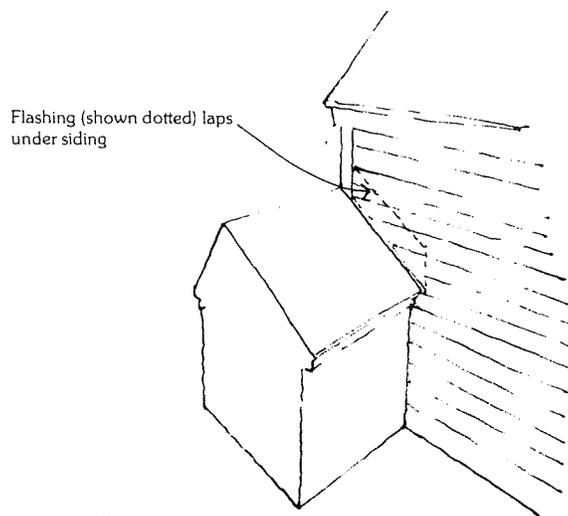
**Correct Flashing Installation**

This ill-considered flashing treatment also occurs frequently at window and door heads throughout the District. Flashing at this location should not be so extensive as to cover several clapboard courses. Instead it should lap under the immediately adjacent clapboard.

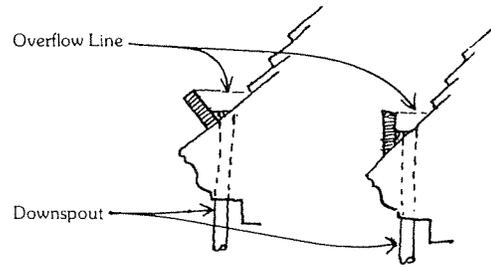
Pole Gutter Detail

Use of a pole gutter enables water to be diverted to locations where a downspout is architecturally unobjectionable. This device, also known as a "standing gutter," consists of a plain board (cypress is commonly used) which is set on the roof at least a foot back from the eave. The board may be installed either vertically or perpendicular to the roof plane and is fitted with a "floor," or trough, between it and the roof surface behind. This trough slopes at least 1/2" per foot towards the end of the gutter where the downspout is located. Whether installed vertically or perpendicularly to the roof plane, it is

essential that the roof shingles stop at the overflow line. The pole gutter is typically covered with continuous metal flashing, generally copper or tin plate, which should extend well beneath the roof material to prevent any accumulated water from backing up under the roofing.

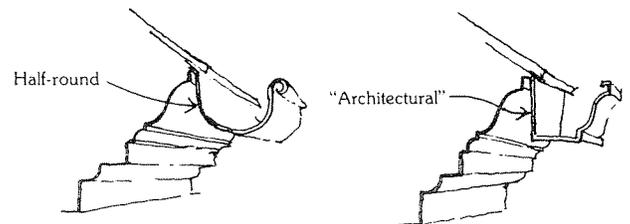
Metal Gutter Profiles

- Half-round. This most commonly used shape is considered desirable not only because of its simplicity, but also because

its profile cannot easily be confused with that of an adjacent cornice. Late nineteenth and early twentieth century gutters were generally half-round. If a pole gutter cannot be used, the half-round is the best selection. However, this should not be considered an enthusiastic recommendation.

- “Architectural” gutters. These gutters have an outer face that is molded with a shape which mimics that of a simple wood cornice. In general, they are not recommended because they either falsify the genuine proportions of an existing cornice or create the illusion of a molded cornice where none would exist. (The latter objection is especially strong when these cornice gutters are hung from the rafters or fascia board of a bungalow-style house.)

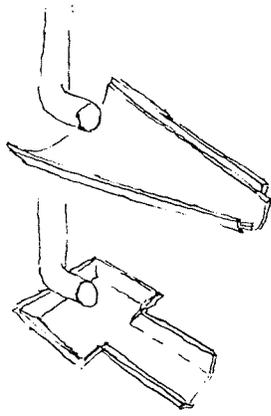
**Splash Blocks**

- **Splash blocks.** Immediate dispersion of water away from the base of the building is the intended purpose of the entire downspout system. If the system discharges at the ground surface, as it does for most buildings in the Historic District, it is essential that all grades at the base of the building slope away from the foundation. No downspout should simply discharge water directly onto the ground. Stone (not concrete) splash blocks will assist in dispersing this water. Several configurations of splash blocks are appropriate to various periods of construction. They are simple devices serving an important purpose. Another acceptable and efficient alternative is a spring-rolled,

perforated hose which extends during a storm to divert water, and retracts automatically during dry weather.

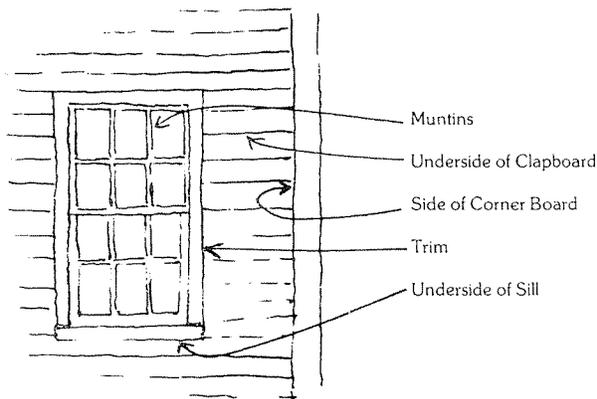
**Sources For Paint Sample Chips**

been applied to a particular surface over a period of time. Small chips of paint are removed down to the bare wood at various strategic spots on the building and analyzed to determine the sequence of colors. If the homeowner is collecting his own samples for analysis, the following factors will be of importance to the professional making the color evaluation:

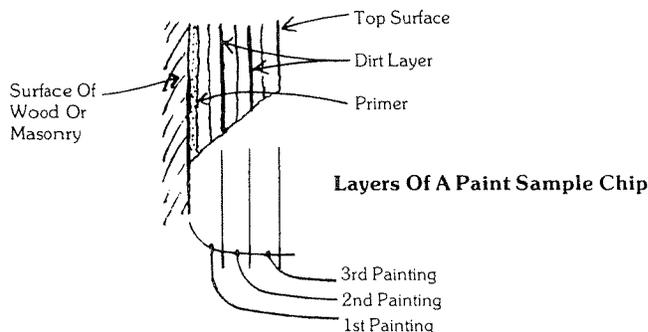
**Layers Of A Paint Sample Chip**

The scraped sample will reveal several layers of color. Former exterior colors will be covered with a thin layer of dirt. Primers

occur immediately below finish colors with no intervening dirt layer. These colors, once exposed, can be carefully matched against samples from modern paint companies, or, for even greater accuracy, against such color systems as Munsell or Federal. (The Federal System is a standardization of color prepared by the U.S. Government which can be obtained for relatively little cost. It is available from the Standardization Division, Federal Supply Service, General Services Administration, Washington, D.C. 20406. The Munsell System is much more extensive with commensurate costs. It offers a series of coded color chips which can be matched by a good paint store. It is available from the Munsell Color Co., Inc., 2441 N. Calvert Street, Baltimore, Maryland 21218. Neither system is associated with any particular brand of paint.) The trained interpreter will be able to match the color, and will take into account these factors:

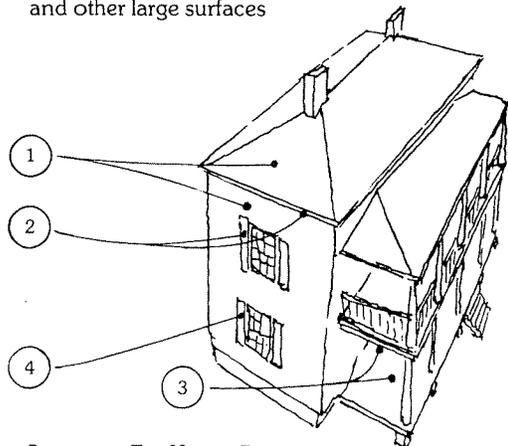
Sequence For House Painting

- Always work from the top down. The following suggests an effective order of work:
  - 1st - the main part of the house, including siding, roofing, and other large surfaces

- 2nd - trim -- cornices, cornerboards, doors, windows, dormers, etc.
  - 3rd - porches -- floors, ceilings, balustrades
  - 4th - shutters and screens (painted when removed from building)
- Also, always work horizontally. Don't leave any given clapboard half done overnight.

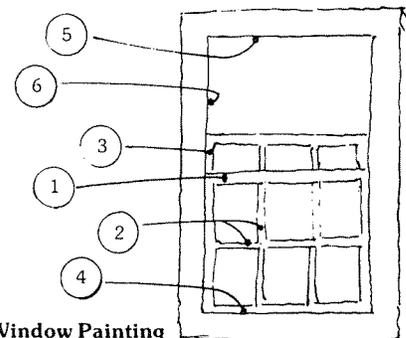
Sequence Of Window Painting

- Always paint window and door elements in the proper sequence to minimize the difficulty in handling certain edges. Caulk and re-glaze windows as required prior to repainting (see "Openings").

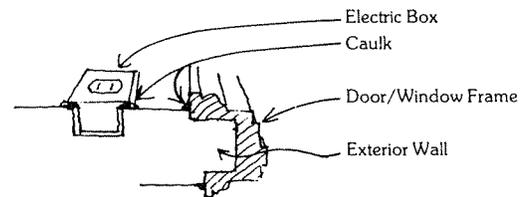
**Interior Caulking to Minimize Air Infiltration**

- **Air infiltration.** Cracks at windows, doors and construction joints admit a continuous and significant quantity of cold or hot air which adds a considerable burden to a cooling or heating system. Simple maintenance procedures such as the following are very cost effective.
- Caulk all construction gaps. Running a hand along interior woodwork, access holes or other joints, will immediately indicate the locations of drafts. Window and door casings should be caulked inside and out. Major construction joints such as those at exterior corners and between different materials are prone to air leaks and should be sealed.

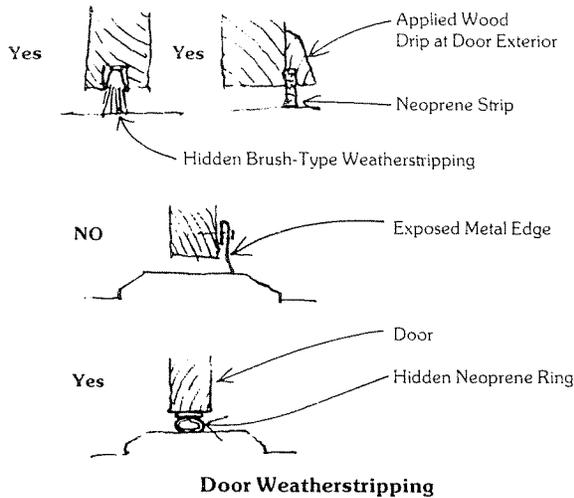
- **Weatherstripping.** Mechanically sealing the numerous cracks between windows and frames or doors and frames with strips of foam rubber, felt, vinyl, or metal greatly diminishes the amount of air which can enter the house. (If metal weatherstripping is used, it should be primed and painted so that it does not present a jarring-obtrusive element to historic doors or windows.) Double-hung windows should be weatherstripped around the inside perimeter and at the meeting rail, which is the most common area of air infiltration. At doors, weatherstripping should be installed on the frame and along the full width

of the bottom door rail. The charm and impact of a paneled door will be destroyed by an insensitive application of weatherstripping. There are several compatible weatherstripping techniques that are greatly preferred to surface applied, metal strips.

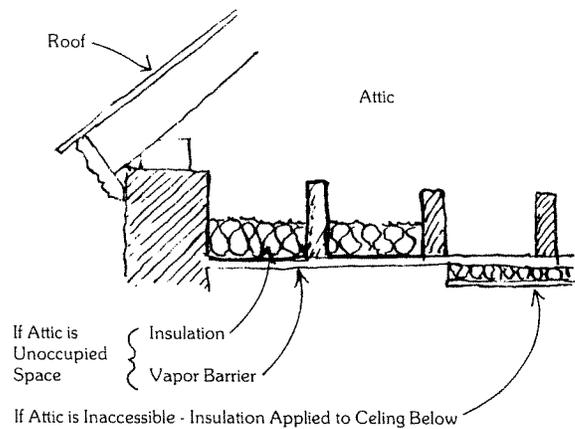
The most common mistake in the installation of attic insulation is incorrect placement. In an unheated attic, the insulation should be placed between the floor joists with the vapor barrier down. It should not be installed between the rafters directly against the underside of the wood roof where it will shut off crucial ventilation to the roof sheathing.

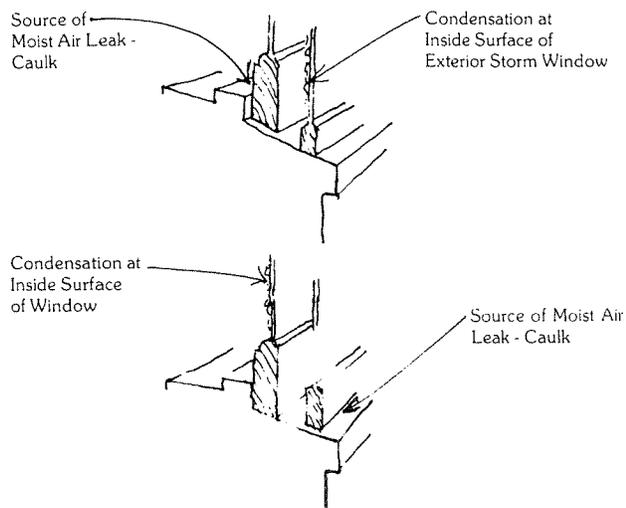
**Storm Windows and Condensation**

Window/storm window assemblies which are suffering from condensation problems in the winter are generally experiencing leakage of moist air. Caulking, when applied correctly, usually alleviates this problem. An option to caulking is a sponge-type "filter" placed on the bottom edge of the frame of the storm window. This treatment allows gradual air movement.

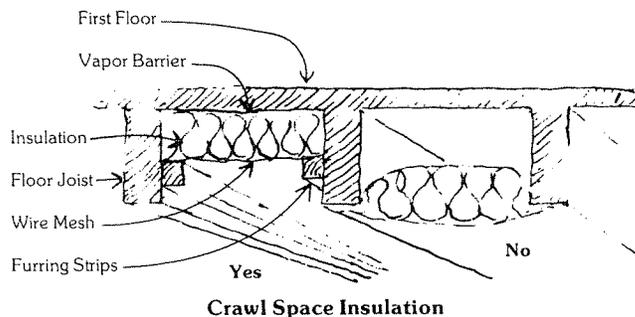
**Crawl Space Insulation**

Crawl space insulation, an effective device for minimizing both cooling and heating loads, should be installed against the underside of the flooring or underlayment between the joists with the vapor barrier up. A common but ill-advised practice is to apply the insulation so as to create an air space between its top surface and the underside of the flooring. Although it makes for easier installation, the insulation can be rendered useless by condensation of moisture in the resulting air space.

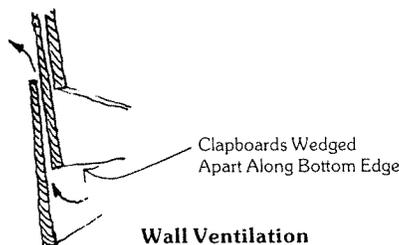
- For blanket and batt insulation work from the outside in by carefully removing (and numbering for replacement) all wood siding. The vapor barrier should be installed in the proper direction; in northern climates the barrier always faces in, although in southern locations it is often placed facing out. For insurance against serious damage, vapor barriers in both directions are sometimes recommended. Consult a local mechanical engineer for the proper installation. In any case, the vapor barrier is absolutely necessary to prevent condensation from destroying the effectiveness of the insulation and threatening the wood frame. The space between each pair of studs must be ventilated.

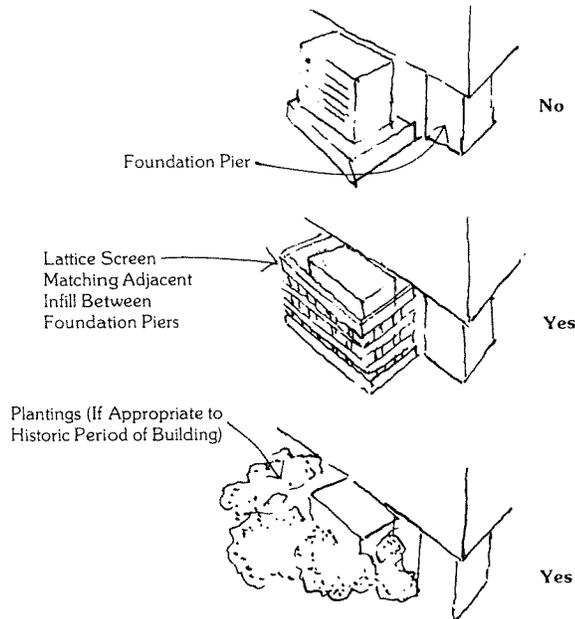
## Obscuring Exterior Air-Conditioning Equipment

- Air-conditioning equipment. Centrally-cooled houses have fairly large and conspicuous equipment which is usually placed at the foundation wall. Such equipment should be screened with plantings or latticework which matches the infill between the foundation piers. These screening techniques can be gracefully accepted by late nineteenth and early twentieth century structures, but in cases of early architecture, where foundation planting should be kept to a minimum, it is best to keep all condenser equipment some distance from the house (see "Landscaping").

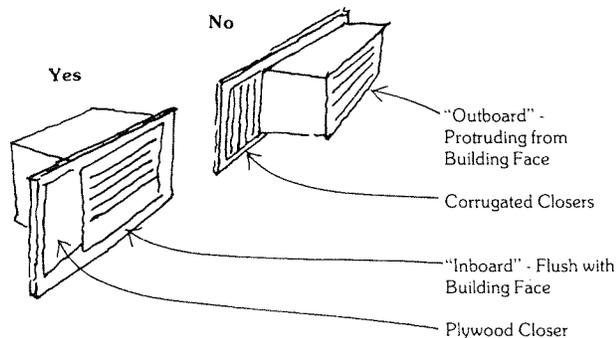
## Mounting Window Air-Conditioning Units

It is also possible, with a little care, to minimize the visual impact of window air-conditioning units. First, in the historic house they can and should be placed "inboard" so that they do not protrude from the face of the house. Few homeowners in Beaufort have taken advantage of this

alternative. Also, it is helpful to paint out all exposed metal in a dark neutral color that appears from a distance to be the same tone as the glass itself again, a simple but effective technique. Instead of plastic or corrugated metal closures, plywood should be cut to flank the unit and close the opening. Such closures should also be painted out. Finally, where the option exists, window units should be located on the side or rear elevations of a building rather than on the principal facade.

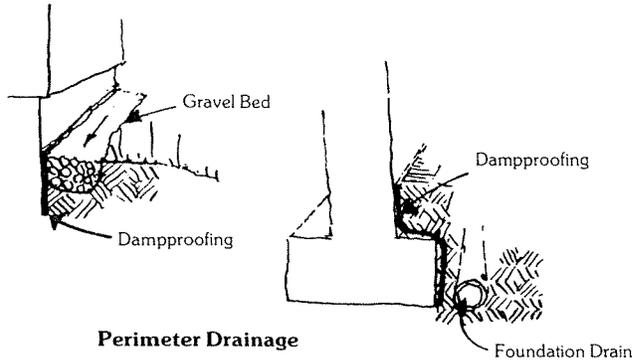
- Install a gravel bed several feet in depth along the perimeter of the house. This is combined with an underground perforated “french drain” of tile or concrete which collects and disperses the accumulated water at a dry well or storm sewer. The system should be installed by a competent contractor to avoid invisible clogs or movement in the system that can result from improper construction. The surface of the gravel bed should slope away from the house, and may be supplemented by a “swale” (a contour grading technique which forms a channel for directing drainage).

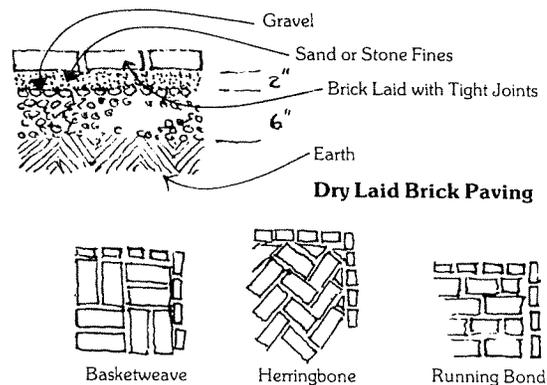
Brick Paving Patterns

walks. These include earth, gravel, oyster shells, or patterns of dry-laid brick, any of which should be installed over a continuous gravel bed of 4" - 6" to facilitate drainage.

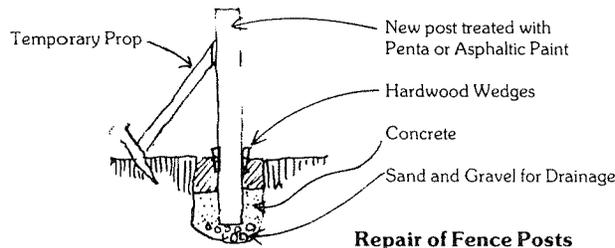
Repair of Fence Posts

- Deterioration of wood post supports due to rot (see "Wood"). This important repair is simple if done according to the following procedures.
  - Prop up the wire fencing and remove/replace one deteriorated post at a time.

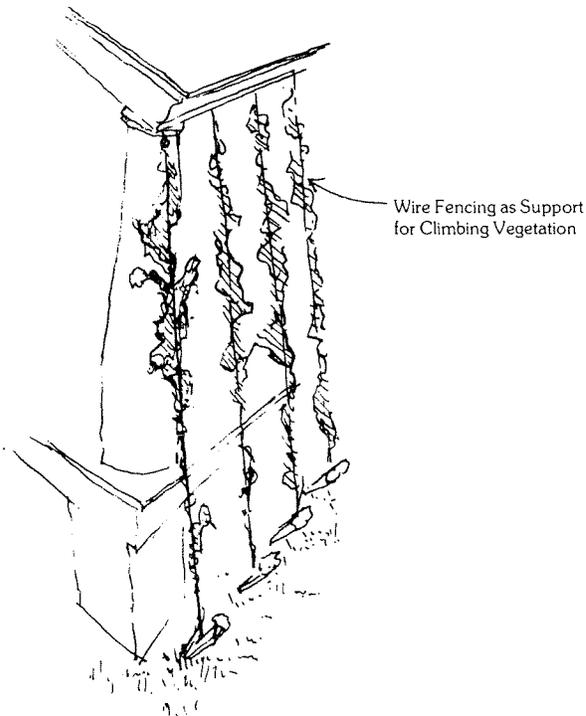
- Prior to installation, soak the new post overnight in preservative, being especially careful to soak the end grains. Consider that the overall length of the post should be at least half again as long as the above-ground portion. Place a gravel bed for drainage in the bottom of the hole and set the post vertically, propping it up in the hole as required. The hole should then be backfilled with earth or concrete. The upper surface of concrete, if used, should be recessed several inches below grade to allow a covering of soil.

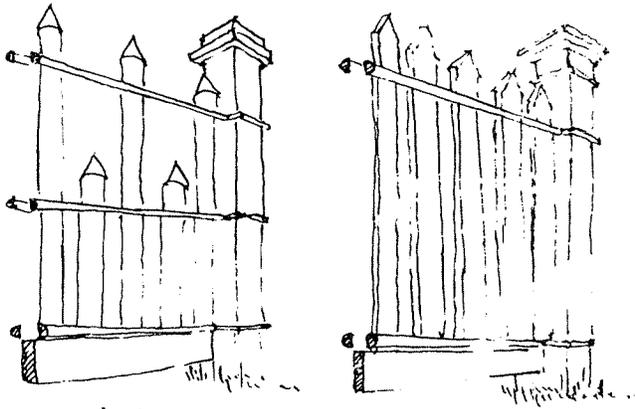
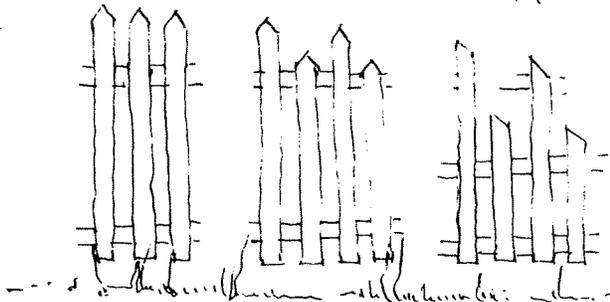
Appropriate Wood Fencing Types

**Wood Fencing** - Wood picket fences are the most dominant site-bordering device employed in the Historic District. The range of appropriate designs is broad enough that the property owner who is considering a new fence need not turn to one of the many modern redwood fences currently on the market. Such fencing is in general a completely inappropriate site-bordering device and should be prohibited from use along streets and dominant facades throughout the District.

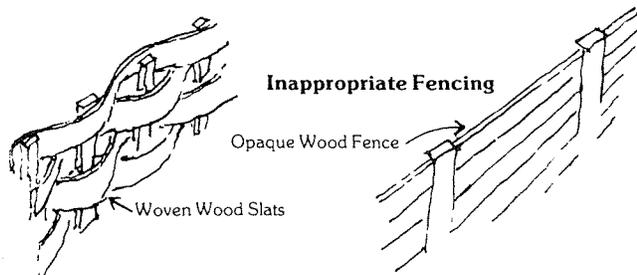
Inappropriate Fencing

Woven Wood Slats
