# The Beaufort Preservation Manual

prepared for  
The City of Beaufort  
Beaufort, South Carolina

by  
John Milner Associates  
West Chester, Pennsylvania

August, 1979

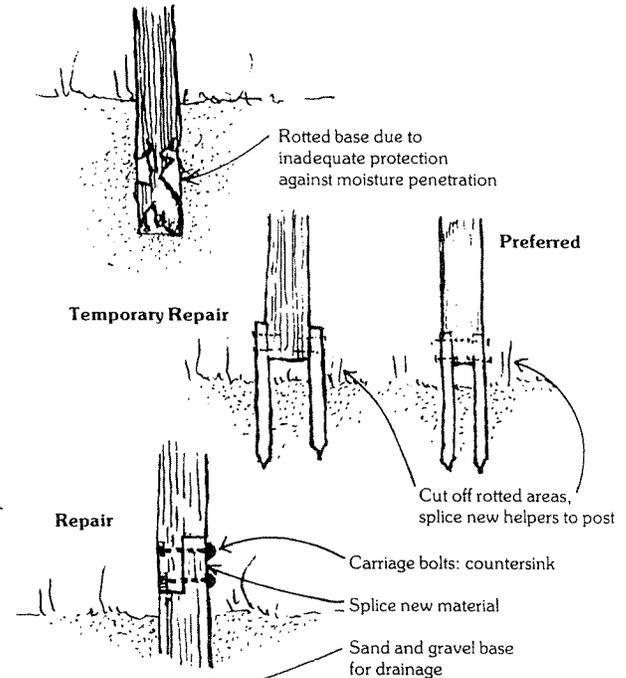
Rotted Fence Posts

- **Rotted fence posts.** If a fence post is so deteriorated as to be unsalvageable, total replacement may be required. In such a case, match the post and re-install according to the process previously discussed in this section under "Wire Fencing." However, if the fencing is an important historic feature, an effort should be made to splice good existing material to new material. The process is as follows:

- Dig out the earth around the post base and cut off the rotted section.
- Liberally brush wood preservative along the bottom face of the trimmed existing post.
- Splice new materials to the bottom of the post using either "helpers" or a matching splice. All new material should be thoroughly soaked in preservative.
- If the post is to be embedded in concrete, the top surface of the concrete should be kept below grade and covered with soil.
- If the entire post is not embedded in the ground, it should be mounted on a stone plinth (base) rather than concrete. Again, the post, and especially the end grain should be thoroughly soaked in preservative.

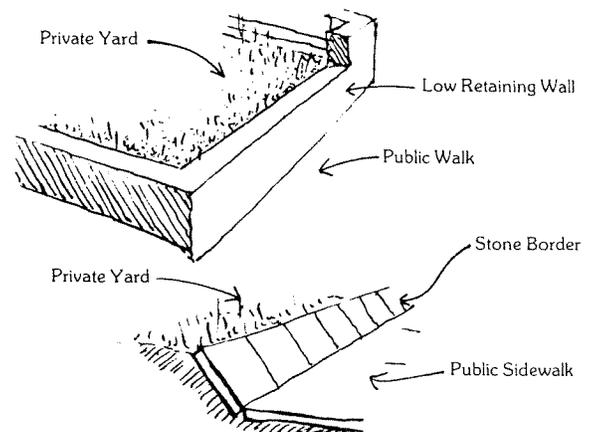
Boundary Treatment

A typical late nineteenth and early twentieth century landscaping device was the slight elevation of the front yard above the public walk which flanked the property. One acceptable border for this condition is the low stuccoed brick retaining wall (for repairs to this wall, see "Brick" and "Stucco"). Less common, but more graceful, is the canted course of stone seen at 901 Craven.

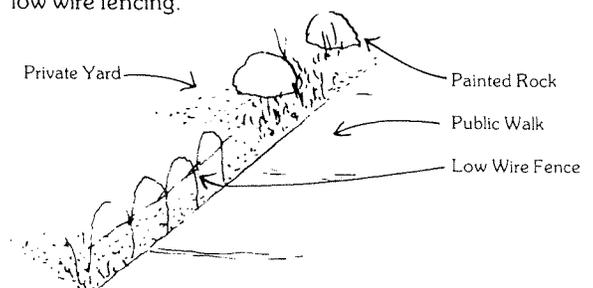
Inappropriate Boundary Treatment

Do not use the following bordering materials in the Historic District:

- concrete block
- painted rocks
- low wire fencing.

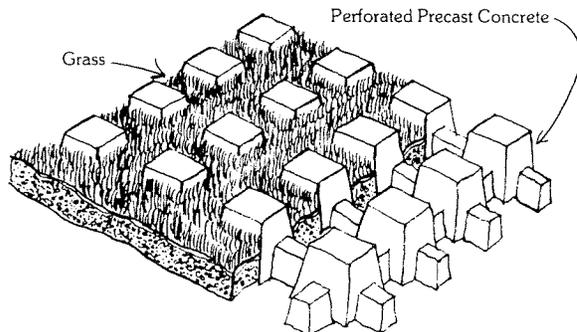
**"Checkerblock" Paving for Parking Areas**

Widening of the paved cartways would alter this scale substantially. Where it is deemed necessary to provide more durable, hard-surfaced, on-street parking in residential areas, perforated, precast concrete would be preferable to asphalt and would allow the areas to remain grass.

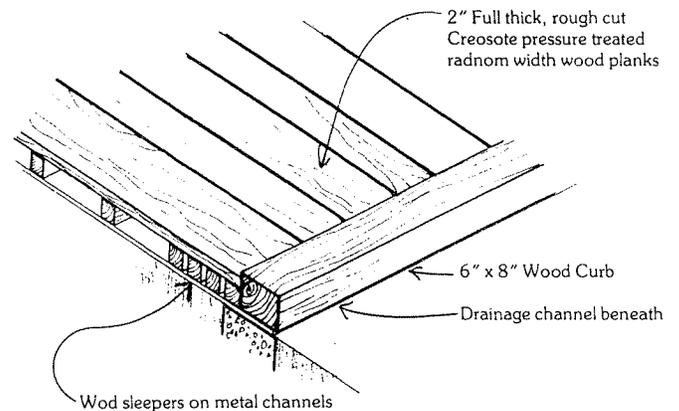
**Wood Sidewalk: Detail**

The abrasive level of brick pavers can be increased through the use of wire cut brick. Wood walks can also be utilized if rough sawn for texture, and either amply treated with a wood preservative such as pentachlorophenol or pressure treated. Both stone and brick should be evaluated for resistance to shear particularly if they are to be dry set. Such paving materials may either be set on a concrete base, in which case the joints should be mortared, or dry set on fines (crushed stone such as granite) as opposed to sand.

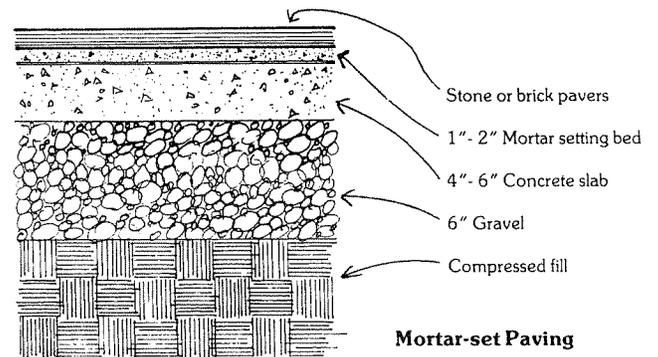
**Mortar-set Paving**

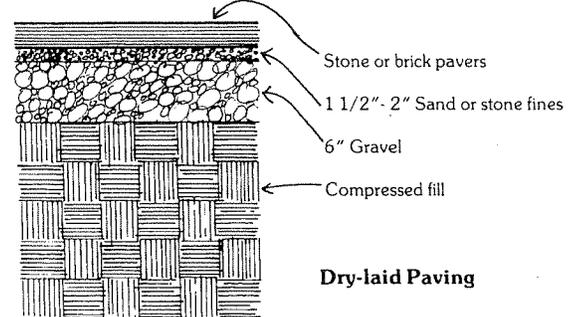
**Dry-laid Paving**

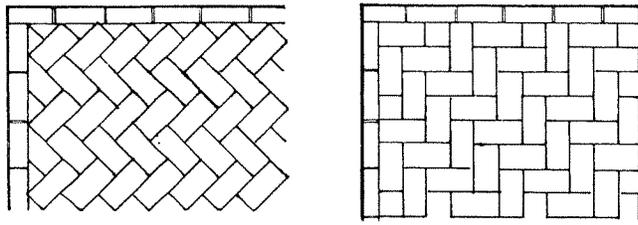
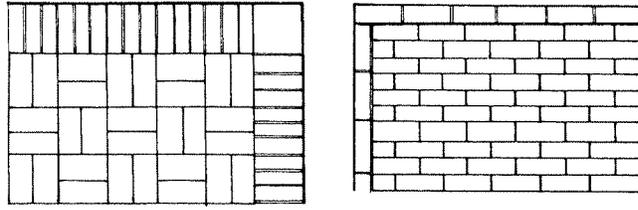
Herringbone

Modified Herringbone

Basketweave

Running Bond (Bricks on Edge)

**Brick Paving Patterns**

Pattern, color, and size are important elements in the use of brick paving. Contemporary colors, such as buff or brown brick, should be avoided. A modular size, while historically

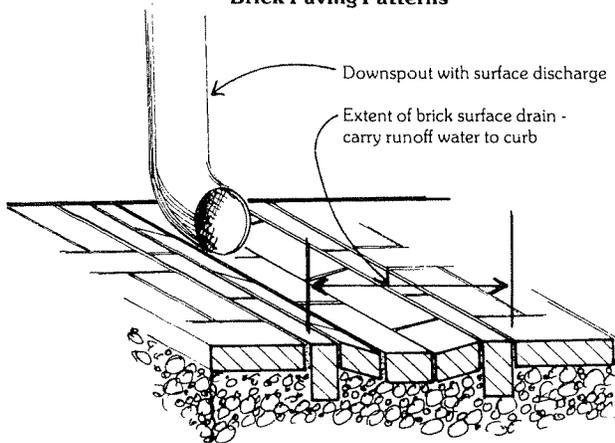
**Brick Surface Drain**

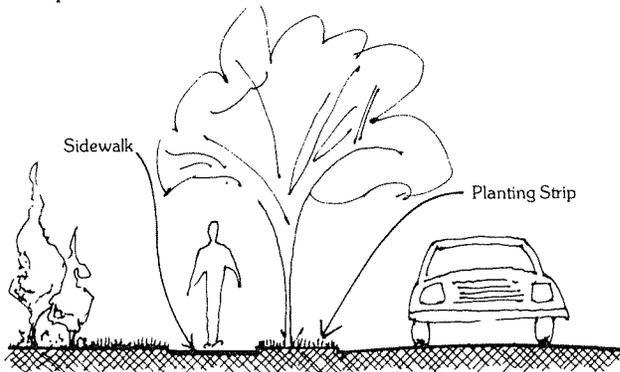
**Sidewalks: Residential Street**

- Walks in residential areas may often be handled in a more casual fashion. While dry-laid red brick, or slate/bluestone walks are appropriate, tanbark chips, oyster shell, or pea gravel provide a more natural, informal walk in areas of light pedestrian traffic. A more permanent walkway can be created using pea gravel or oyster shell set in a clear epoxy base. Even concrete or asphalt walks will be more in keeping with the setting if finished in exposed aggregate. Wherever possible, residential walks should be limited to 3-to-4 feet in width and separated from the cartway by a grass planting strip several feet wide.

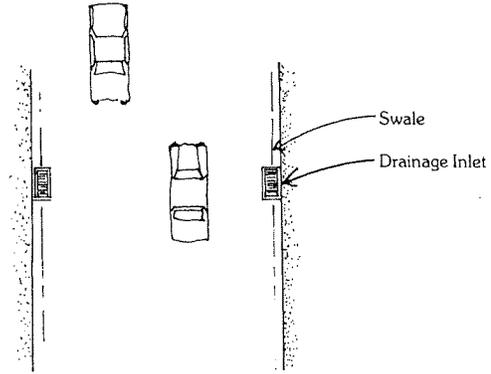
**Cartway Drainage**

- Curbing, like walks, can be minimized in residential areas. Again, the formality of 6" vertical face curbing is unnecessary in most streets, and would reduce the present parking flexibility. Rather, improved drainage may be established, where required, through grading and the incorporation of an asphalted drainage channel.

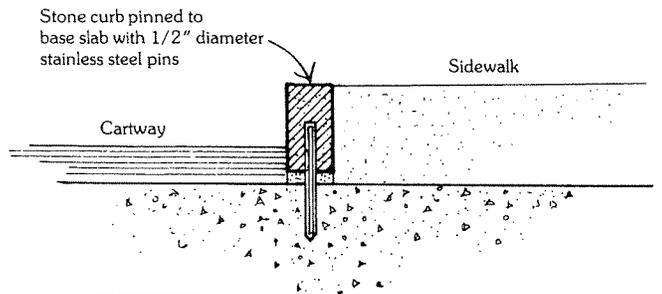
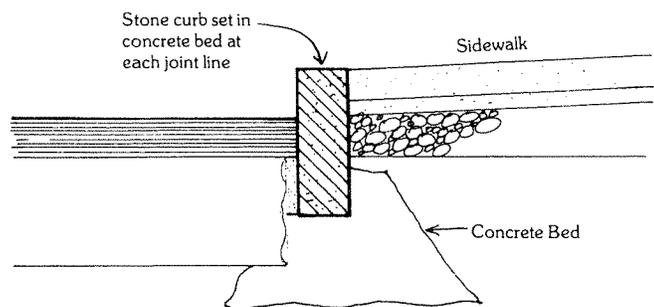
**Stone Curb Anchorage**

Vertical curbing exists along most commercial streets and is a necessity. However, like concrete walks, concrete curbing does little to enhance the streetscape. Split face granite curbing is a more compatible material and is more durable than concrete. Wood curbing may also be installed alongside wooden walks, using pressure treated railroad ties.

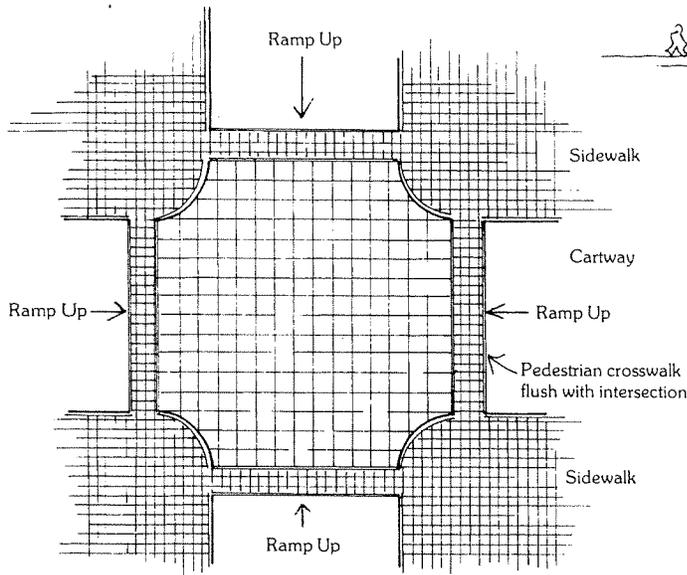
**Flush Intersection: Plan**

- Paving of intersections and crosswalks in brick or other materials which reflect pedestrian use can reduce the expanse of cartway and impart a feeling of pedestrian activity and dominance over the automobile.
- In some instances intersections may be raised flush with the sidewalks. The use of approach ramps in cobbled materials will further define the intersection as a pedestrian area and help restrict traffic speeds. Raised intersections also eliminate the need for handicap ramps.
- In addition, parking laybys can be paved in patterned concrete, cobbles, etc., to create a definition of use and

minimize the extent of asphalt roadway. In general, pedestrian areas should be paved in smooth materials, whereas parking laybys, ramps, and other vehicular areas can be suitably surfaced in cobbles or other rough textured materials which inhibit extensive pedestrian use.

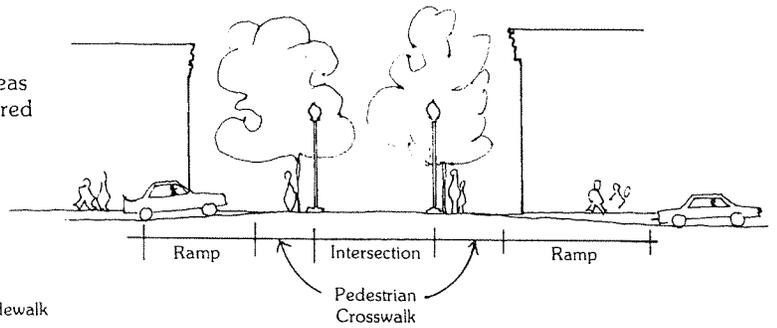
**Flush Intersection: Section**

Intersections, curb cuts, planting areas, and sidewalk drainage may also be handled in a variety of ways, such as those illustrated.

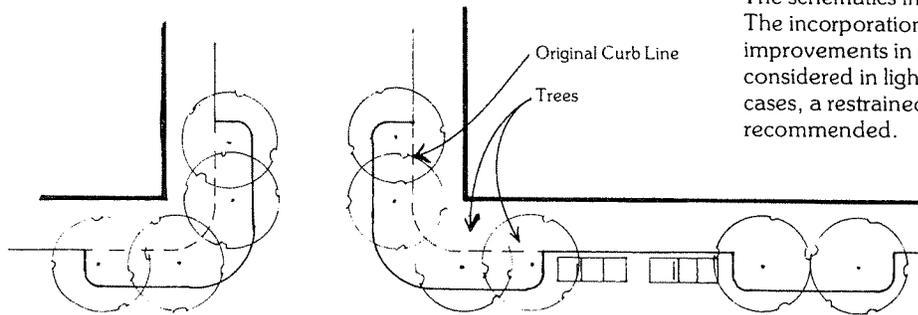
**Expanded Sidewalk Area: Corner Treatment**

- Expanded pedestrian space (which can serve as seating or planting areas, space for sidewalk sales, vendors, or other activities) can be created by increasing the walkway widths where on-street parking is not essential. An eight-foot increase in sidewalk width provides usable pedestrian space without reducing the cartway width. Such sidewalk expansion is particularly appropriate at intersections, reducing by sixteen feet the effective distance that a pedestrian must traverse in crossing the cartway.

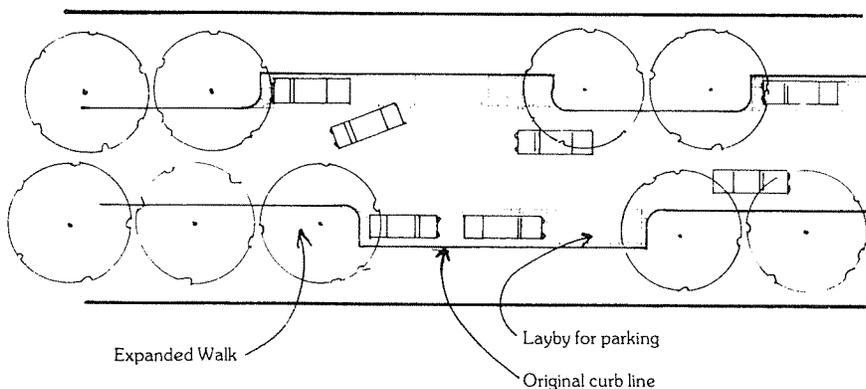
**Expanded Sidewalk Area**

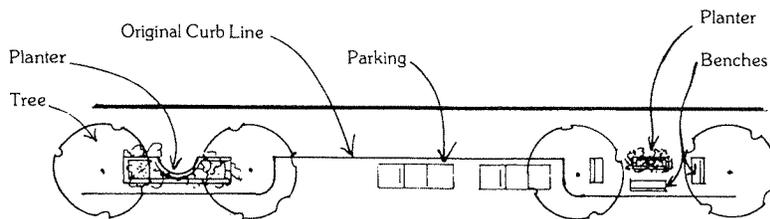
**Seating Plans at Expanded Sidewalk Area**

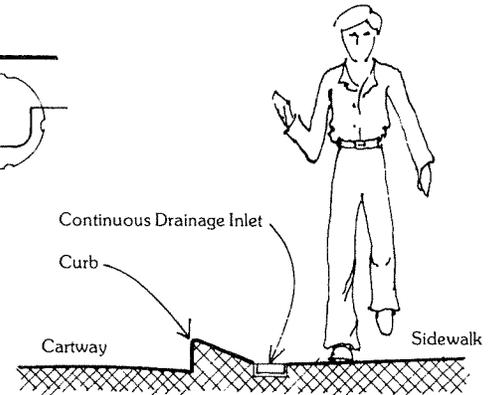
**Sidewalk Drainage**

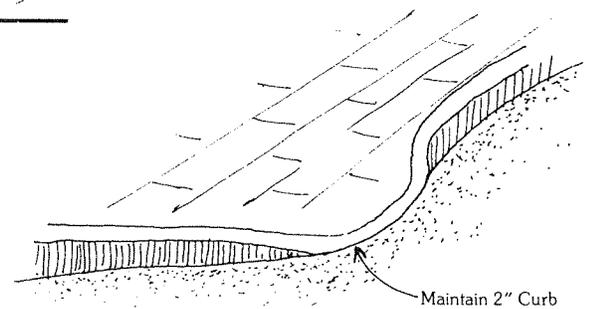
**Handicapped Ramp at Curb Line**

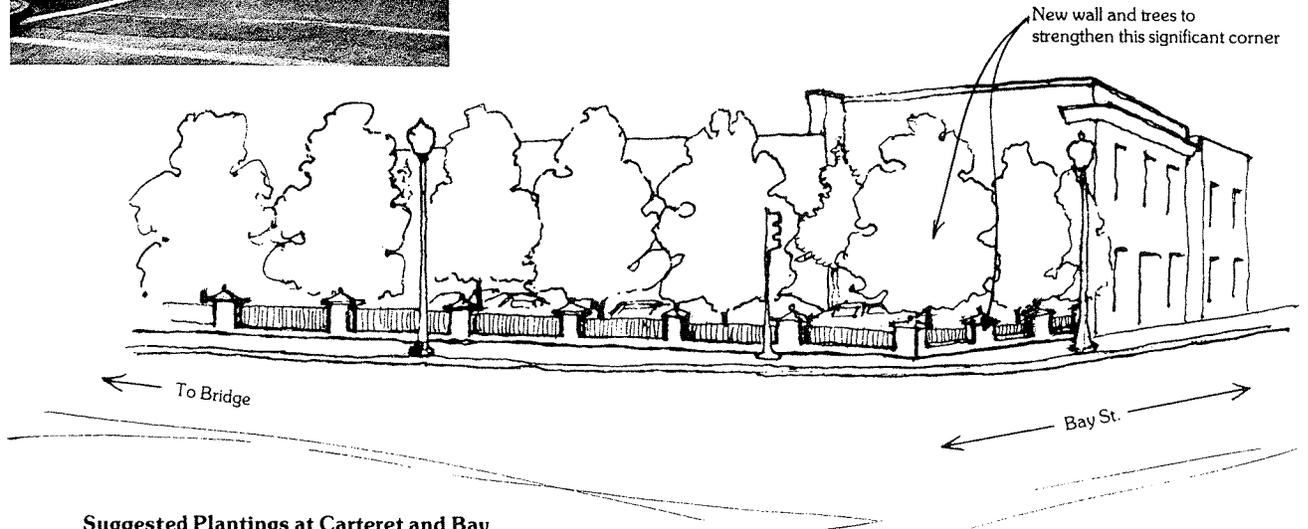
Suggested Plantings at Carteret and Bay

Plantings may also be used to define spaces, either historical or contemporary. For example, the southwest corner at Bay and Carteret is a weak terminus to the commercial district due to the presence of a surface parking lot and consequent lack of a strong corner structure. A fairly regimented stand of trees at this corner, coupled with a brick wall or other structure to partially conceal the proliferation of cars, would assist in strengthening this end of the commercial block. In general, surface parking lots adjacent to streets detract heavily from a commercial area.

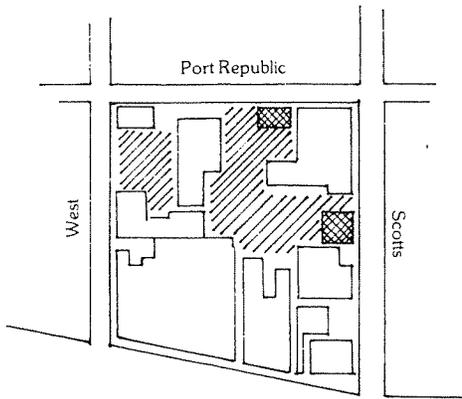
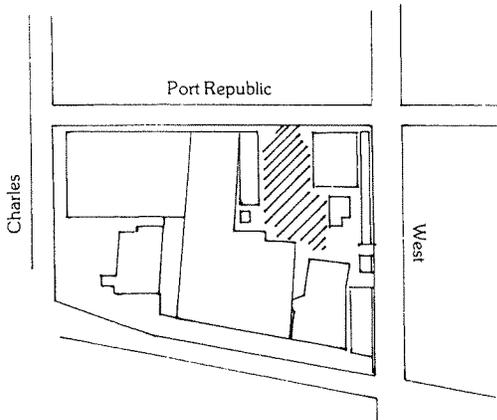
**Intra-block Parking in Existing Open Space**

This is particularly true at corners where strong architectural elements are often critical in setting the tone for the block beyond, or in making a smooth transition from one block to the next. It is strongly recommended that any additional parking areas in the commercial section be limited to the intra-block area, although the demolition of buildings for this purpose should be avoided. The loss of early building stock for surface parking is irretrievable, and this approach reaches a point of

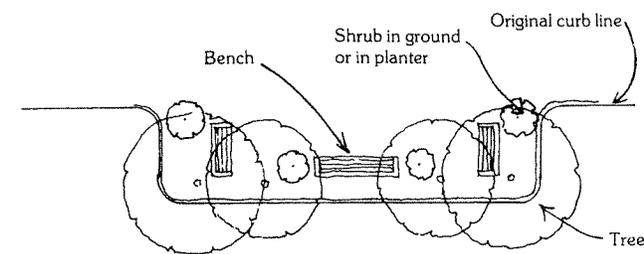
**Plan: Expanded Sidewalk Area**

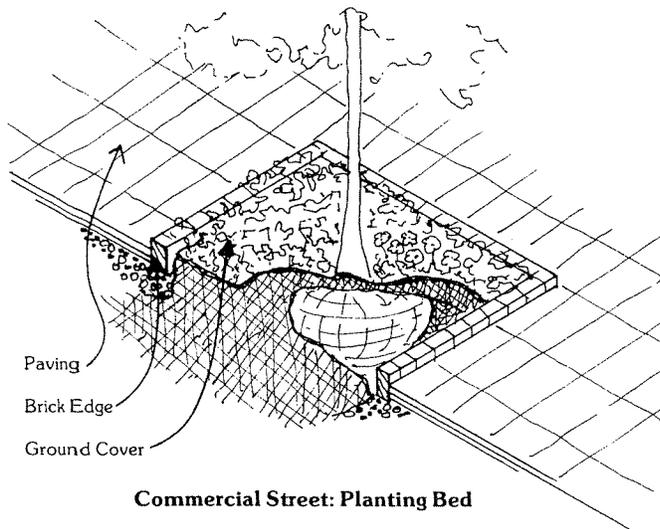
**Commercial Street: Planting Bed**

- Vandalism to plants and planters is a major concern in many communities dealing with revitalization. Thus, plant containers should be durable and of adequate weight/size to preclude theft. An alternative is to utilize in-ground planting methods as opposed to movable planters. Similarly, plants themselves should be of hardy varieties and installed in relatively large calipers. Many trees can be installed at a 5" - 6" caliper planted size. Shrubs, also, should be selected which are of adequate growth to give the impression of permanency and imply difficulty in removal. Increased plant sizes will also create a much greater positive impact on a completed project.

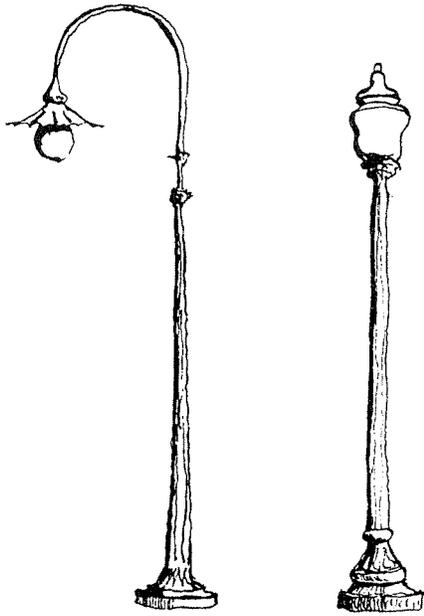
Cast Iron Street Light Fixture:  
Early 20th Century Design

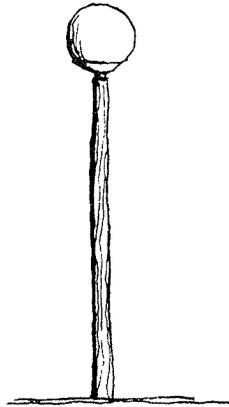
Street Light Fixture:  
Modern Design

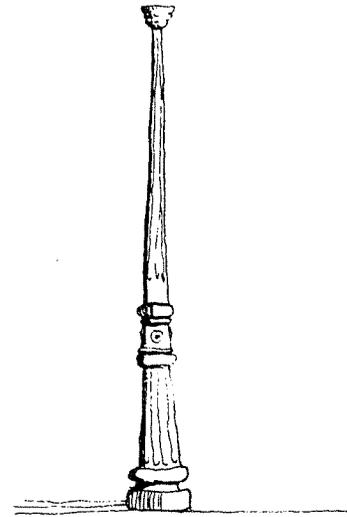
Cast Iron Street Light Pole

In addition to high quality detailing, durable materials should be selected which are compatible with the historic character of the street. Cast iron or solid wood poles, copper or cast hoods, porcelain burners, granite bases, wrought iron arms or brackets, and brass fittings are examples of appropriate materials; conversely, contemporary materials such as aluminum, while durable, are of a distinctly modern character. While globes can be glass, polycarbonate globes (either clear or translucent) are considerably more durable and retain the appearance of glass.

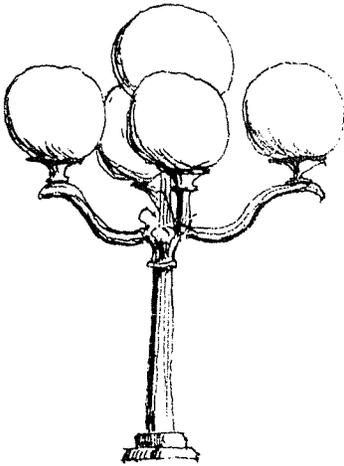
Cast Iron Street Light Fixture

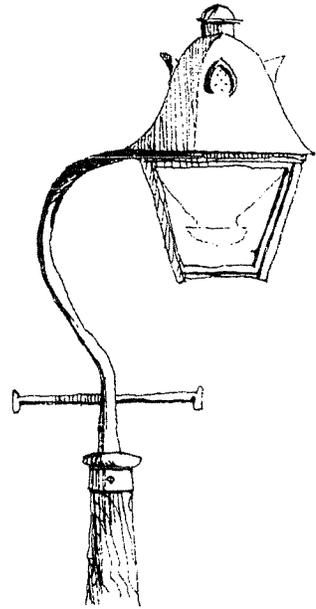
Street Light Fixture: Colonial Design

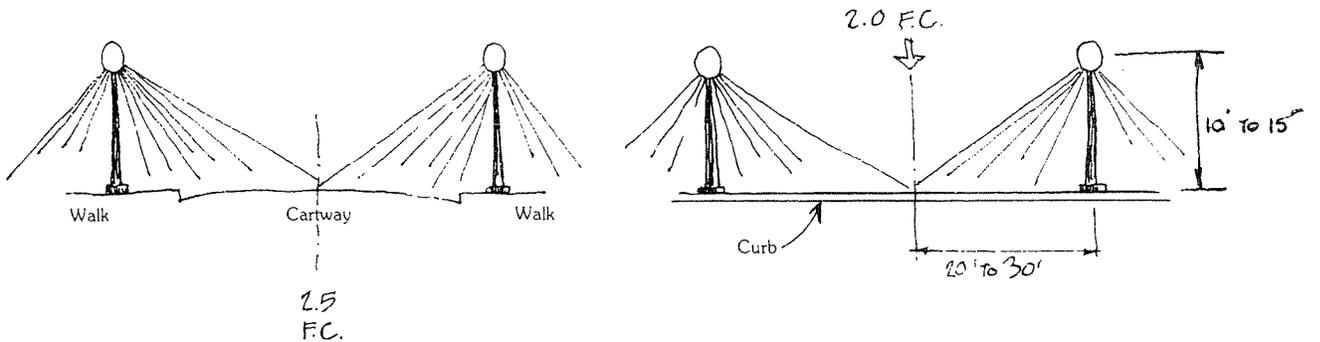
Lighting Level Criteria: Commercial Street
